# Utility Crossing Inspection Program

Reference ID (DS\_ID): 17369

## Detailed Field Report

Sutter Maintenance Yard - (ST0003)

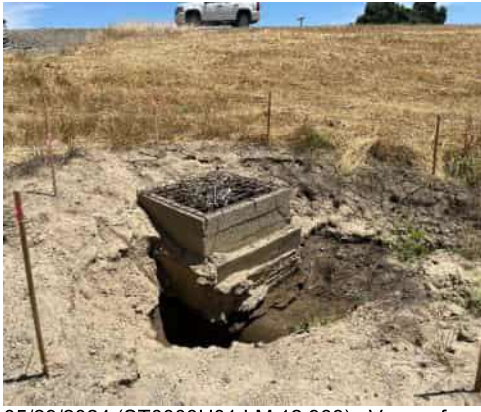
05/29/2024 Pipe remains urgent, severe erosion was noted at concrete box. (J. Singh - DWR UCIP)

05/29/2024 (ST0003U01 LM:12.963) : Veew of severe erosion at concrete box

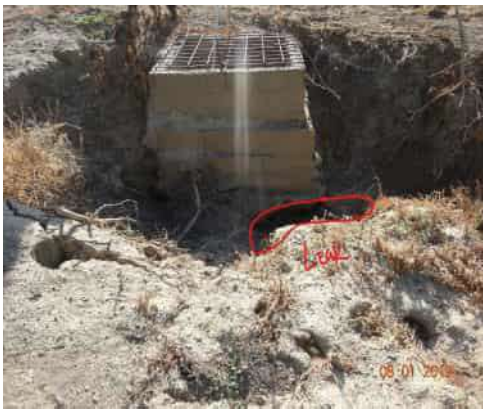
11/12/2019 (ST0003U01 LM:12.963) : WS view: erosion associated with concrete box.

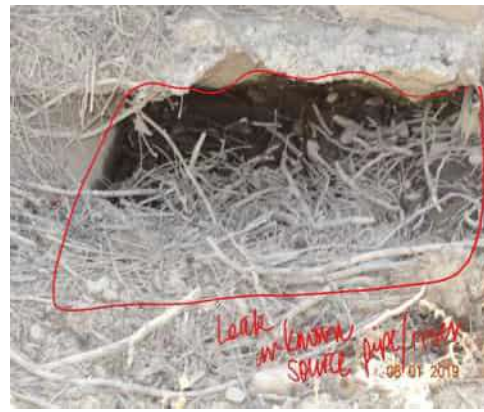
11/12/2019 (ST0003U01 LM:12.963) : WS view: leak visible on WS.

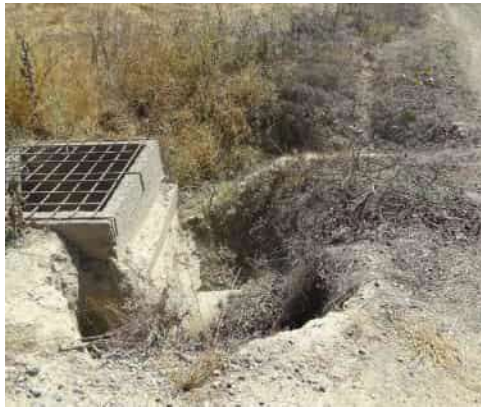
08/30/2018 Same as last inspection; erosion at surge box so crossing remains Urgent. (D. Sanoski - DWR UCIP)

08/30/2018 (ST0003U01 LM:12.963) : WS view: same massive erosion around concrete surge box.

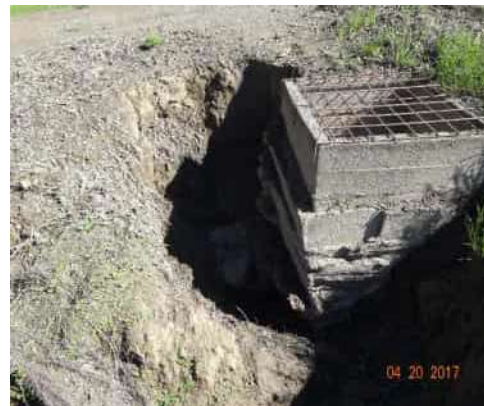
04/20/2017 Erosion hole at WS surge box has gotten worse after the Jan/Feb 2017 high water event. Pipe also leaked which is believed to be caused by the screw gate not fully closing. (A. Freitag - DWR Sutter Yard)

04/20/2017 (ST0003U01 LM:12.963) : Erosion hole at WS surge box 4/20/2017

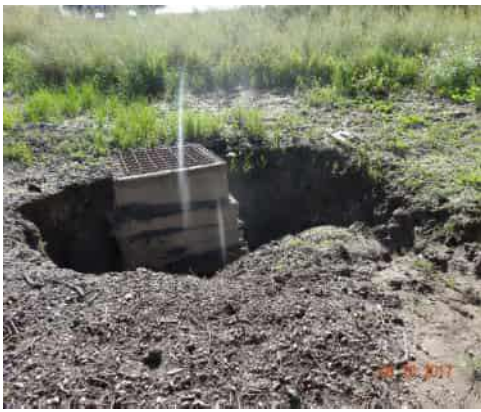
04/20/2017 (ST0003U01 LM:12.963) : Erosion hole at WS surge box 4/20/2017

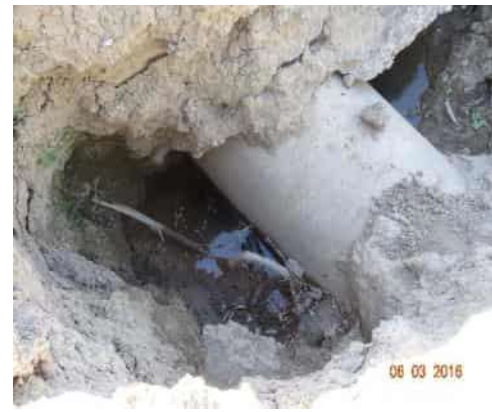
06/03/2016 Bad erosion still present all around the WS surge box. Pipes were flowing water at the time of inspection and the bottom of the erosion hole was wet and had standing water in it indicating a leak coming from the surge box. (A. Freitag - DWR Sutter Yard)

06/03/2016 (ST0003U01 LM:12.963) : WS slope: close-up view of scour hole at WS slope.

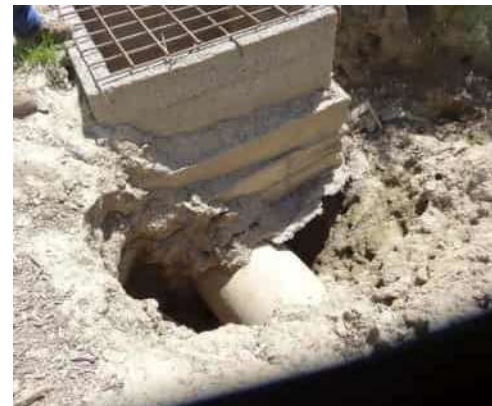
04/14/2016 Heavy scour still present around surge box on WS exposing pipe. Levee caved in and severely damaged around surge box. Erosion around CMP riser on WS cited previously not found. (K. Fazel - DWR UCIP)

04/14/2016 (ST0003U01 LM:12.963) : WS slope: Massive erosion and scour hole on two sides of concrete surge box. Pipe exposed.

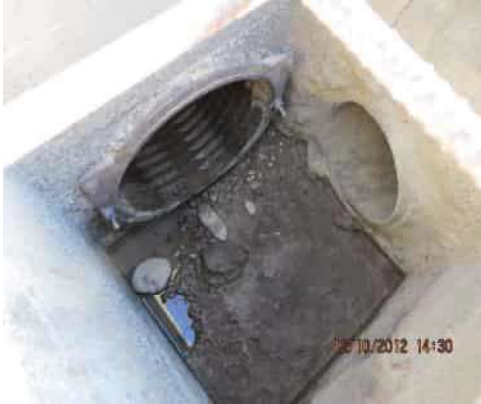
12/10/2012 Soil erosion around CMP riser and surge concrete box on WS damaged due to overflow. Pump not found. Flap gate missing on WS concrete box. WS slope eroded. Structure might have been used as drainage structure. This needs to be determined during routine inspection. (P. Amatyia - DWR UCIP)

12/10/2012 (ST0003U01 LM:12.963) : WS view: CMP in surge box. Flap gate missing.

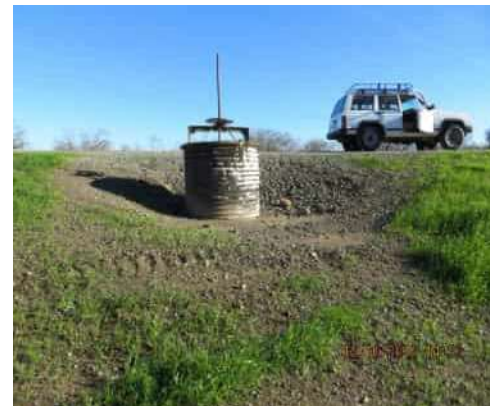
12/10/2012 (ST0003U01 LM:12.963) : WS view: soil erosion around CMP riser

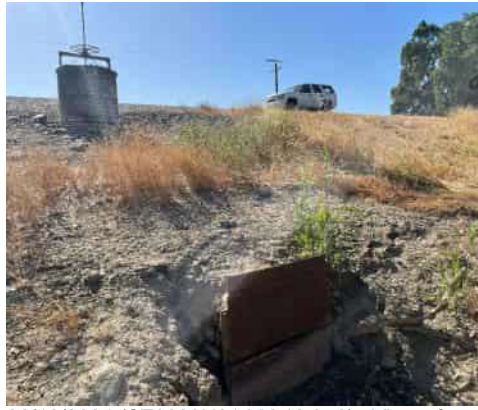
06/13/2024 Pipe abandoned, capped on WS. Code 12b removed since LMA responsible pipe. (J. Singh - DWR UCIP)

06/13/2024 (ST0003U01 LM:13.376) : View of capped pipe on WS

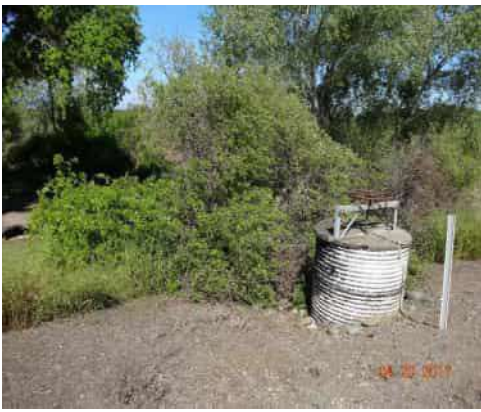
04/20/2017 Abandoned- needs to be done properly. A oak tree has fallen down onto the WS pipe end. It does not appear to have damaged the pipe but it will need to be better inspected after the tree has been cleared away. (A. Freitag - DWR Sutter Yard)

04/20/2017 (ST0003U01 LM:13.376) : Fallen oak tree over WS pipe end

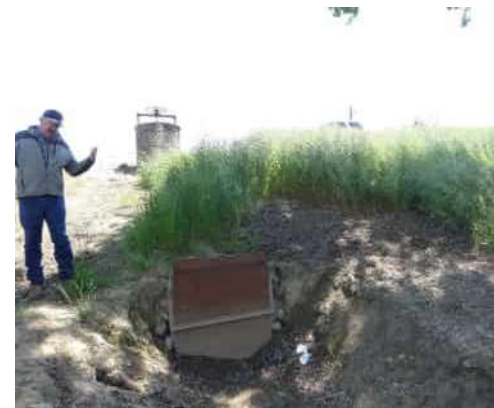
04/16/2016 A wooden board has been placed on WS outlet of pipe to prevent sediment from entering pipe. This is a temporary repair measure by Sutter Yard until pipe can be grouted. Need to contact owner to ensure pipe's proper abandonment. Blockage of pipe outlet by wooden board or sediment will pose a hazard during high water. Pipe owner unclear, as landowner differs on LS and WS. (K. Fazel - DWR UCIP)

04/14/2016 (ST0003U01 LM:13.376) : View up WS slope: sediment buildup against board covering pipe outlet. Board placed as a temporary fix.

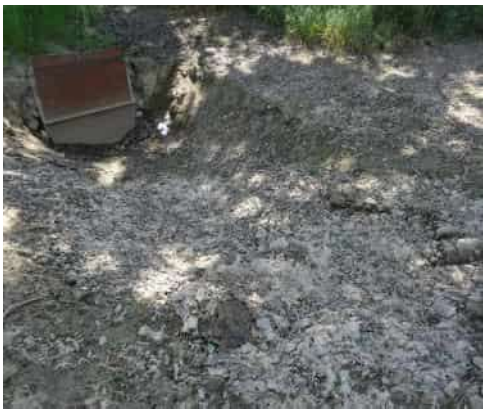
04/14/2016 (ST0003U01 LM:13.376) : WS slope:  
sediment buildup temporarily prevented from  
entering WS pipe outlet by wooden board.

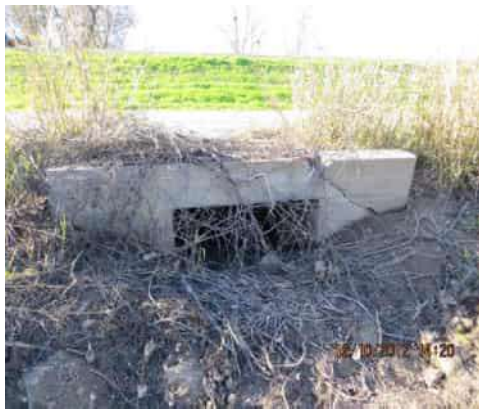
Outlet pipe silted on WS. Inlet structure damaged on LS. Not properly abandoned. (A. Freitag - DWR Sutter Yard)

12/10/2012 (ST0003U01 LM:13.376) : LS view:  
damaged concrete culvert across the road

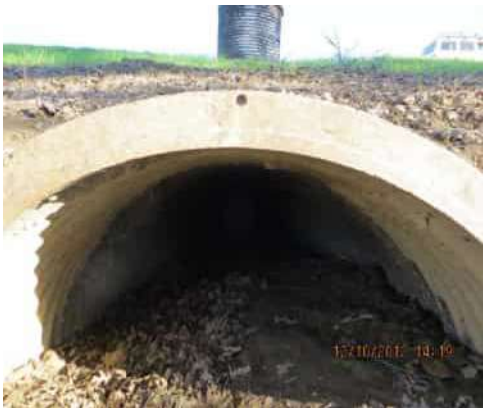
12/10/2012 (ST0003U01 LM:13.376) : WS view:  
silted concrete lined CMP outlet pipe

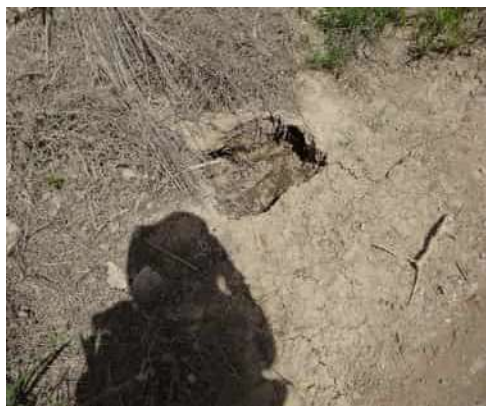
04/14/2016 (ST0003U01 LM:18.612) : WS slope: slight borrowing activity

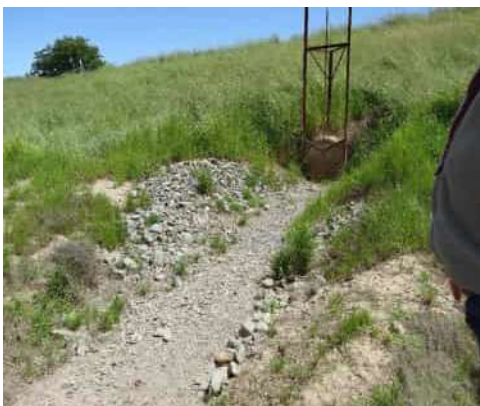
04/14/2016 (ST0003U01 LM:18.612) : WS slope: rock revetment placed along slide gate to repair sloughing.

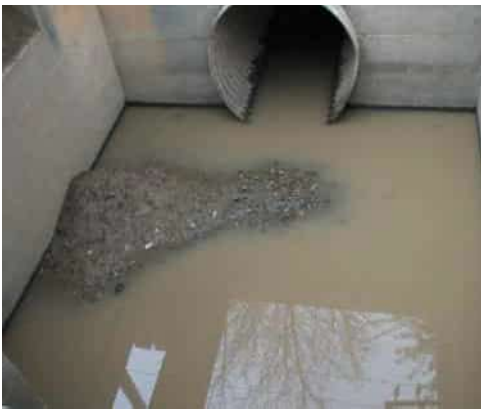
11/27/2012 (ST0003U01 LM:18.612) : LS view: soil deposite in inlet box

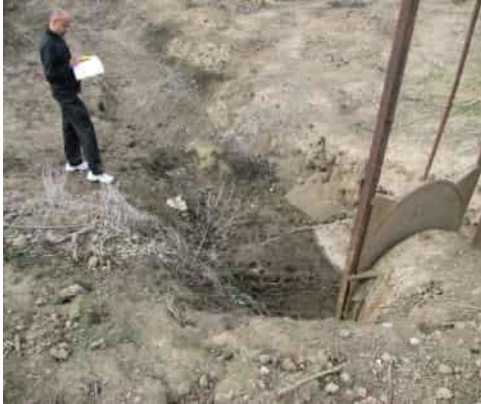
11/27/2012 (ST0003U01 LM:18.612) : WS view: damaged levee slope
