# Request For Information

Project Name: Replace Roofs (Program Phase 1 - 4)

Title: Roof Replacement - Phase 1 Facility B

## 22-090 CIM Replace Roofs Phase 1, Facility B, RFI 006 Notes on SFM-Approved Drawings

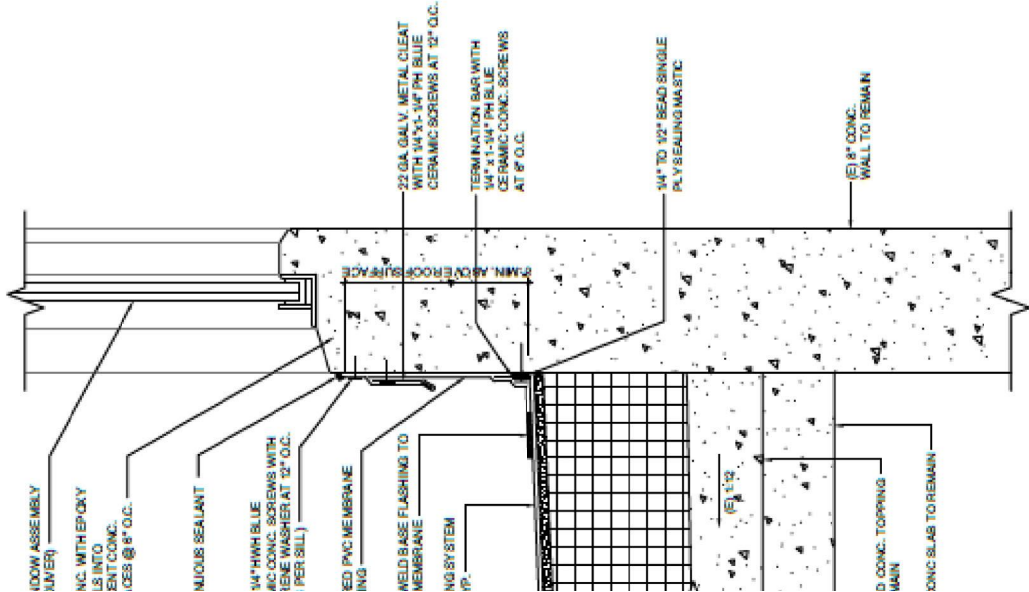
2 SPECIAL CONDITION - 1

1. Plan Set 22-090 Plan sheet A3.9 Special Condition 1 and 4 shows to remove and replace existing windows. CCM Field wants to verify that glazing is to be replaced not windows. See attached drawings.
  2. CCM also wants to verify Detail 1 A3.9 will be used for Special Condition 1 and 4 per plan?
- Please Advise?

FIELD DETERMINE DIMENSIONS

- REMOVE AND REPLACE (E) STAIRS. SEE 98.133 FOR ADDITIONAL INFORMATION
- REMOVE LANTANCE, PEELING PAINT, ETC. AND PREPARE SURFACE TO BE RE-PAINTED. PAINT ENTIRE WALL THAT CONTAINS WINDOWS
- REMOVE (E) WINDOWS AND REPLACE. FIELD DETERMINE DIMENSIONS

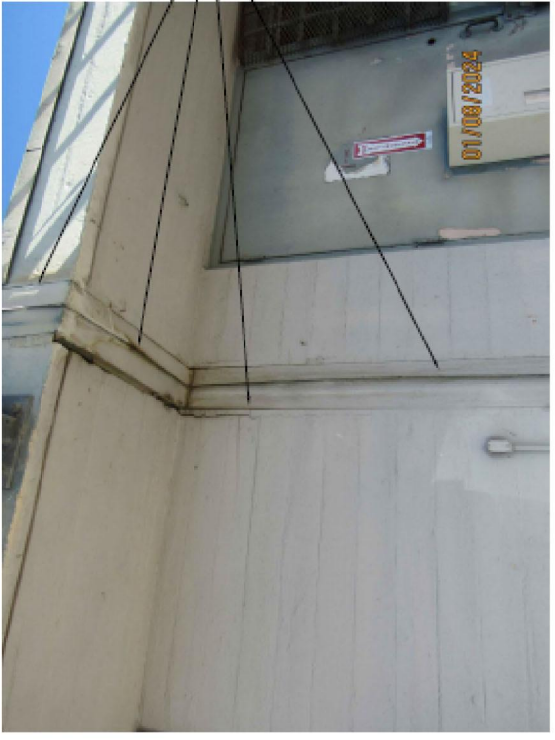
3 SPECIAL CONDITION - 2

- REMOVE (E) EXPANSION JOINTS. REPAIR SUBSTRATE AND PREPARE FOR INSTALLATION OF NEW EXPANSIONS JOINTS

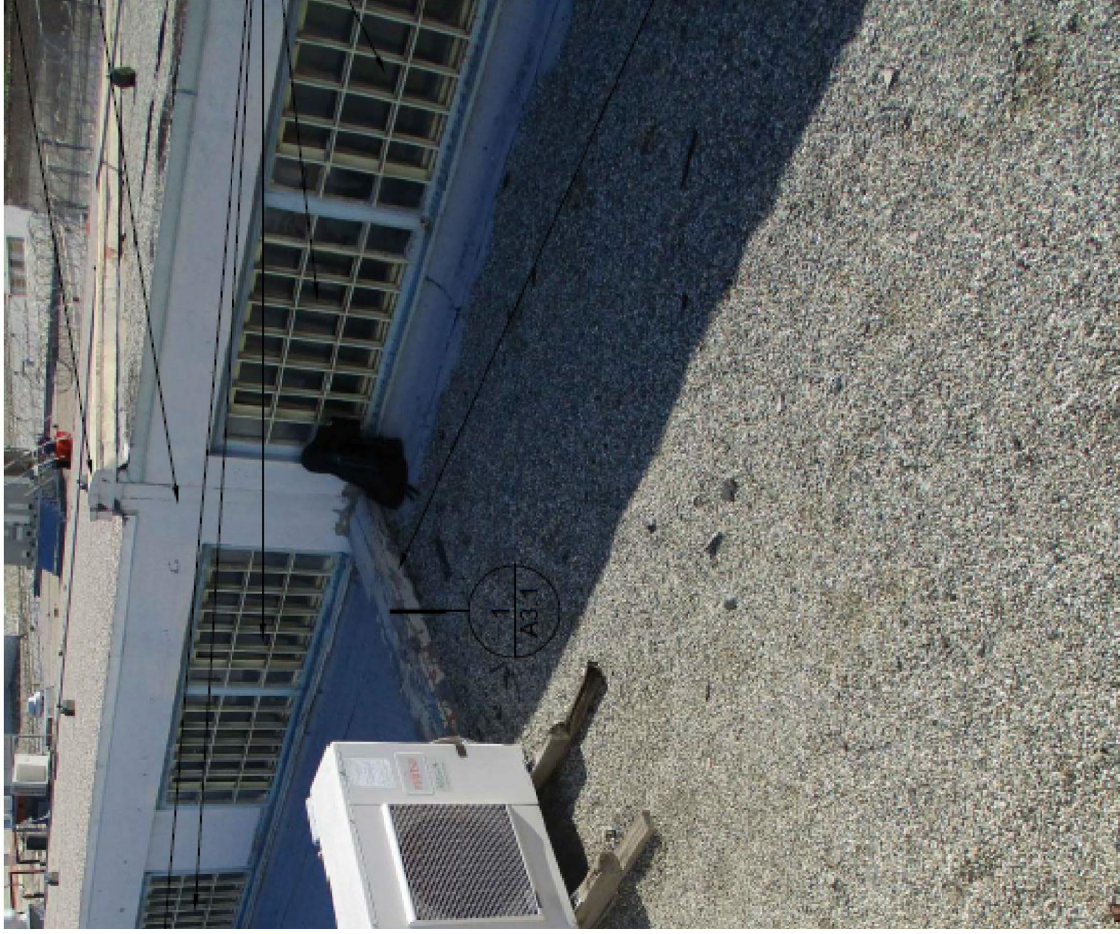
REMOVE (E) EXPANSION JOINT, CURB, FLASHING, ETC.

REMOVE VERTICAL EXPANSION JOINT COVER. REPAIR CONCRETE WALLS AND PREPARE SURFACE TO RECEIVE (N) EXPANSION JOINT ASSEMBLY

REMOVE WINDOWS AND FLASHING AND PREPARE FOR NEW WINDOWS

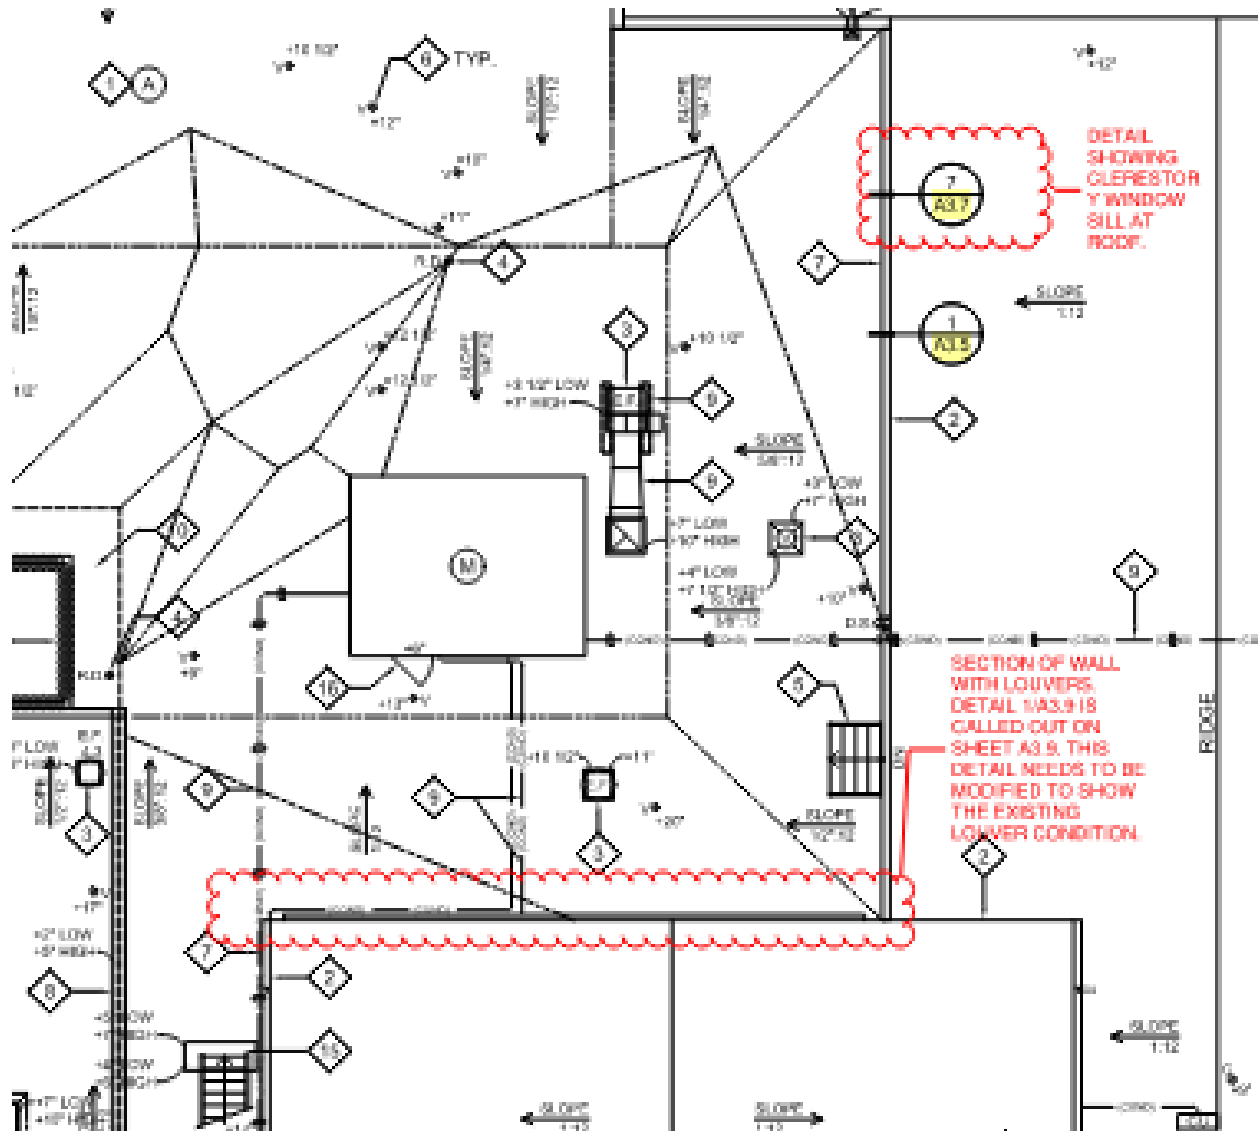
Figure 1: Snip from Sheet A1.5 showing demolition at Unit 2 roof. Detail 7/A3.7 is called out at existing clerestory window sill but there is no detail called out for the section of wall with the existing louvers.

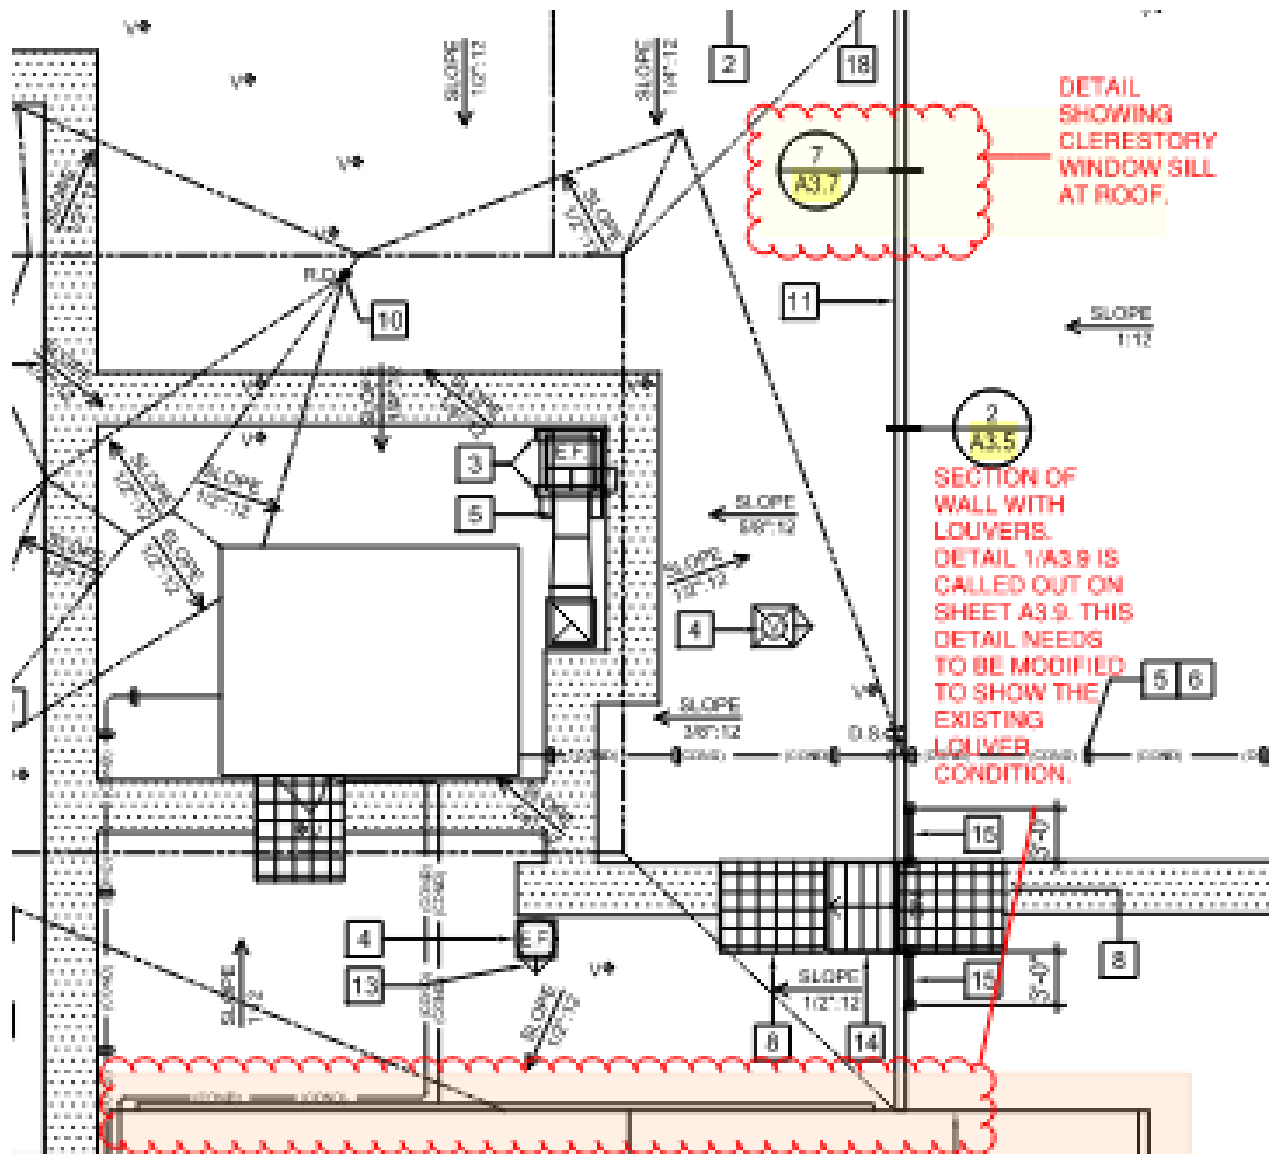
Figure 2: Snip from Sheet A2.5 showing new work at Unit 2 roof. Detail 7/A3.7 is called out at existing clerestory window sill but there is no detail called out for the section of wall with the existing louvers.

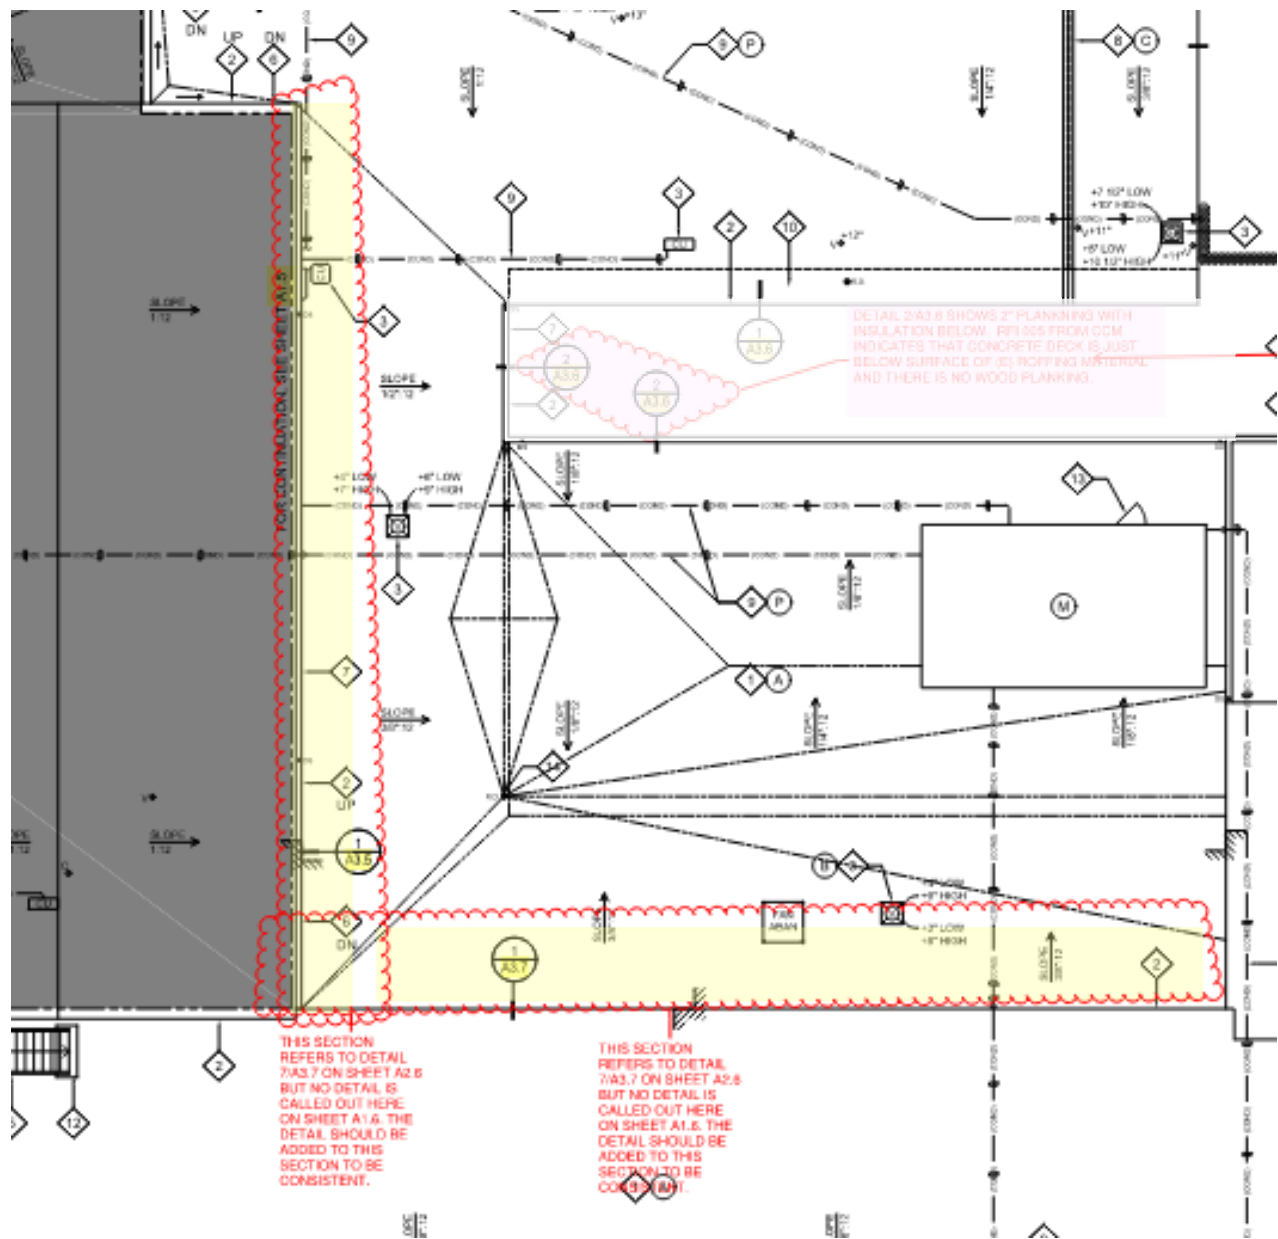
Figure 3: Snip from Sheet A1.6 showing demolition at Unit 2 roof. Detail 7/A3.7 is not called out at existing clerestory window sill and there is no detail called out for the section of wall with the existing louvers. Details at these conditions should be added.

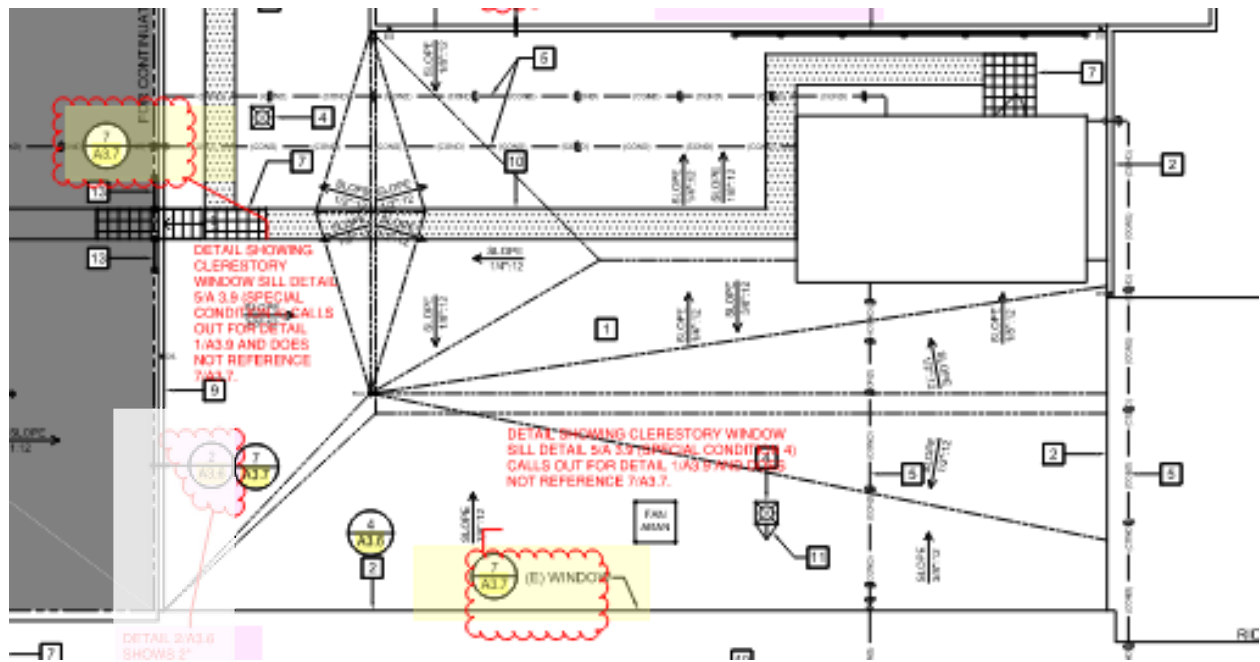
Figure 4: Snip from Sheet A2.6 showing demolition at Unit 2 roof. Detail 7/A3.7 is called out at existing clerestory window sill and at the section of wall with the existing louvers. Details at these conditions should be added/corrected. Detail 1/3.9 is referred to at this location on Sheet A3.9 but does it apply here? The details need to be corrected.

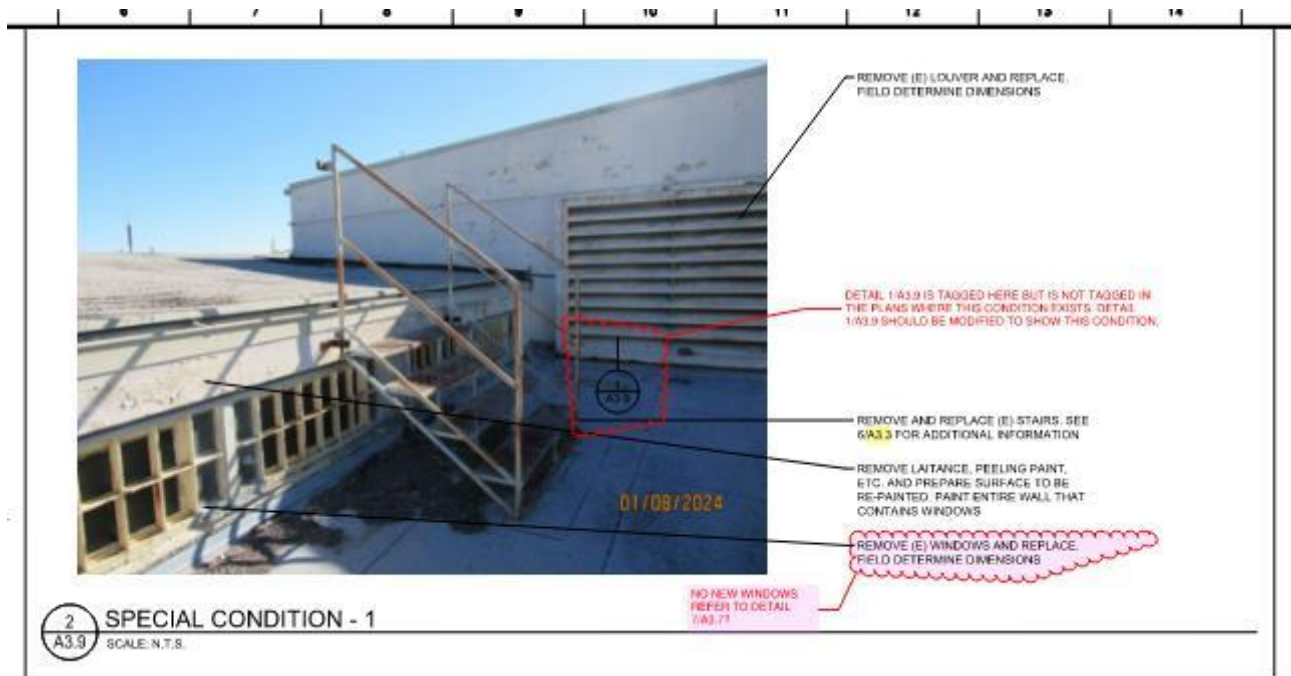
Figure 4: Snip from Sheet A3.9 showing detail 1/A3.9 tagged at louver wall. Detail 1/A3.9 needs to be modified to show louver condition. Does Detail 7/A3.7 should be tagged at clerestory window and any reference to removing and replacing windows should be removed. Glazing may need to be removed and replaced with steel plate per Detail 7/A3.7 but windows are not being replaced.

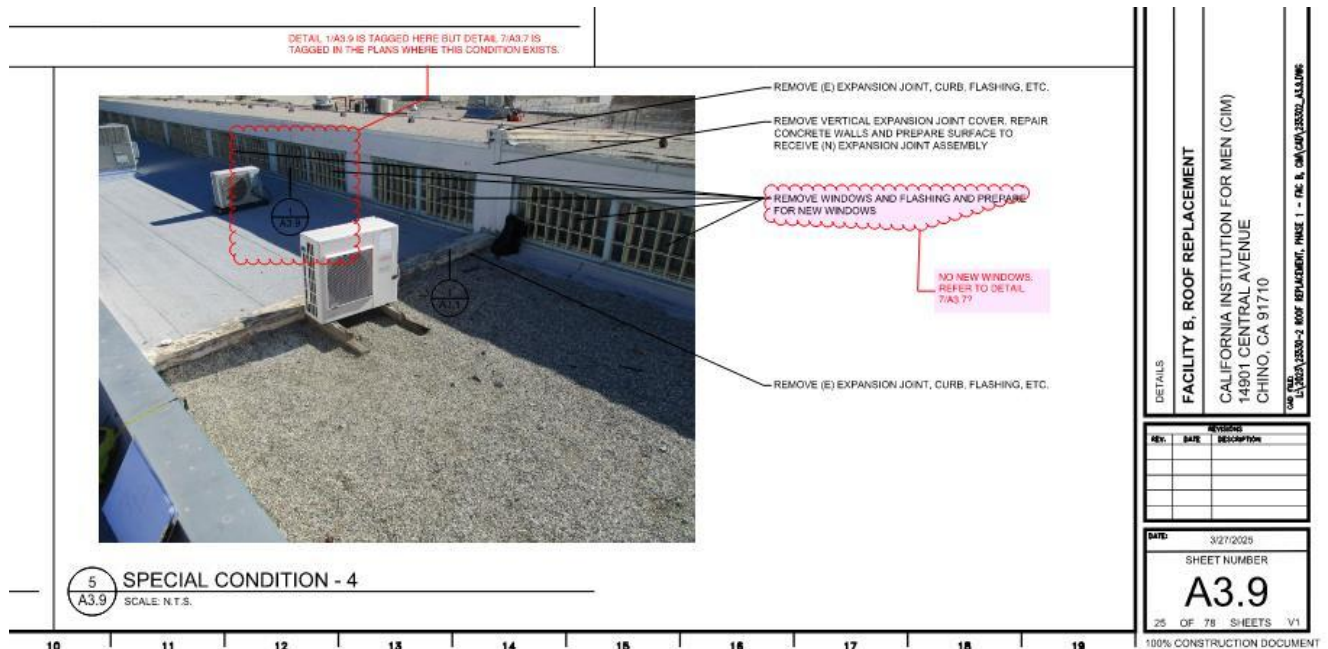
Figure 5: Snip from Sheet A3.9 showing detail 1/A3.9 tagged at louver wall. Detail 1/A3.9 needs to be modified to show louver condition. Does Detail 7/A3.7 should be tagged at clerestory window and any reference to removing and replacing windows should be removed. Glazing may need to be removed and replaced with steel plate per Detail 7/A3.7 but windows are not being replaced.

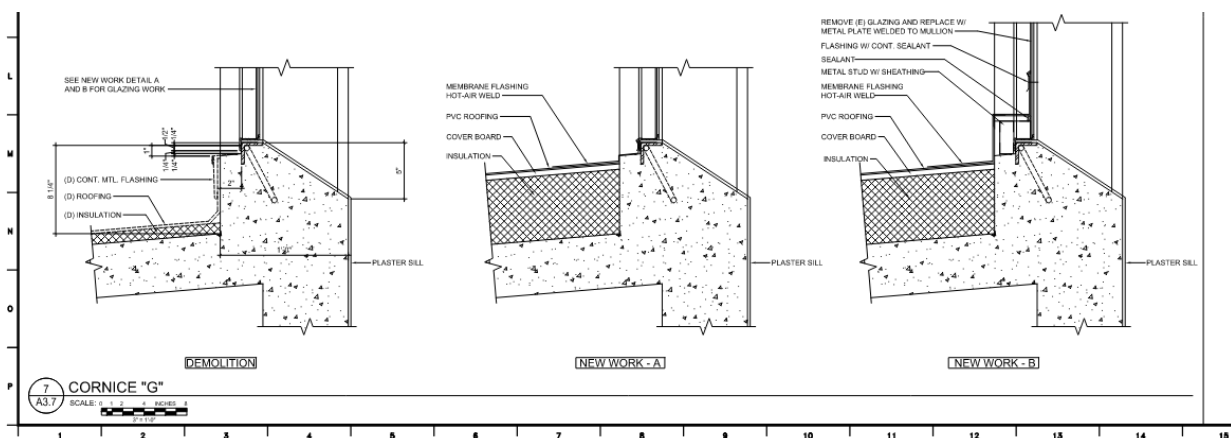
Figure 6: Snip from Sheet A3.7 showing Detail 7/A3.7. This is not a “Cornice” detail, it is a clerestory window sill detail and that should be corrected. This detail needs to be tagged in all locations where it applies.

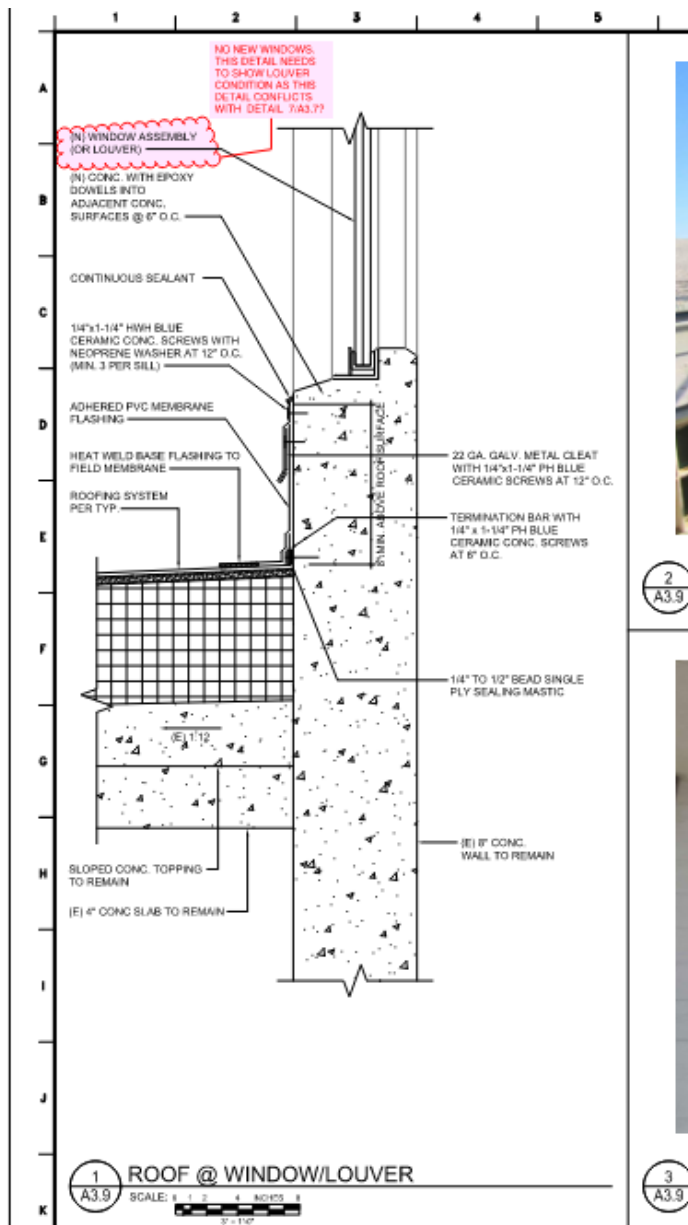
Figure 7: Snip from Sheet A3.9 showing Detail 1/A3.9. There are no new windows so references to this should be removed everywhere. This detail either conflicts with Detail 7/A3.7 or is redundant. There is no detail properly showing how existing louvers will be dealt with at new roof assembly. This detail should be corrected and tagged appropriately to represent the actual conditions and proposed new work.
