RE: SUBMITTAL OF ASBESTOS & LEAD SURVEY REPORT
Ft. Bliss Bldg. #2414
ENCON Project #103-08-150

ASBESTOS SURVEY REPORT
BUILDING 2414
FORT BLISS, TEXAS 79916

ENCON Project No. 103-08-150

ASBESTOS SURVEY REPORT
Ft. Bliss, Bldg. 2414

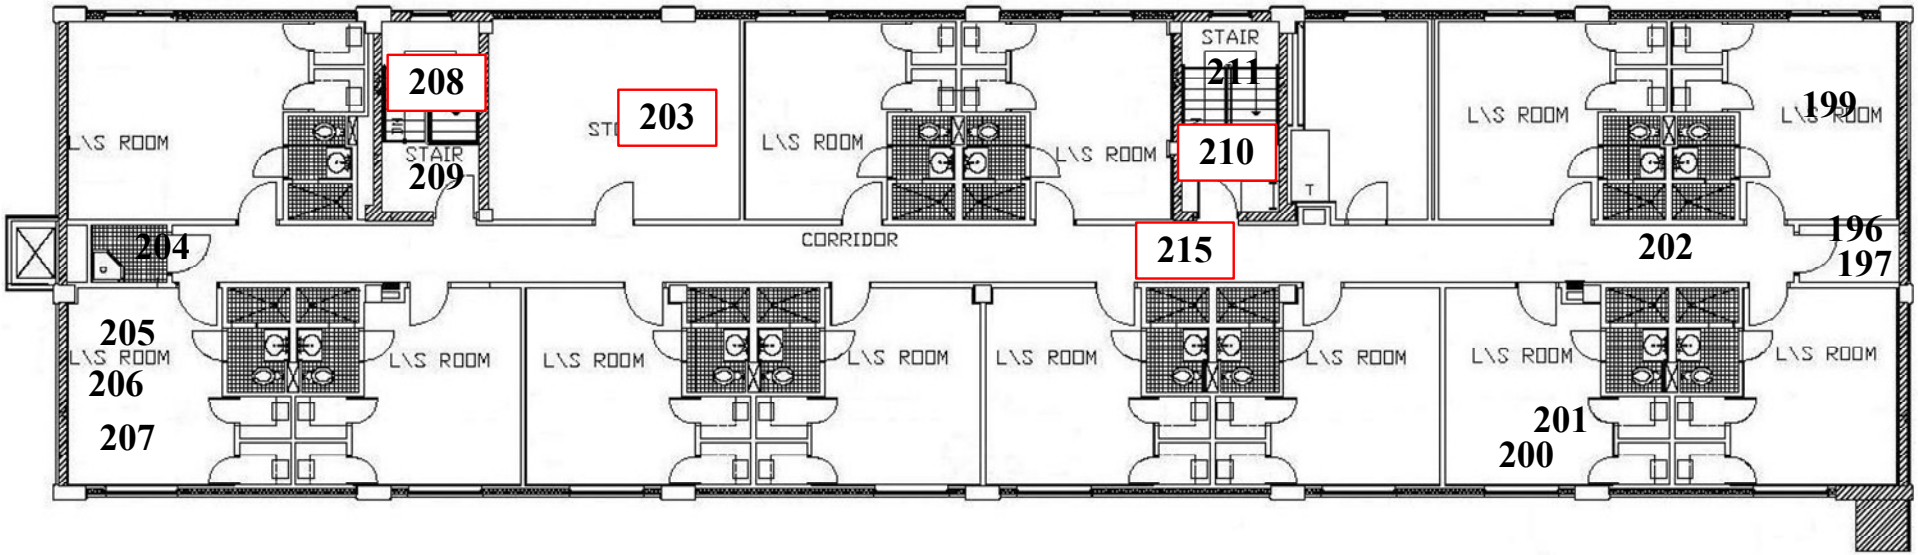
Lead Sample Locations **ENCON #: 103-08-150** **Date: 12/08/2008**	**Legend** **# Lead Sample Location** **[#] Positive Lead Sample**	**Bldg. 2414** **Lead Sample Location Drawing** **Third Floor**	**N.T.S**

LEAD - Results indicate that thirty-two (32) of the one hundred thirty-nine (139) XRF readings tested at or above the limit of 0.3 mg/cm^2.

Care shall also be taken for surfaces that contain levels of lead below the Action Level stated above for the instrument (0.3 mg/cm^2), which could create lead dust or lead-contaminated soil hazards if the paint is turned into dust by abrasion, scraping, or sanding.

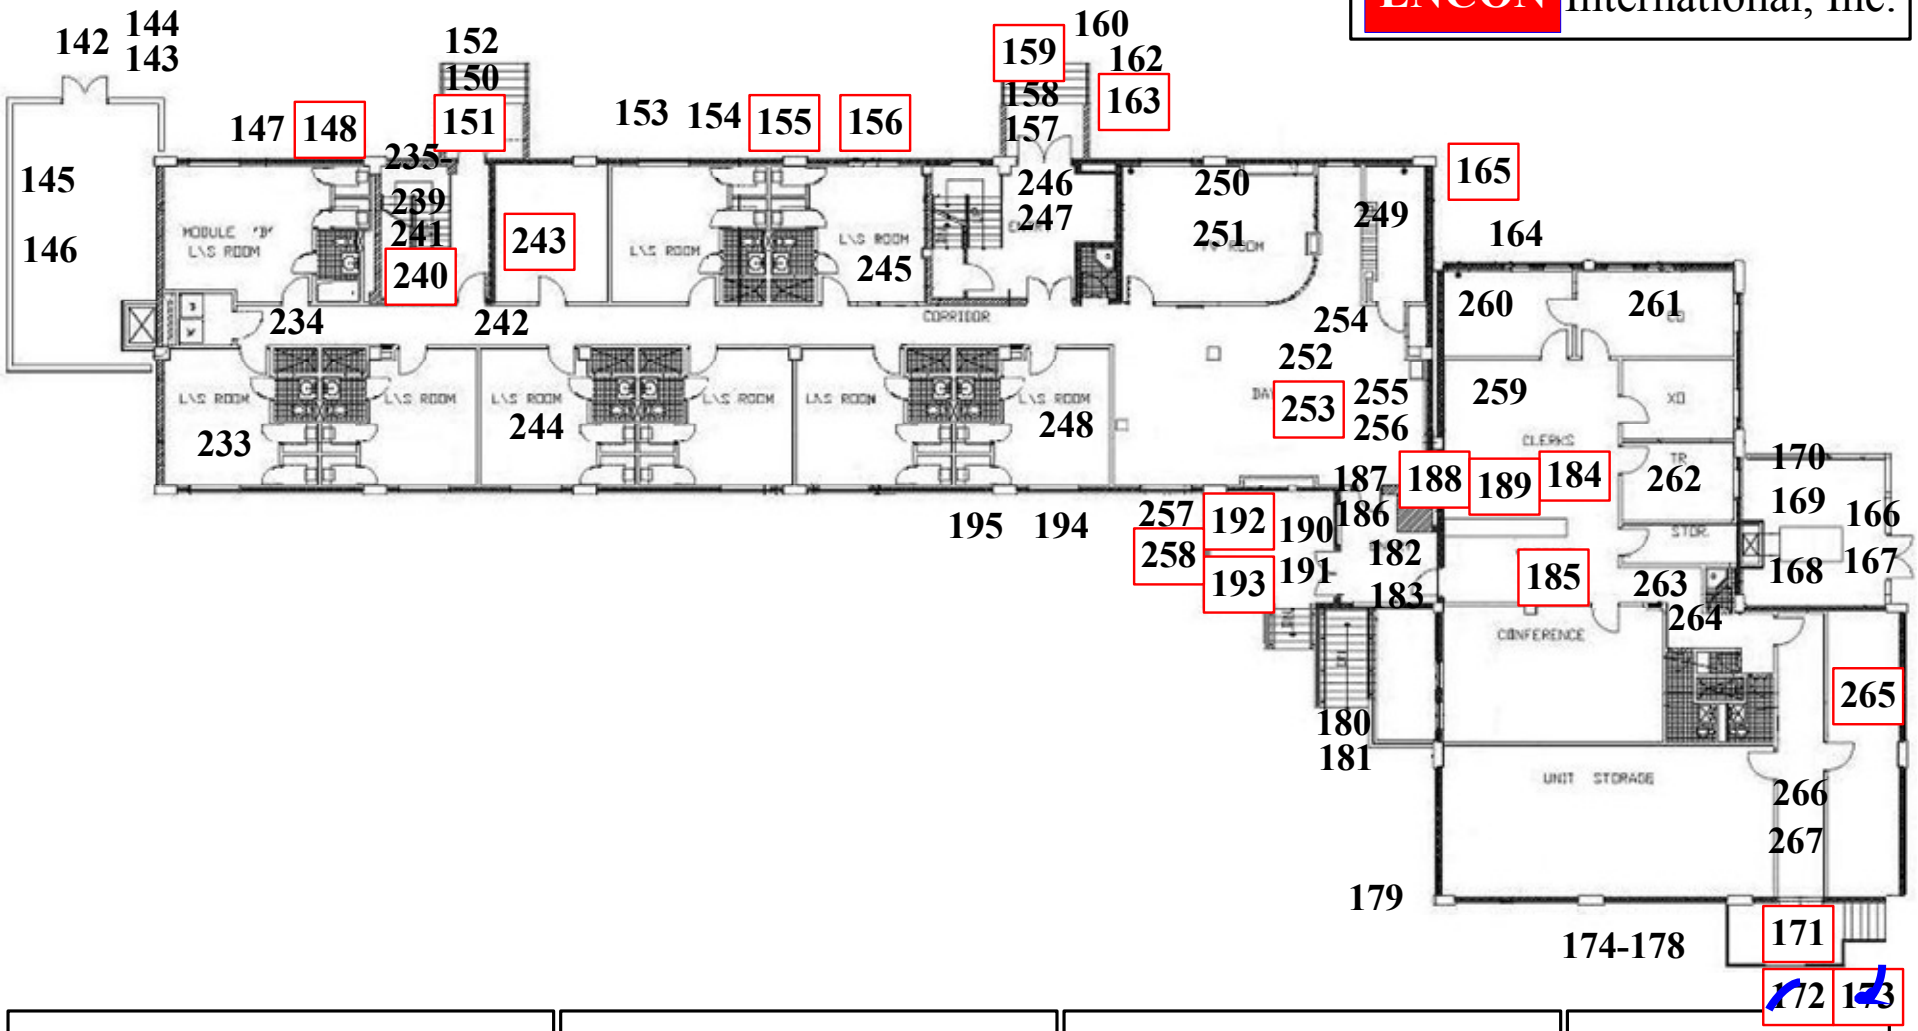
Lead Sample Locations **ENCON #: 103-08-150** **Date: 12/08/2008**	**Legend** # Lead Sample Location [#] Positive Lead Sample	**Bldg. 2414** **Lead Sample Location Drawing** **First Floor**	**N.T.S**

No.	Component	Substrate	Condition	Color	Room	PbC
148	COLUMN	PLASTER	FAIR	TAN	OUTSIDE	0.7
151	WALL	STUCCO	FAIR	TAN	PORCH	0.4
155	COLUMN	PLASTER	FAIR	BROWN	OUTSIDE	6.6
156	COLUMN	PLASTER	FAIR	BROWN	OUTSIDE	8.3
159	WALL	PLASTER	FAIR	TAN	PORCH	10.8
161	CEILING	PLASTER	FAIR	TAN	PORCH	13.9
163	CEILING	PLASTER	FAIR	TAN	PORCH	12
165	COLUMN	PLASTER	FAIR	BROWN	OUTSIDE	6.7
171	DOOR	METAL	FAIR	BROWN	PORCH	9.4
172	RAIL	METAL	FAIR	BROWN	PORCH	0.8
173	EDGE	METAL	FAIR	BROWN	PORCH	3.8
184	COLUMN	CONCRETE	FAIR	BEIGE	MECH	0.4
185	WALL	CONCRETE	FAIR	BEIGE	MECH	3.8
188	CEILING	PLASTER	FAIR	TAN	OUTSIDE	0.8
189	WALL	PLASTER	FAIR	TAN	OUTSIDE	10.8
192	WALL	PLASTER	FAIR	TAN	PORCH	14.1
193	COLUMN	PLASTER	FAIR	TAN	OUTSIDE	6.3
203	CEILING	CONCRETE	FAIR	WHITE	STORAGE	0.6
208	WALL	PLASTER	FAIR	TAN	STAIR	2.4
210	LADDER	METAL	FAIR	PINK	STAIR	0.5
215	WALL	DRYWALL	FAIR	TAN	HALL	0.7
218	CEILING	CONCRETE	FAIR	TAN	STORAGE	8.3
220	WALL	DRYWALL	FAIR	TAN	205-BATH	0.5
