ASBESTOS MANAGEMENT SURVEY REPORT

AEDY - 562 - Hsg Sup Stor F, RAF Alconbury, Alconbury, Huntingdon, PE28 4DA

139617-021

Report Issue date: 30/06/2021

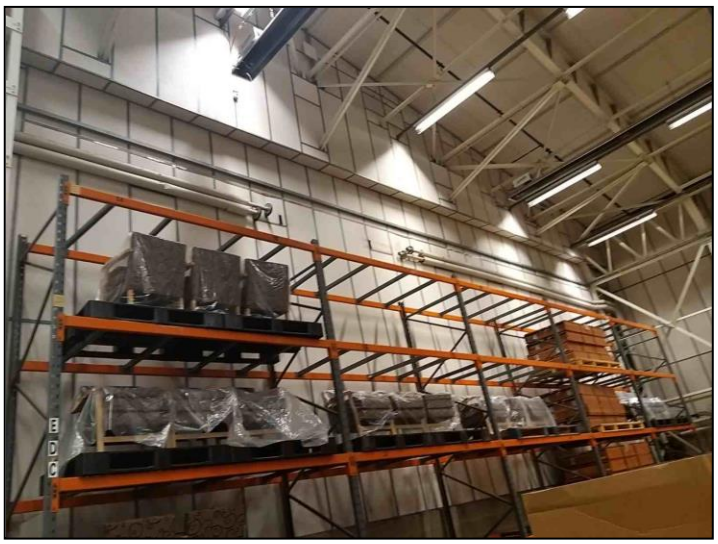
ASSESSMENT		Sample No:	001
Material Risk:	**N/A**	Position:	Internal
Asbestos Type:	0 - No asbestos detected	Approx Size of Item:	180 m²
Product Type:		**COMMENTS AND RECOMMENDATIONS:**	
Extent of Damage:		Timescale for Recommendation : No action	
Surface Treatment:		Recommendation:	No further action required
Priority Risk:	**N/A**		
Normal Occupant Activity:			
Likelihood of Disturbance:		Comments:	
Human Exposure Potential:			
Maintenance Activity :		**Total Risk Score:**	**N/A**

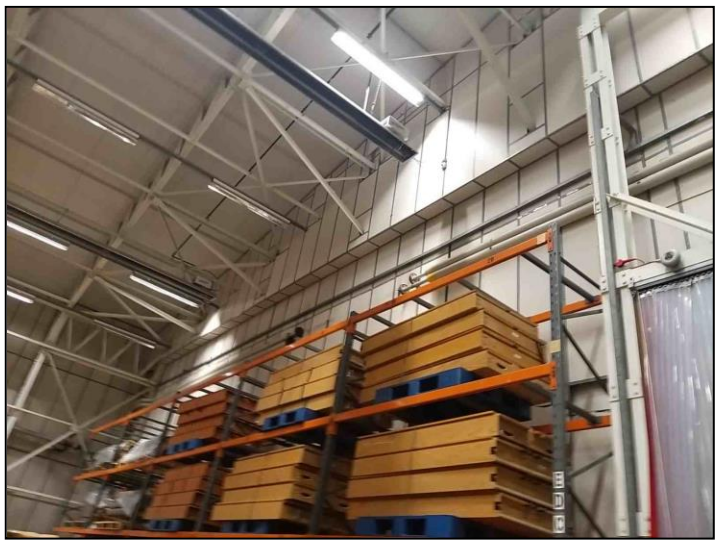
ASSESSMENT		Sample No:	002
Material Risk:	**N/A**	Position:	Internal
Asbestos Type:	0 - No asbestos detected	Approx Size of Item:	180 m²
Product Type:		**COMMENTS AND RECOMMENDATIONS:**	
Extent of Damage:		Timescale for Recommendation : No action	
Surface Treatment:		Recommendation:	No further action required
Priority Risk:	**N/A**		
Normal Occupant Activity:			
Likelihood of Disturbance:		Comments:	
Human Exposure Potential:			
Maintenance Activity :		**Total Risk Score:**	**N/A**

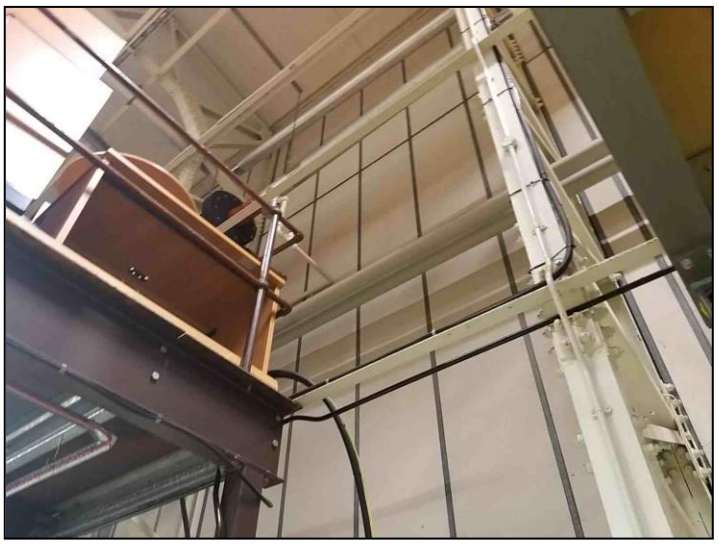
ASSESSMENT		Sample No:	004
Material Risk:	**N/A**	Position:	Internal
Asbestos Type:	0 - No asbestos detected	Approx Size of Item:	200 m²
Product Type:		**COMMENTS AND RECOMMENDATIONS:**	
Extent of Damage:		Timescale for Recommendation : No action	
Surface Treatment:		Recommendation:	No further action required
Priority Risk:	**N/A**		
Normal Occupant Activity:			
Likelihood of Disturbance:		Comments:	
Human Exposure Potential:			
Maintenance Activity :		**Total Risk Score:**	**N/A**

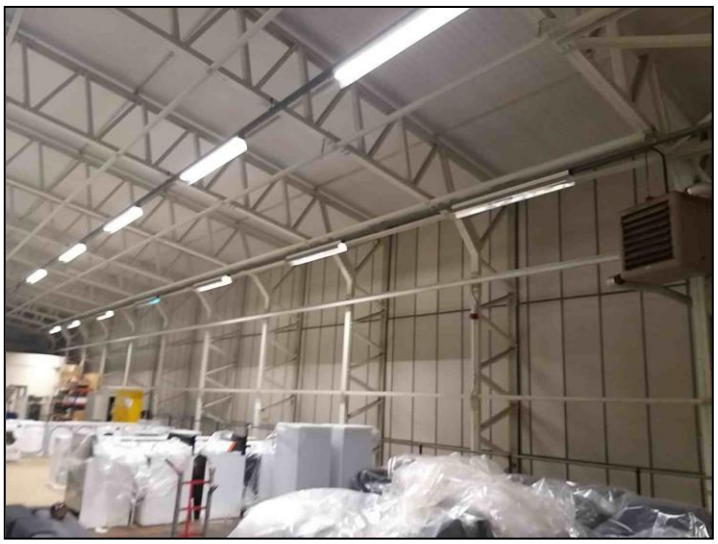
ASSESSMENT		Sample No:	005
Material Risk:	**N/A**	Position:	Internal
Asbestos Type:	0 - No asbestos detected	Approx Size of Item:	200 m²
Product Type:		**COMMENTS AND RECOMMENDATIONS:**	
Extent of Damage:		Timescale for Recommendation : No action	
Surface Treatment:		Recommendation:	No further action required
Priority Risk:	**N/A**		
Normal Occupant Activity:			
Likelihood of Disturbance:		Comments:	
Human Exposure Potential:			
Maintenance Activity :		**Total Risk Score:**	**N/A**

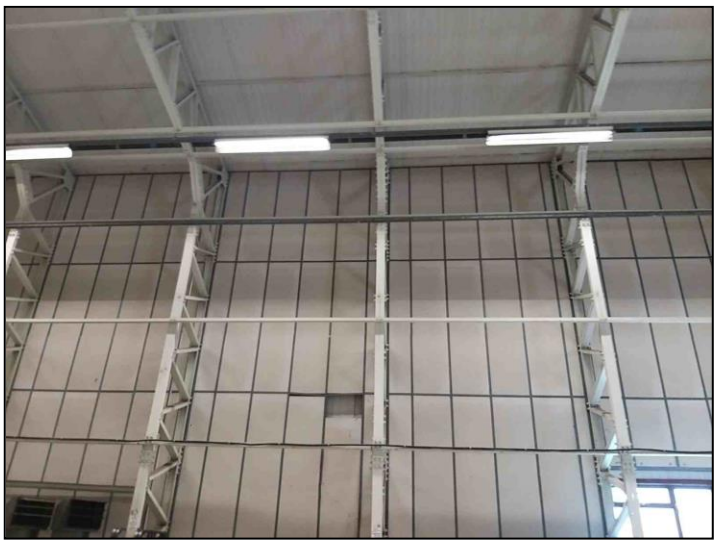
ASSESSMENT		Sample No:	006
Material Risk:	**N/A**	Position:	Internal
Asbestos Type:	0 - No asbestos detected	Approx Size of Item:	200 m²
Product Type:		**COMMENTS AND RECOMMENDATIONS:**	
Extent of Damage:		Timescale for Recommendation : No action	
Surface Treatment:		Recommendation:	No further action required
Priority Risk:	**N/A**		
Normal Occupant Activity:			
Likelihood of Disturbance:		Comments:	Some areas have small holes/dents.
Human Exposure Potential:			
Maintenance Activity :		**Total Risk Score:**	**N/A**

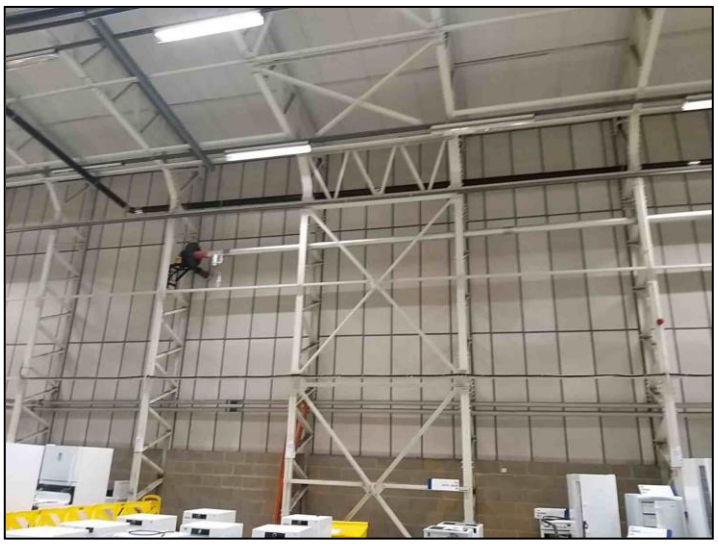
ASSESSMENT		Sample No:	007
Material Risk:	**N/A**	Position:	Internal
Asbestos Type:	0 - No asbestos detected	Approx Size of Item:	200 m²
Product Type:		**COMMENTS AND RECOMMENDATIONS:**	
Extent of Damage:		Timescale for Recommendation : No action	
Surface Treatment:		Recommendation:	No further action required
Priority Risk:	**N/A**		
Normal Occupant Activity:			
Likelihood of Disturbance:		Comments:	
Human Exposure Potential:			
Maintenance Activity :		**Total Risk Score:**	**N/A**

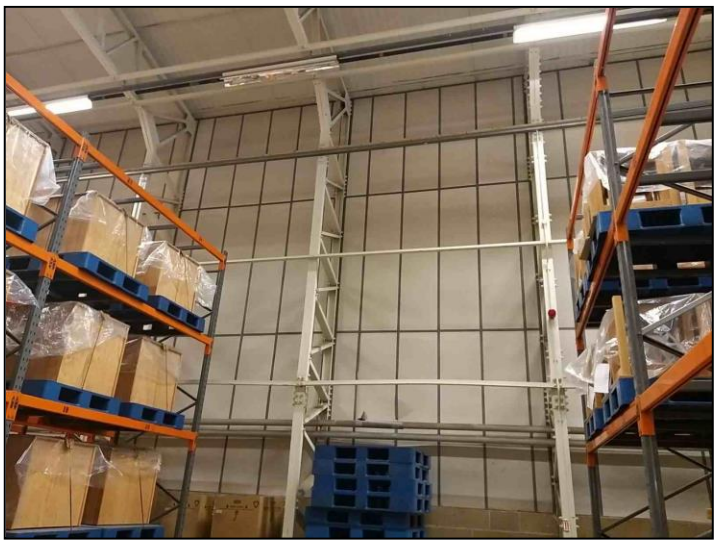
ASSESSMENT		Sample No:	008
Material Risk:	**N/A**	Position:	Internal
Asbestos Type:	0 - No asbestos detected	Approx Size of Item:	200 m²
Product Type:		**COMMENTS AND RECOMMENDATIONS:**	
Extent of Damage:		Timescale for Recommendation : No action	
Surface Treatment:		Recommendation:	No further action required
Priority Risk:	**N/A**		
Normal Occupant Activity:			
Likelihood of Disturbance:		Comments:	Some areas have small holes/dents.
Human Exposure Potential:			
Maintenance Activity :		**Total Risk Score:**	**N/A**

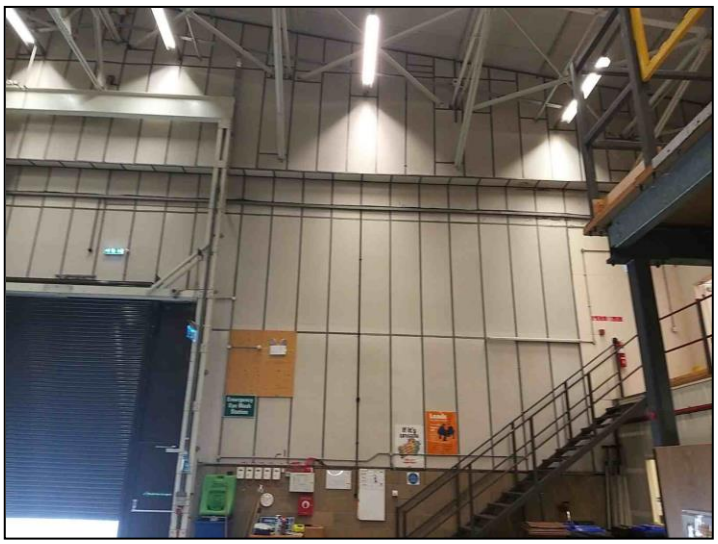
ASSESSMENT		Sample No:	009
Material Risk:	**N/A**	Position:	Internal
Asbestos Type:	0 - No asbestos detected	Approx Size of Item:	180 m²
Product Type:		**COMMENTS AND RECOMMENDATIONS:**	
Extent of Damage:		Timescale for Recommendation : No action	
Surface Treatment:		Recommendation:	No further action required
Priority Risk:	**N/A**		
Normal Occupant Activity:			
Likelihood of Disturbance:		Comments:	
Human Exposure Potential:			
Maintenance Activity :		**Total Risk Score:**	**N/A**

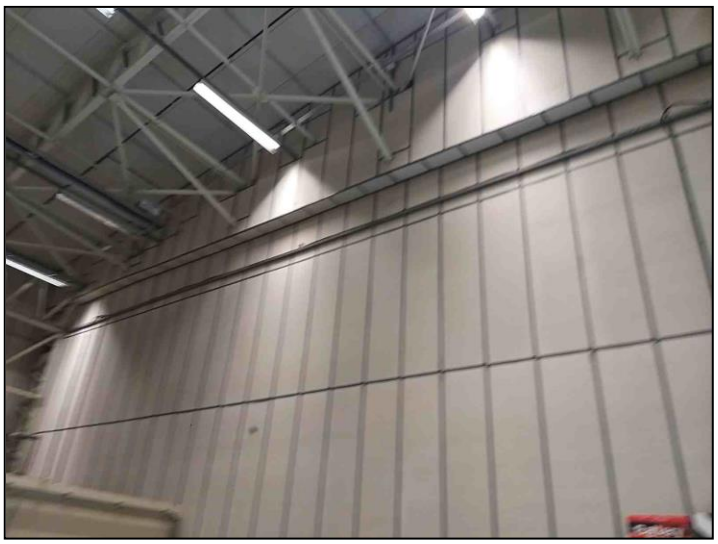
ASSESSMENT		Sample No:	010
Material Risk:	**N/A**	Position:	Internal
Asbestos Type:	0 - No asbestos detected	Approx Size of Item:	180 m²
Product Type:		**COMMENTS AND RECOMMENDATIONS:**	
Extent of Damage:		Timescale for Recommendation : No action	
Surface Treatment:		Recommendation:	No further action required
Priority Risk:	**N/A**		
Normal Occupant Activity:			
Likelihood of Disturbance:		Comments:	
Human Exposure Potential:			
Maintenance Activity :		**Total Risk Score:**	**N/A**

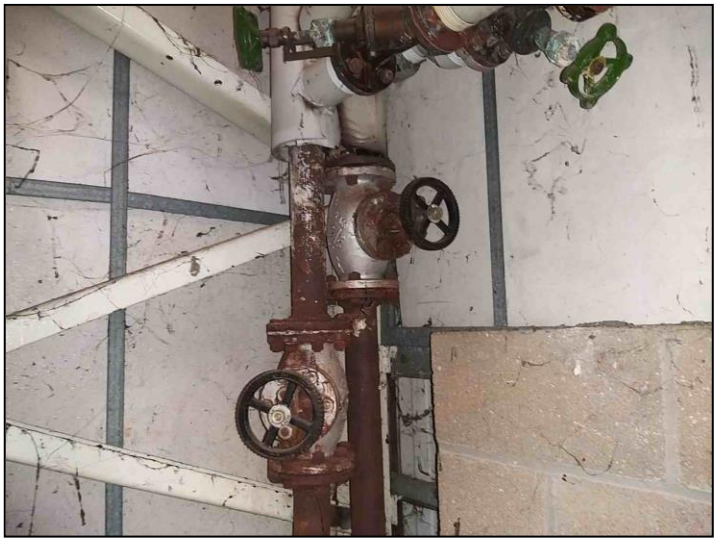
ASSESSMENT		Sample No:	012
Material Risk:	**N/A**	Position:	Internal
Asbestos Type:	0 - No asbestos detected	Approx Size of Item:	7 Items
Product Type:		**COMMENTS AND RECOMMENDATIONS:**	
Extent of Damage:		Timescale for Recommendation : No action	
Surface Treatment:		Recommendation:	No further action required
Priority Risk:	**N/A**		
Normal Occupant Activity:			
Likelihood of Disturbance:		Comments:	
Human Exposure Potential:			
Maintenance Activity :		**Total Risk Score:**	**N/A**

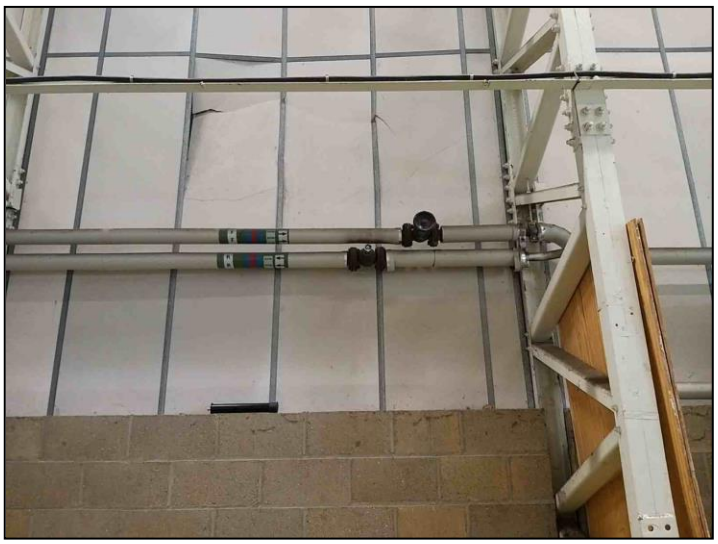
ASSESSMENT		Sample No:	AWS - 011
Material Risk:	**5**	Position:	Internal
Asbestos Type:	1 - Chrysotile	Approx Size of Item:	4 Items
Product Type:	2 - AIB, Millboard, gaskets, paper etc	**COMMENTS AND RECOMMENDATIONS:**	
Extent of Damage:	1 - Low damage	Timescale for Recommendation : 12 months	
Surface Treatment:	1 - Enclosed sprays and lagging, AIB, AC sheets etc	Recommendation:	Manage
Priority Risk:	**5**		
Normal Occupant Activity:	1 - Low Disturbance		
Likelihood of Disturbance:	1 - Low Likelihood of Disturbance	Comments:	
Human Exposure Potential:	2 - Medium Human Exposure Potential		
Maintenance Activity :	1 - Low Risk Maintenance Activity	**Total Risk Score:**	**10**

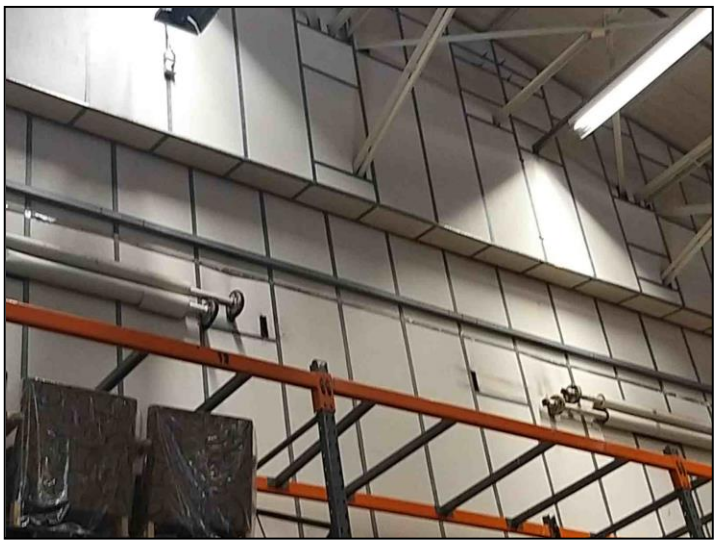
ASSESSMENT		Sample No:	P001
Material Risk:	**5**	Position:	Internal
Asbestos Type:	1 - Chrysotile	Approx Size of Item:	20 Items
Product Type:	2 - AIB, Millboard, gaskets, paper etc	**COMMENTS AND RECOMMENDATIONS:**	
Extent of Damage:	1 - Low damage	Timescale for Recommendation : 12 months	
Surface Treatment:	1 - Enclosed sprays and lagging, AIB, AC sheets etc	Recommendation:	Manage
Priority Risk:	**5**		
Normal Occupant Activity:	2 - Periodic Disturbance		
Likelihood of Disturbance:	0 - Very Low Likelihood of Disturbance	Comments:	Presumption Reason: Height Restriction
Human Exposure Potential:	2 - Medium Human Exposure Potential		
Maintenance Activity :	1 - Low Risk Maintenance Activity	**Total Risk Score:**	**10**

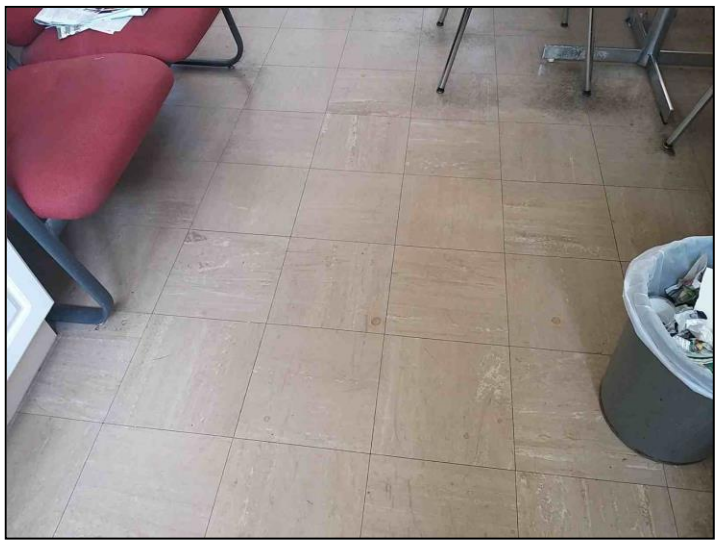
ASSESSMENT		Sample No:	014
Material Risk:	**N/A**	Position:	Internal
Asbestos Type:	0 - No asbestos detected	Approx Size of Item:	12 m²
Product Type:		**COMMENTS AND RECOMMENDATIONS:**	
Extent of Damage:		Timescale for Recommendation : No action	
Surface Treatment:		Recommendation:	No further action required
Priority Risk:	**N/A**		
Normal Occupant Activity:			
Likelihood of Disturbance:		Comments:	
Human Exposure Potential:			
Maintenance Activity :		**Total Risk Score:**	**N/A**

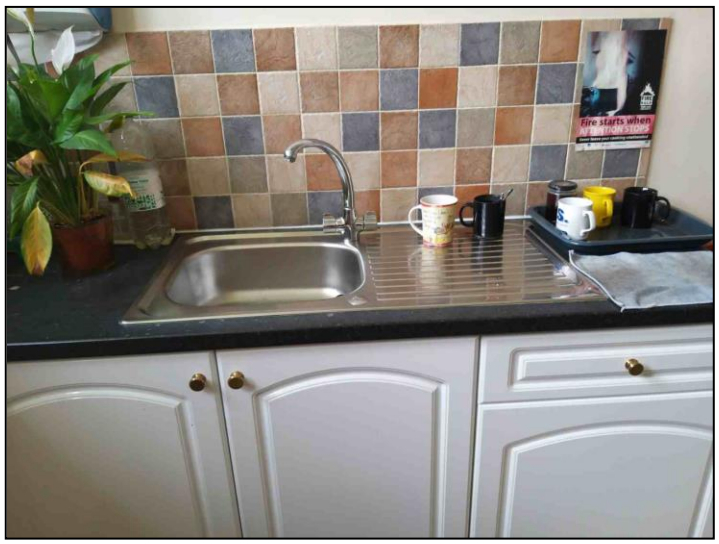
ASSESSMENT		Sample No:	015
Material Risk:	**N/A**	Position:	Internal
Asbestos Type:	0 - No asbestos detected	Approx Size of Item:	1 Items
Product Type:		**COMMENTS AND RECOMMENDATIONS:**	
Extent of Damage:		Timescale for Recommendation : No action	
Surface Treatment:		Recommendation:	No further action required
Priority Risk:	**N/A**		
Normal Occupant Activity:			
Likelihood of Disturbance:		Comments:	
Human Exposure Potential:			
Maintenance Activity :		**Total Risk Score:**	**N/A**

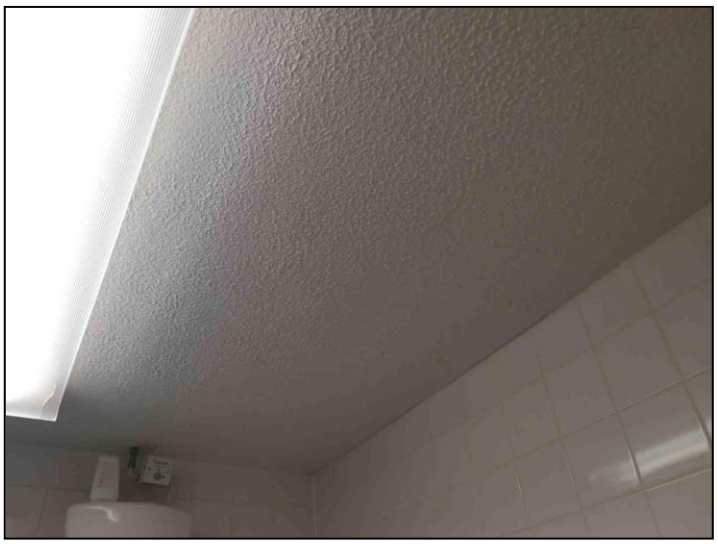
ASSESSMENT		Sample No:	013
Material Risk:	**N/A**	Position:	Internal
Asbestos Type:	0 - No asbestos detected	Approx Size of Item:	15 m²
Product Type:		**COMMENTS AND RECOMMENDATIONS:**	
Extent of Damage:		Timescale for Recommendation : No action	
Surface Treatment:		Recommendation:	No further action required
Priority Risk:	**N/A**		
Normal Occupant Activity:			
Likelihood of Disturbance:		Comments:	
Human Exposure Potential:			
Maintenance Activity :		**Total Risk Score:**	**N/A**

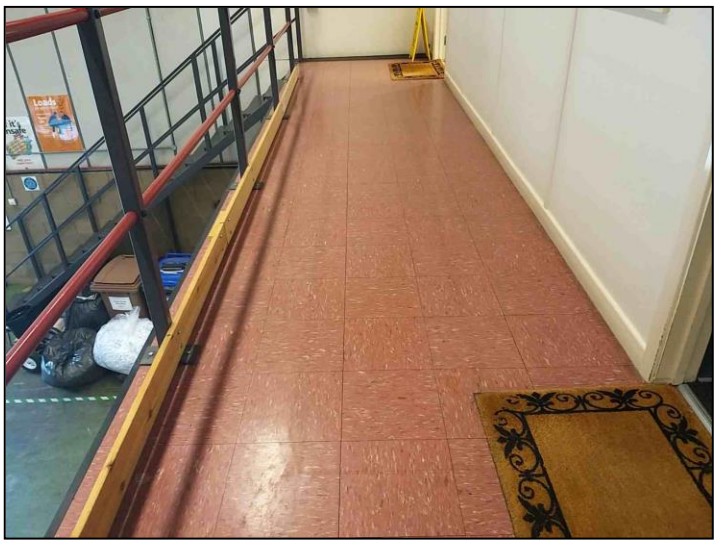
ASSESSMENT		Sample No:	016
Material Risk:	**N/A**	Position:	Internal
Asbestos Type:	0 - No asbestos detected	Approx Size of Item:	10 m²
Product Type:		**COMMENTS AND RECOMMENDATIONS:**	
Extent of Damage:		Timescale for Recommendation : No action	
Surface Treatment:		Recommendation:	No further action required
Priority Risk:	**N/A**		
Normal Occupant Activity:			
Likelihood of Disturbance:		Comments:	
Human Exposure Potential:			
Maintenance Activity :		**Total Risk Score:**	**N/A**
