Overton Brooks V.A. Medical Center - 2018 Reinspection
Plumbing Piping Asbestos Sample Locations - Building 1 - Sub-Basement

Overton Brooks VA Medical Center Shreveport, Louisiana

Plumbing Piping Asbestos Sample Locations Building 1 - Sub-Basement

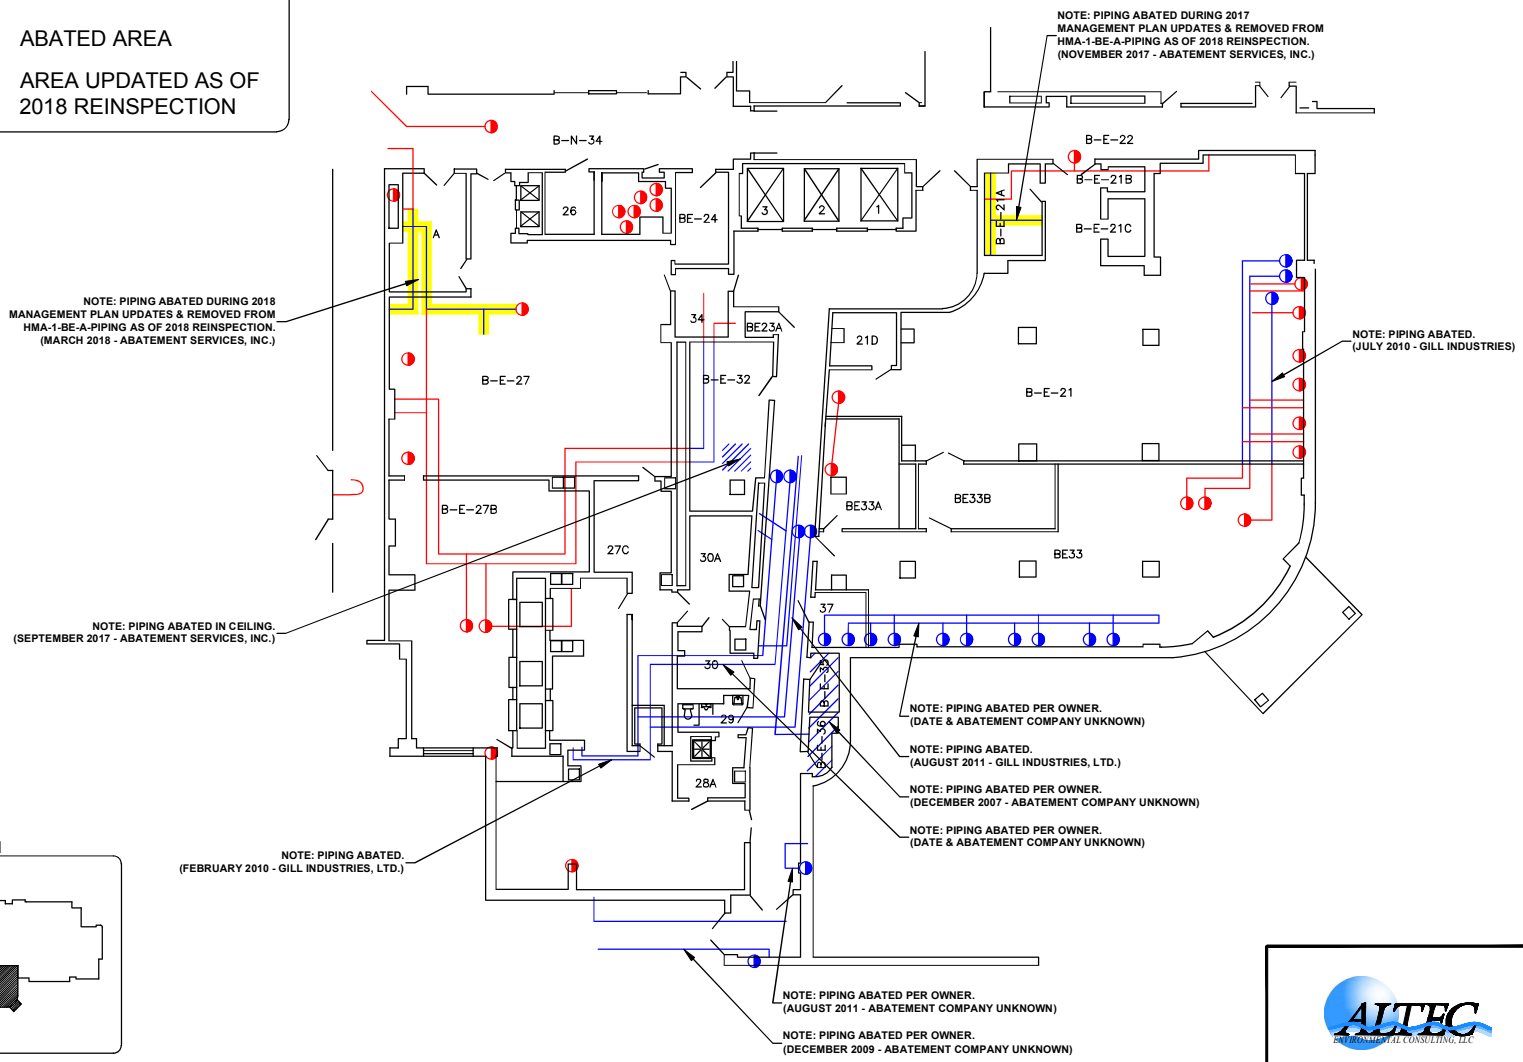
Piping Asbestos Homogeneous Areas Building 1 - Basement

- HMA-1-BE-A-PIPING
- ABATED PIPING
- ABATED AREA
- AREA UPDATED AS OF 2018 REINSPECTION
