ASBESTOS AND LEAD-PAINT SURVEY

REPAIR BEQ HP135

MARINE CORPS BASE CAMP LEJEUNE
JACKSONVILLE, NORTH CAROLINA 28542

ECS PROJECT NO. 49:26342

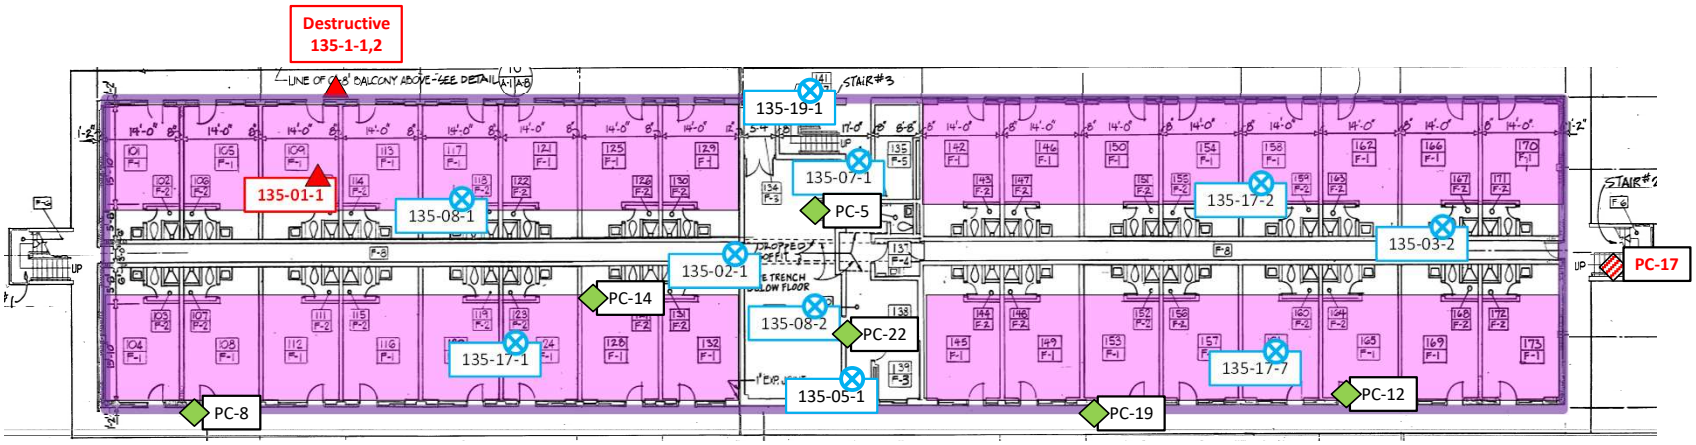
First Floor

- Black Mastic associated with Beige Floor Tiles
- Black Damp Proofing Mastic behind Brick Venner

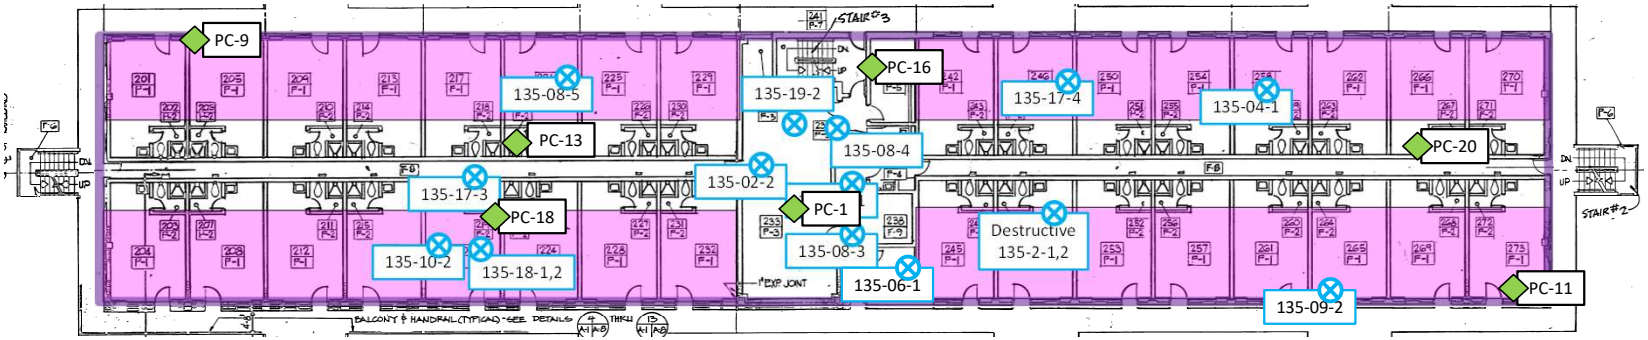
2nd Floor

- Black Mastic associated with Beige Floor Tiles
- Black Damp Proofing Mastic behind Brick Venner

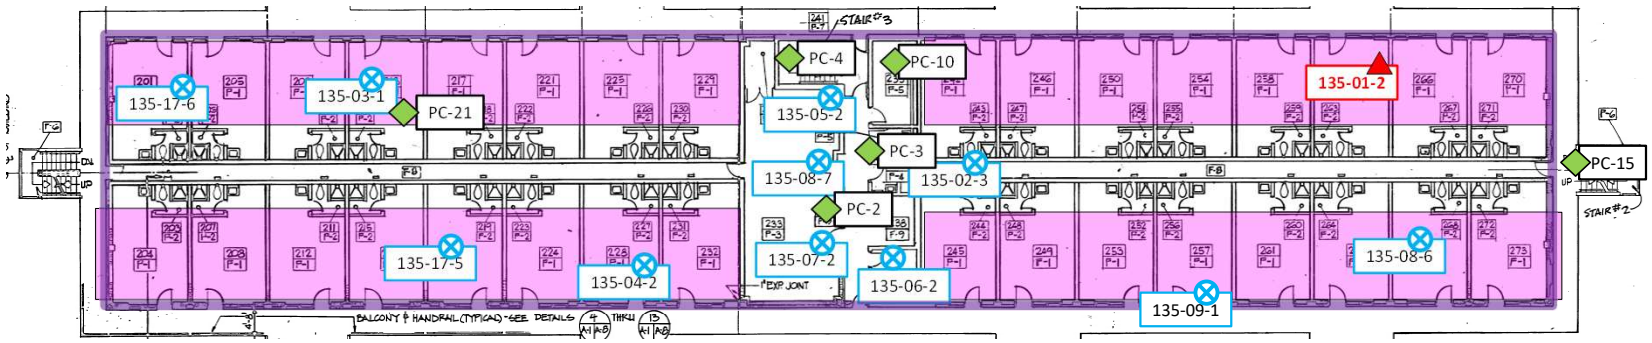
3rd Floor

Black Mastic associated with Beige Floor Tiles

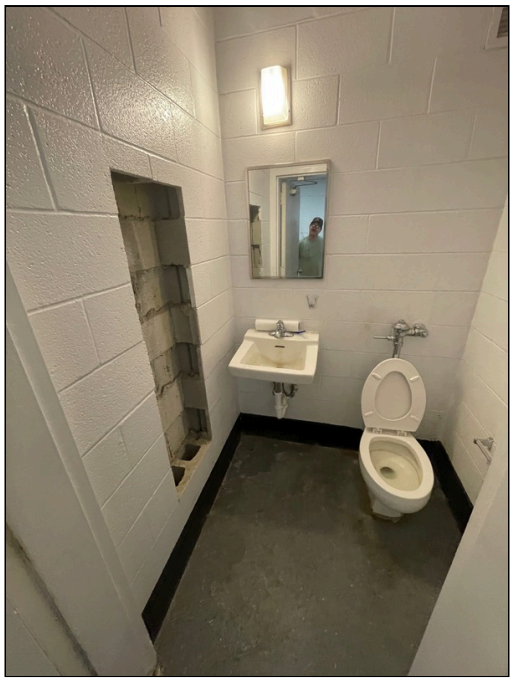
11 - View of typical private bathrooms.
