Hazardous Material Report for Buildings HP51, HP53, HP55, HP57, and 1340

MCB Camp Lejeune, North Carolina

Naval Facilities Engineering Systems Command Mid-Atlantic

Date: March 2026

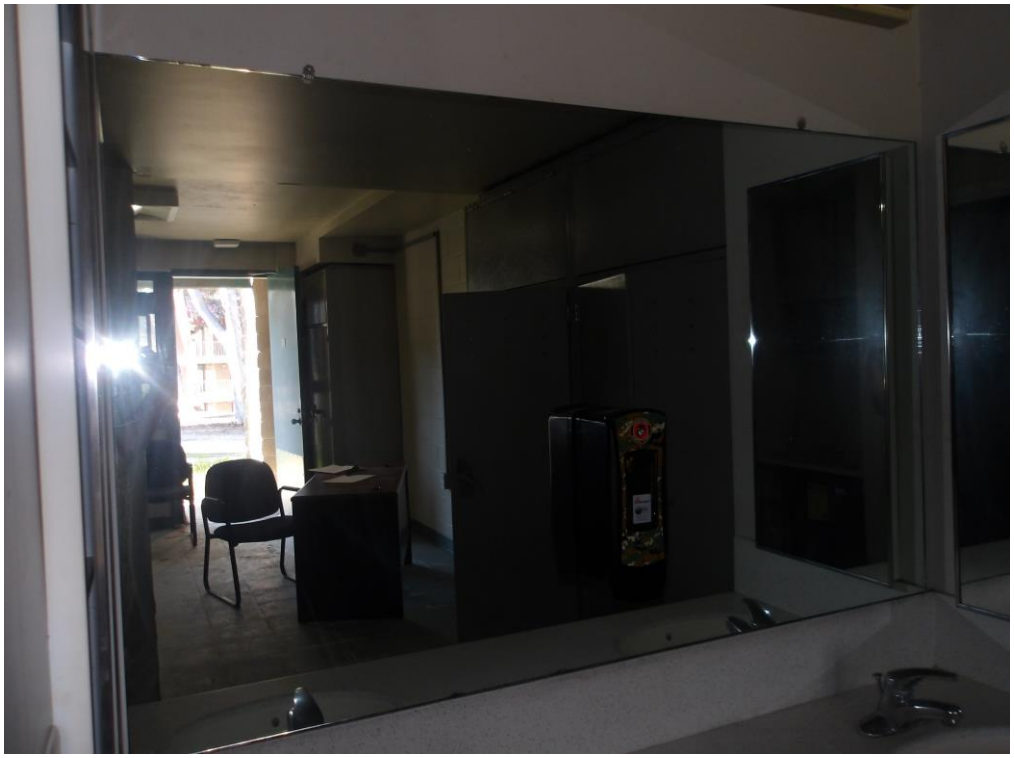
PHOTOGRAPH 3

Comments: Assumed ACM – Mirror Mastic (example photo – no exposure mastic - no samples were taken)

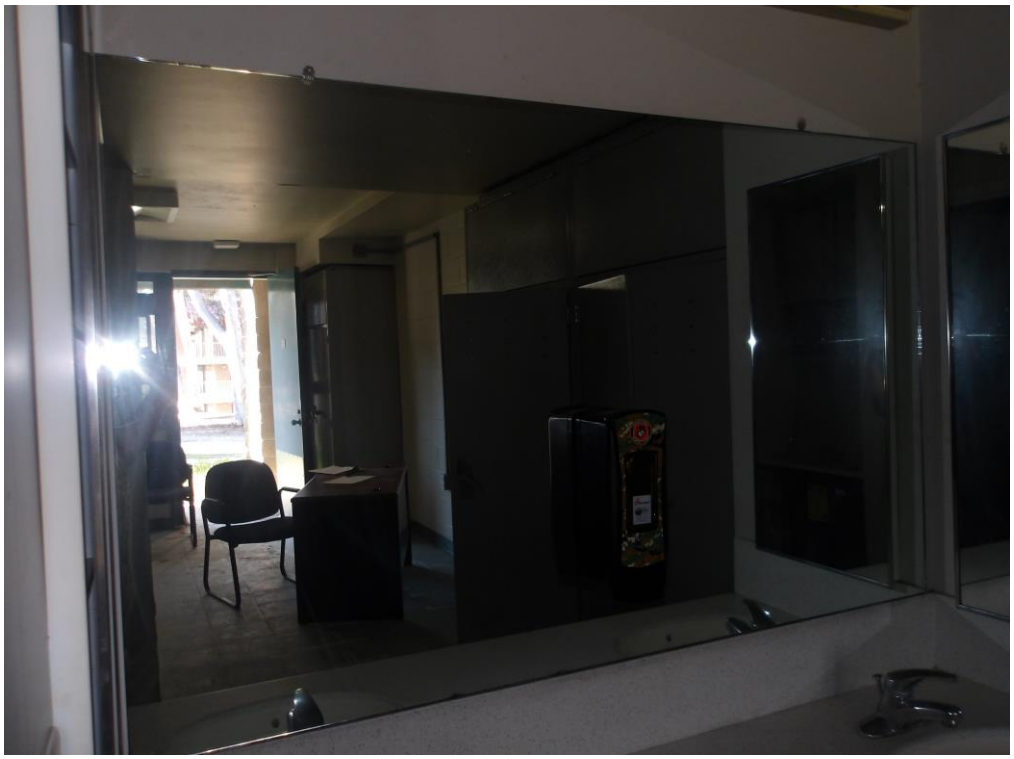
PHOTOGRAPH **5**

Comments: Assumed ACM – Mirror Mastic (example photo – no exposure mastic - no samples were taken)

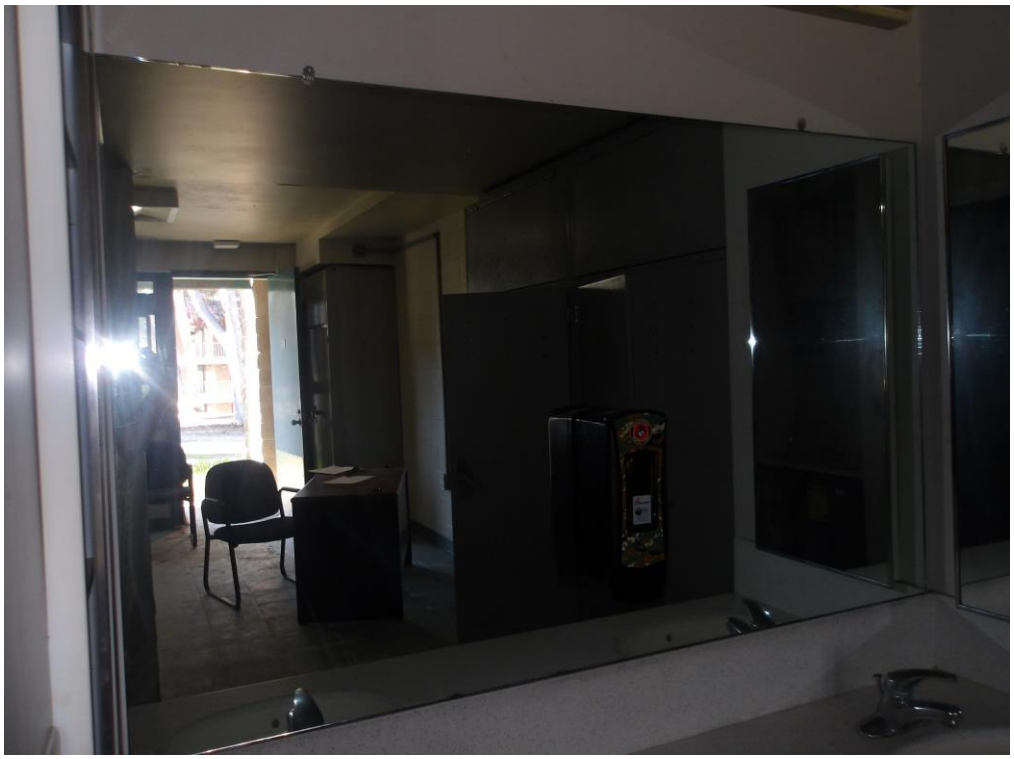
PHOTOGRAPH **7**

Comments: Assumed ACM – Mirror Mastic (example photo – no exposure mastic - no samples were taken)

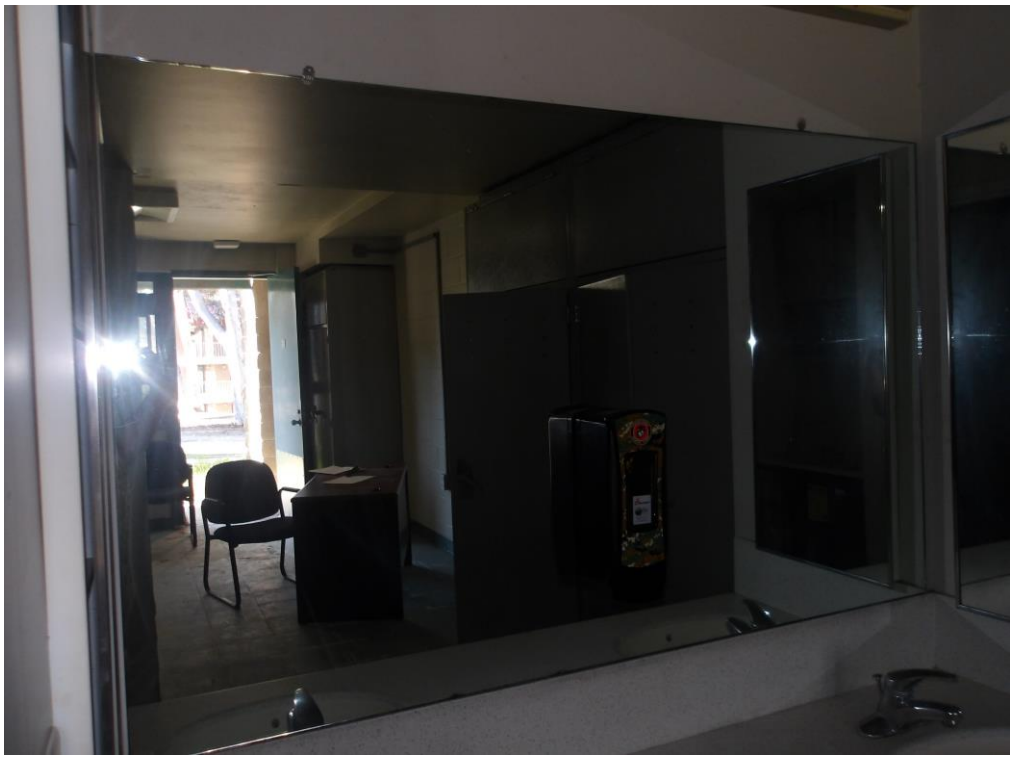
PHOTOGRAPH **11**

Comments: Assumed ACM – Mirror Mastic (example photo – no exposure mastic - no samples were taken)

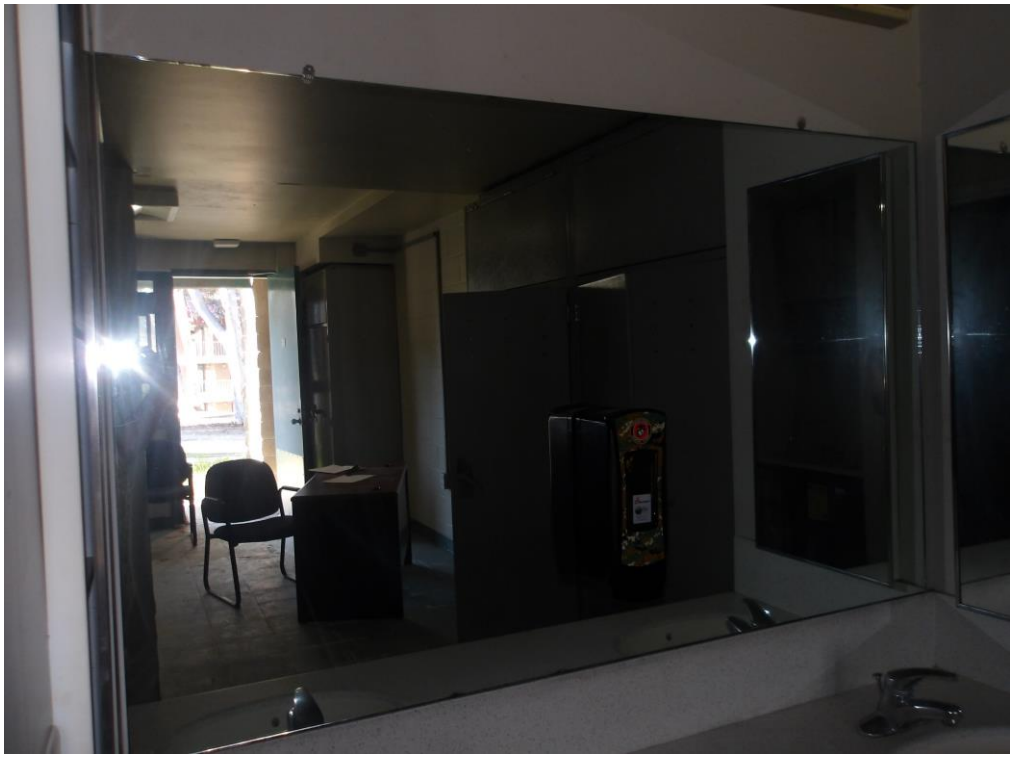
PHOTOGRAPH **14**

Comments: Assumed ACM – Mirror Mastic (example photo – no exposure mastic - no samples were taken)
