WebAIM Short Form TASK GROUP INSTRUCTION

TGI NO:	COMPONENT NAME:	TYPE:	PHASE:	REPEAT:	CHG/VER:
	1B BOILER	**BO**	**A**	**9**	**0/0**

SHIP/HULL NO:	SHIP/HULL NAME:	PROJECT:	SYSTEM:	PLANT ID:	CASREP CAT:
LCC-19	**USS BLUE RIDGE**	19P	**22111**

CU PHASE TITLE: *(H9-01) F/O - ACCOMPLISH SET UP AND RST OF 1B BLR DSUPHTR TIGHTNESS TEST

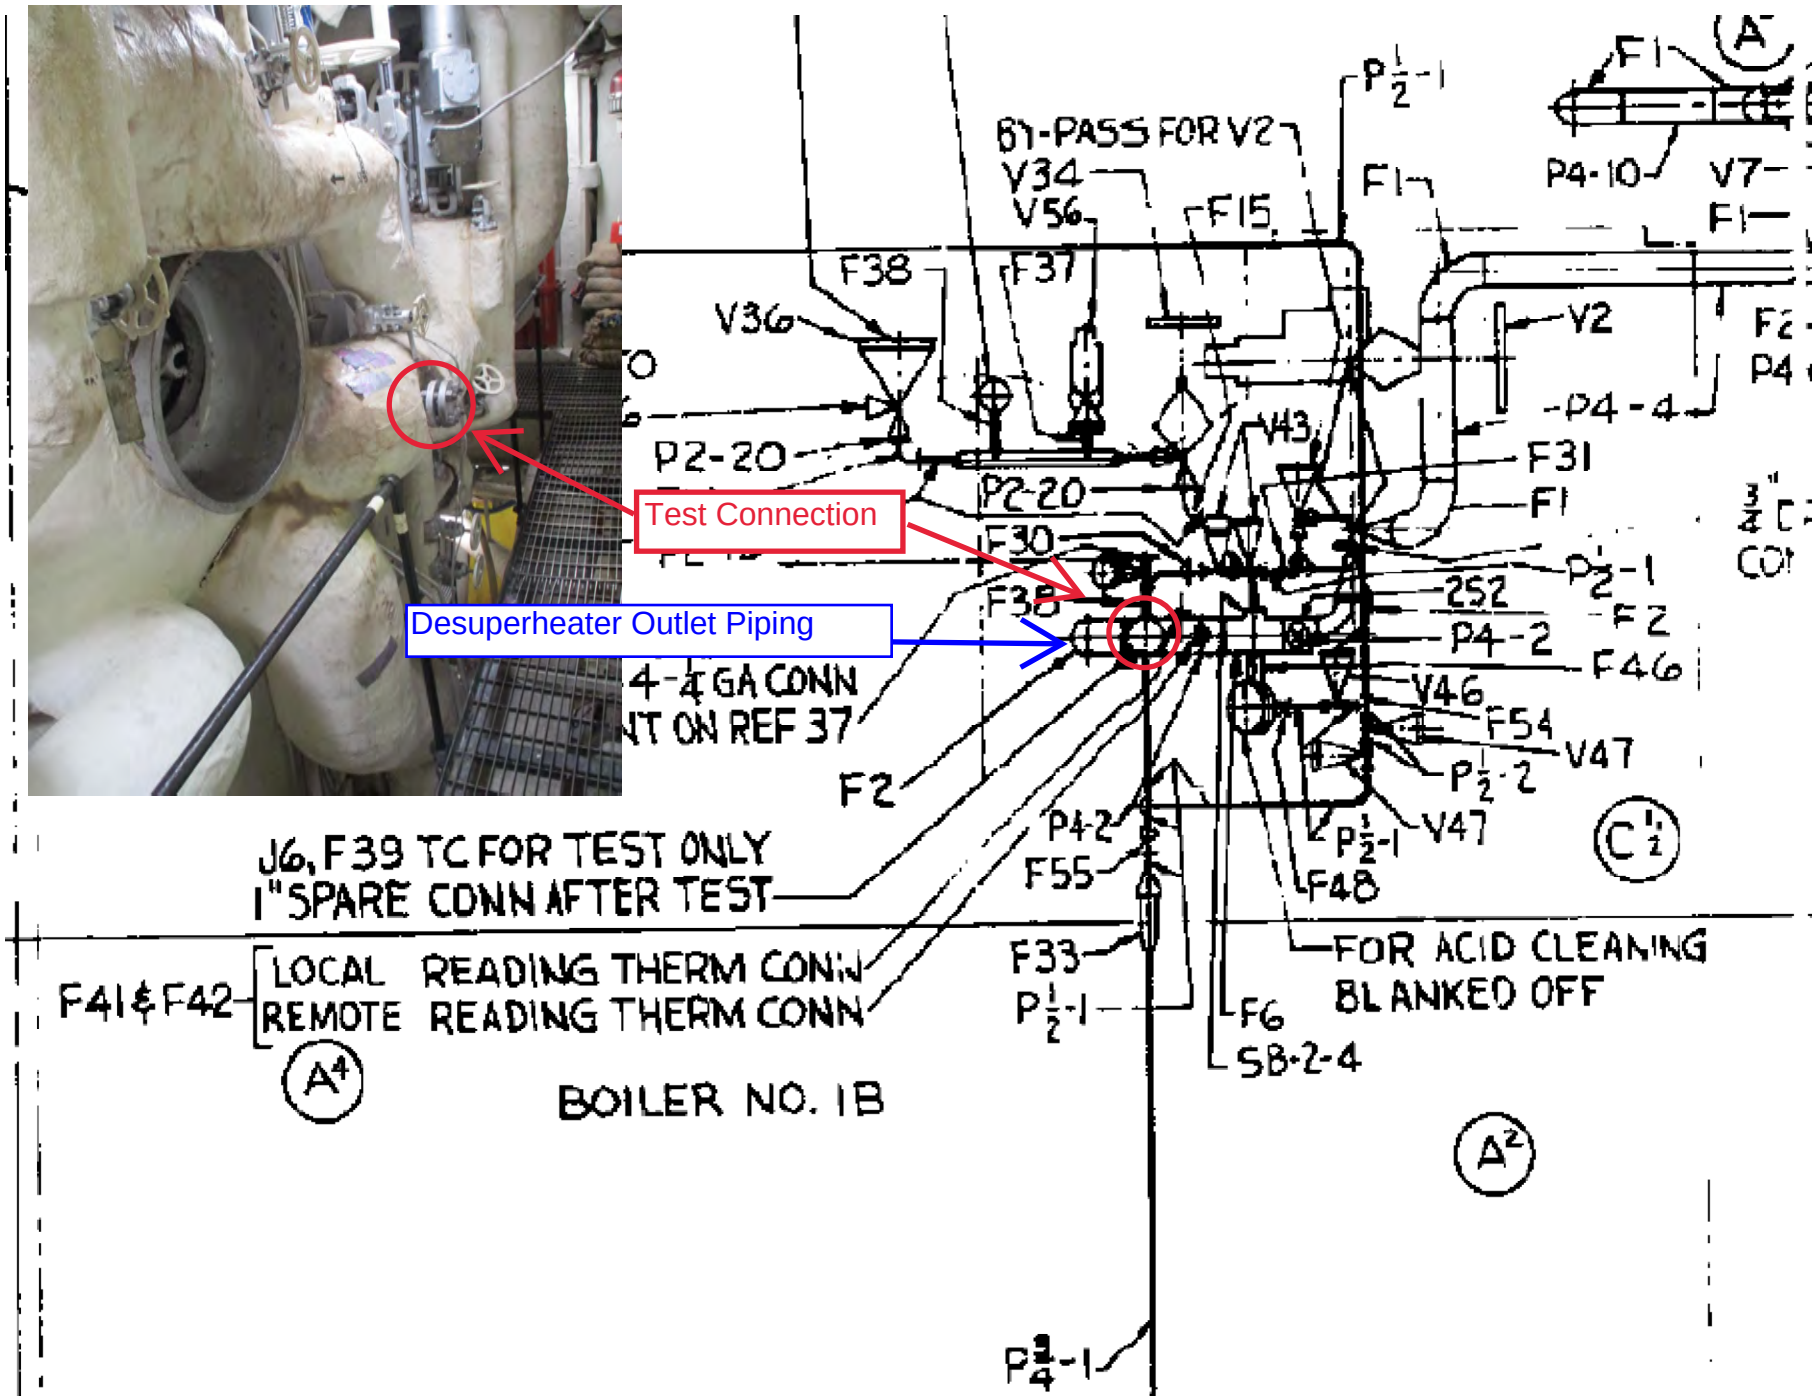
3819P22115A08 **ENCLOSURE-01** **Sheet 1 of 1**

2.2 Install test fitting to the desuperheater outlet piping of the boiler listed in 1.3.1 to accomplish tightness test for each mechanical joint of the desuperheater after reinstallation, using Ref. No. 3, Ref. No. 4 and Enclosure-01 for guidance.

2.3 Remove test fitting from the desuperheater outlet piping of the boiler listed in 1.3.1 after completion of tightness test for the desuperheater, using Ref. No. 3, Ref. No. 4 and Enclosure-01 for guidance.

2.2.1 Remove blank flange from the boiler desuperheater outlet piping.

2.3.1 Install blank flange to the boiler desuperheater outlet piping.

2.3.1.1 Remove existing and install new gasket conforming to MIL-G-24716.
