AMISTAD DAM

ASBESTOS and LEAD-BASED PAINT SURVEY

United States Section, International Boundary and Water Commission
Amistad Dam Facility

Issue Date: December 17, 2004

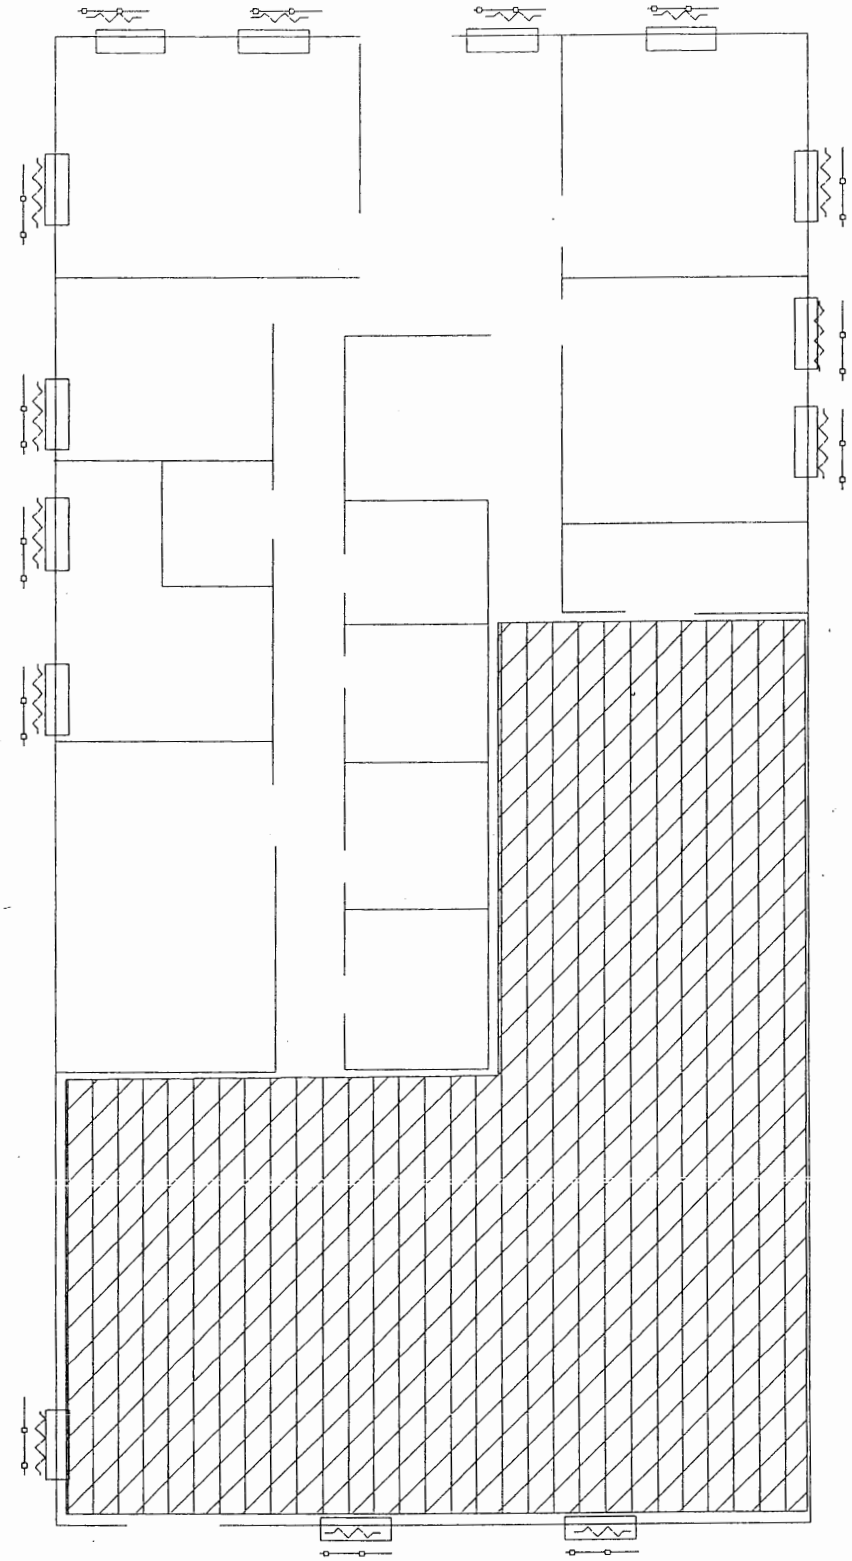
Legend:

Black Mastic and Floor Tile

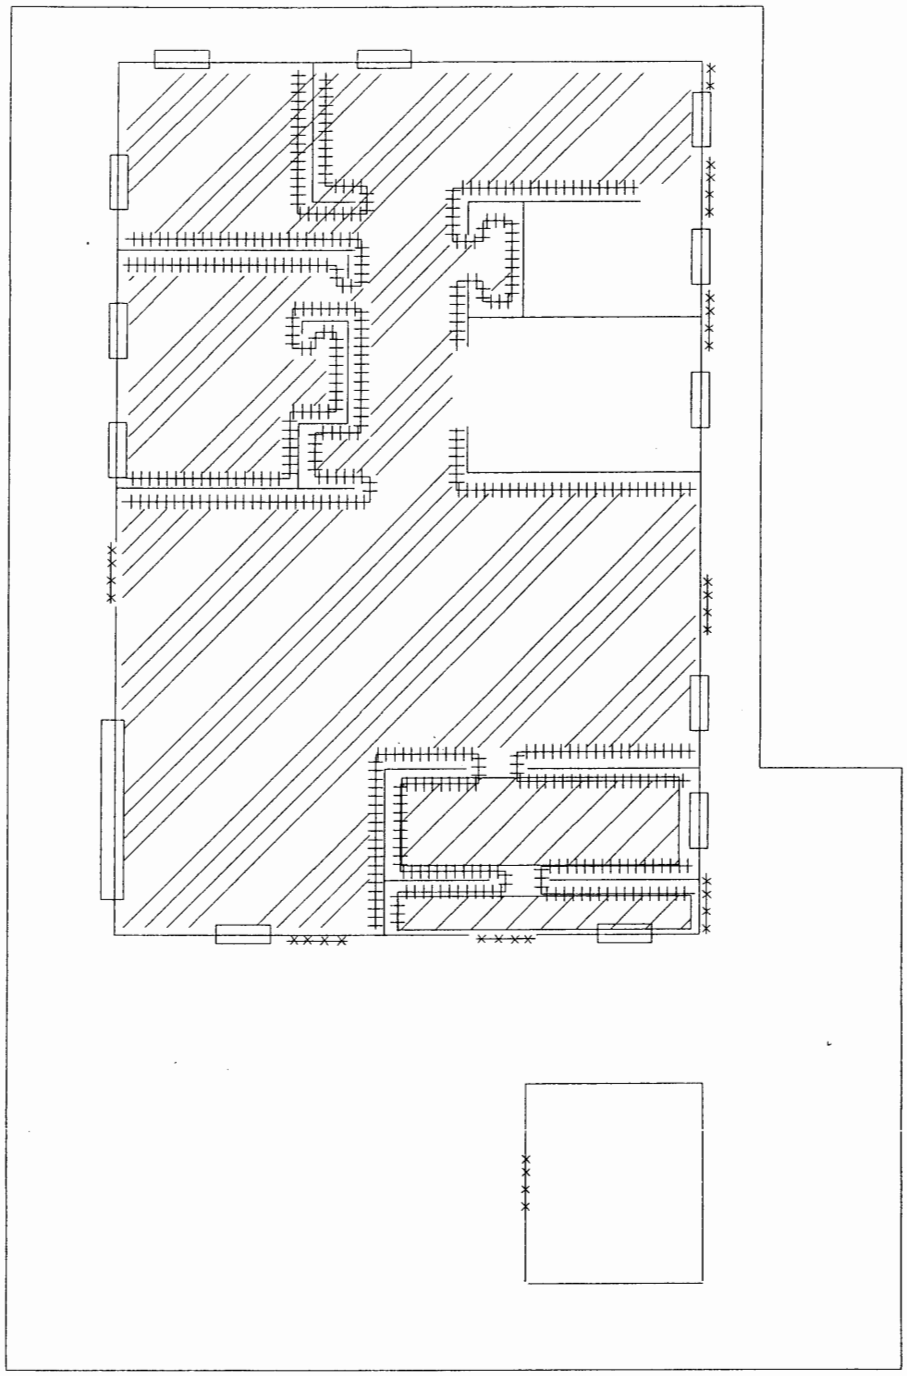
Legend:

9"x9" Biege Floor Tile and Black Mastic

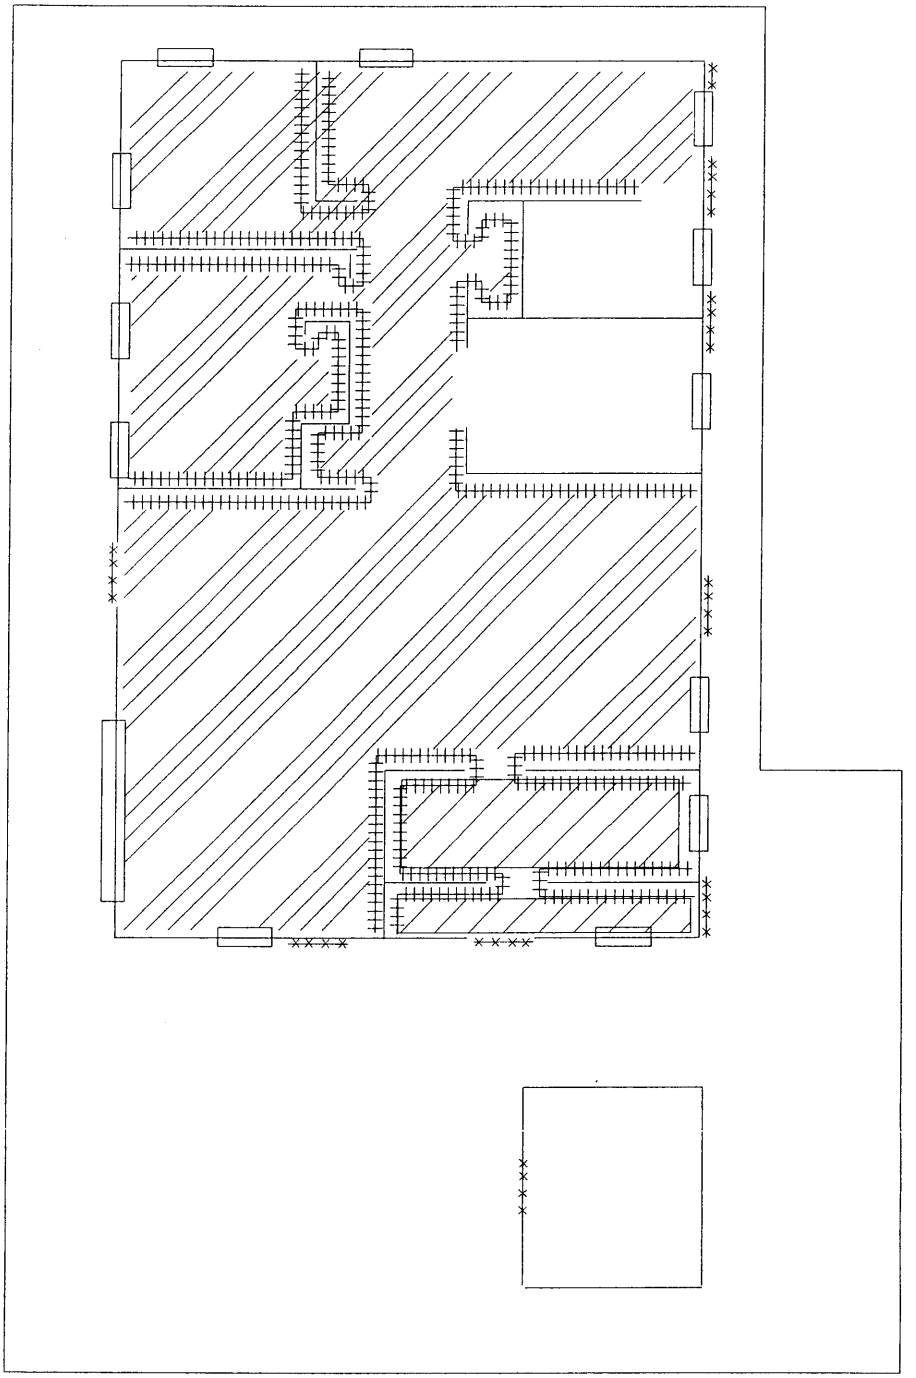
Legend:

9"x9" Biege Floor Tile and Black Mastic

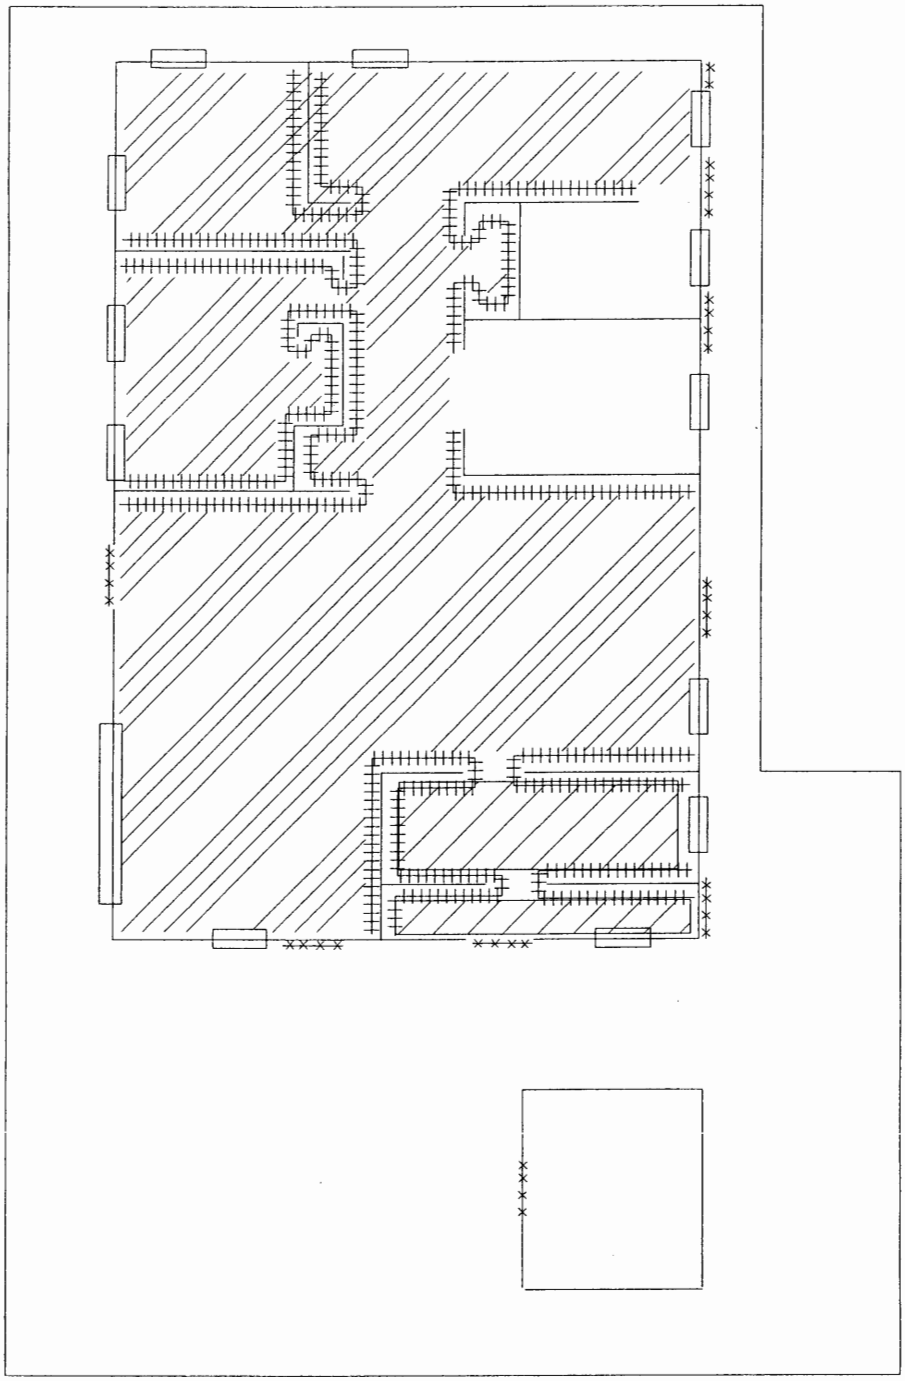
Legend:

9"x9" Biege Floor Tile and Black Mastic

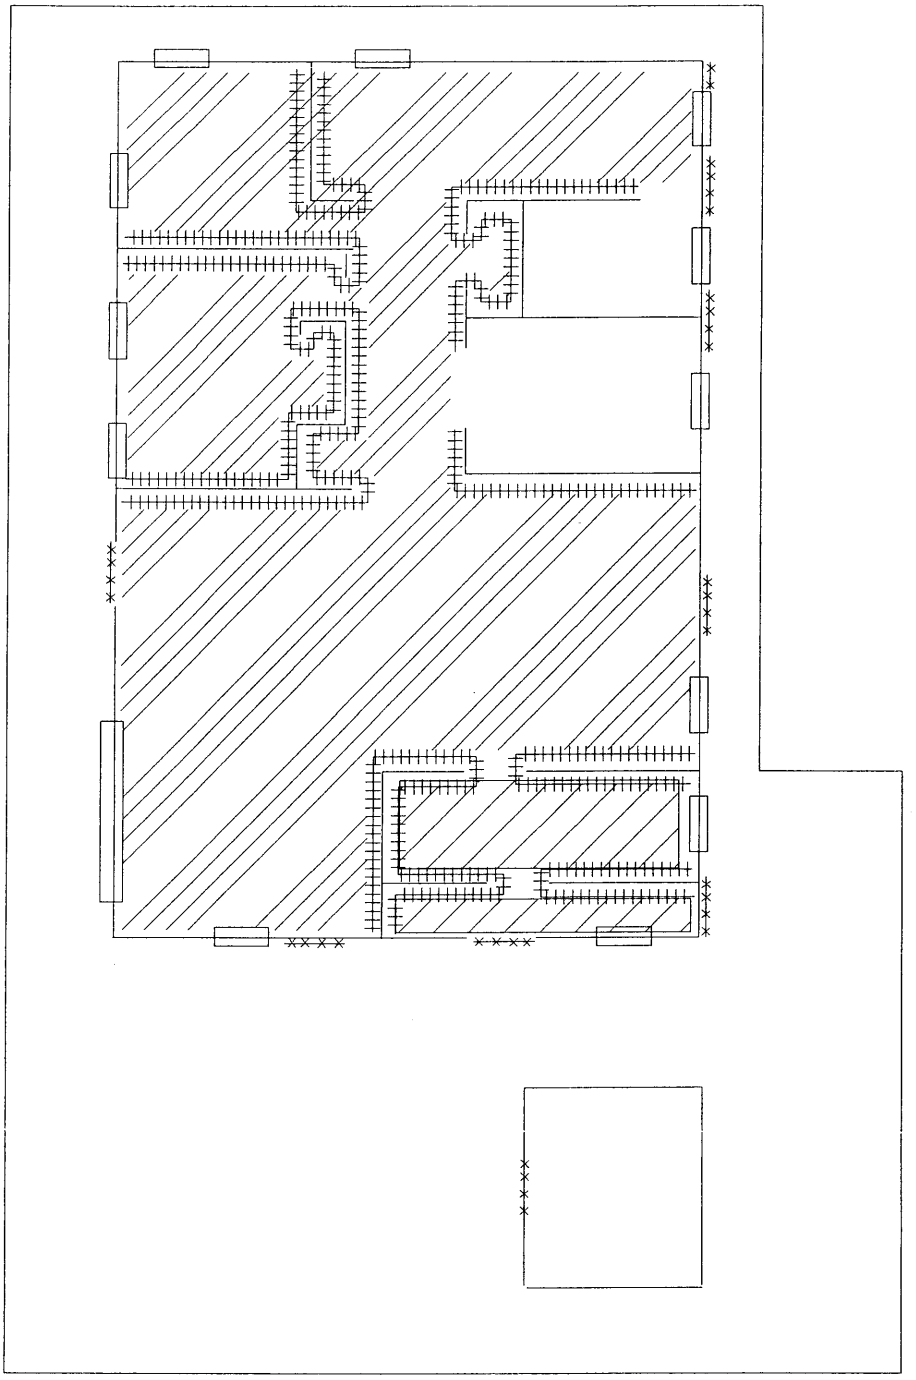
Legend:

9"x9" Biege Floor Tile and Black Mastic

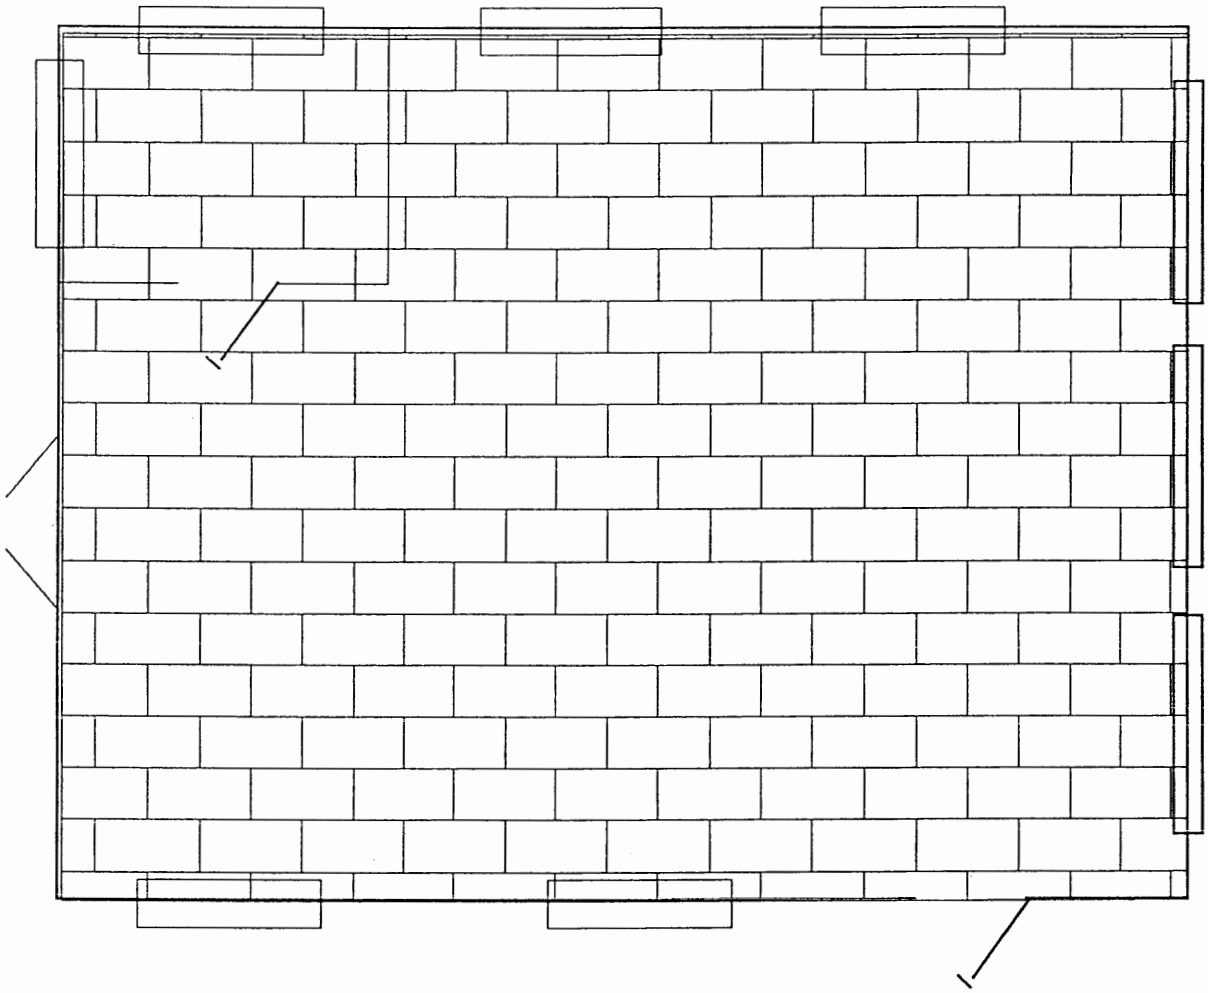
Legend:

Sheetrock and Joint Compound
Interior Walls and Ceiling

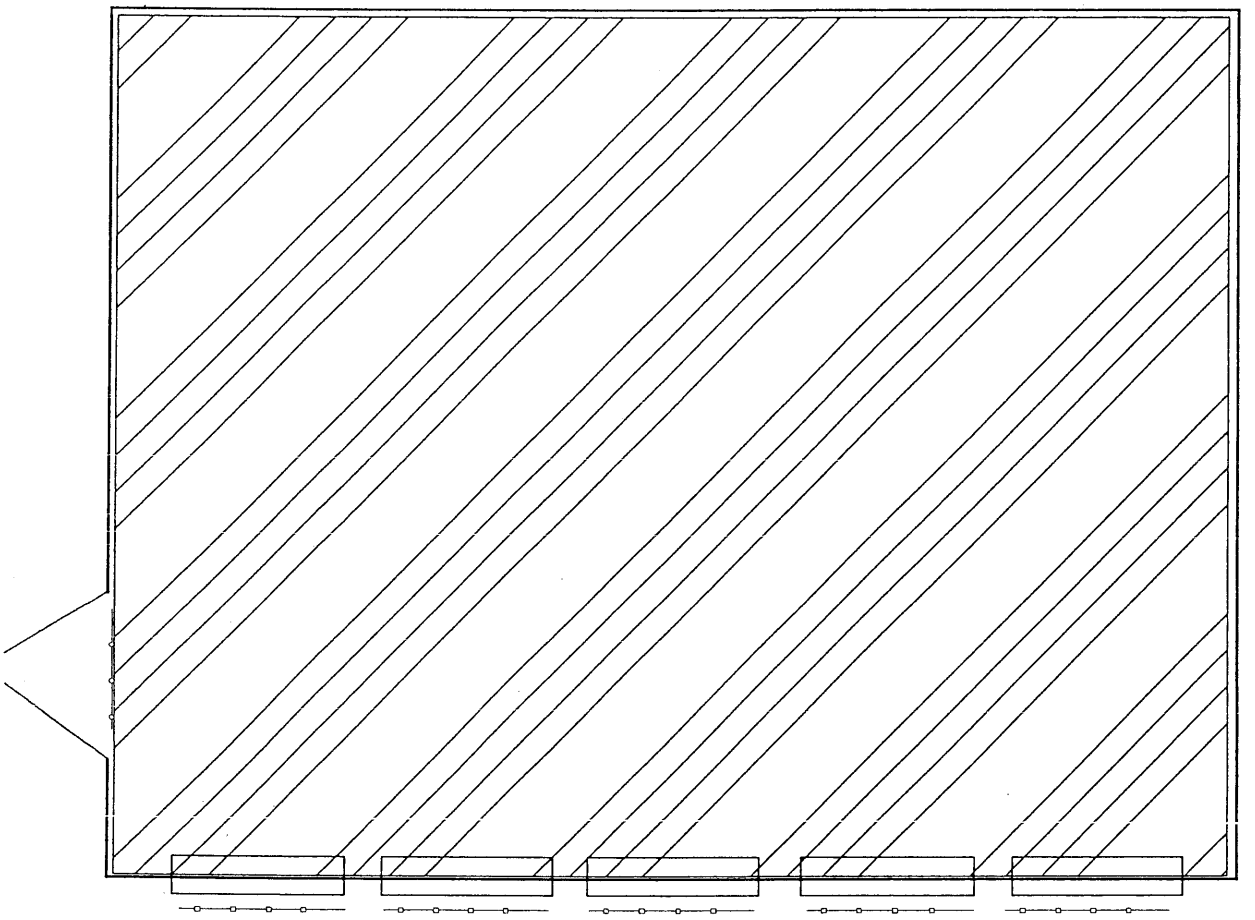
Legend:

Brown Linoleum (Under Carpet)

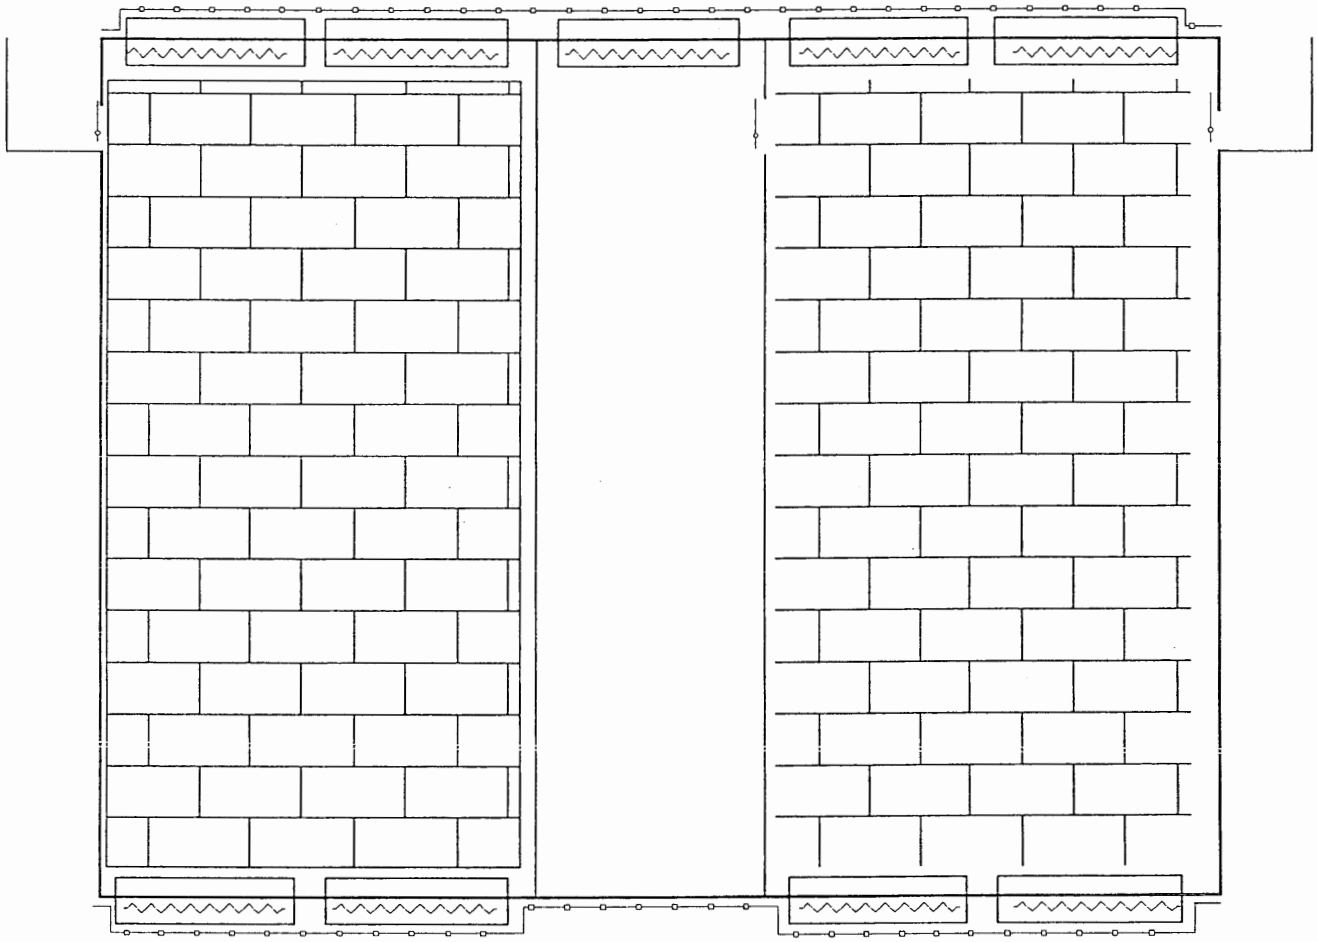
Legend:

Sheetrock Wall and Joint Compound Texture

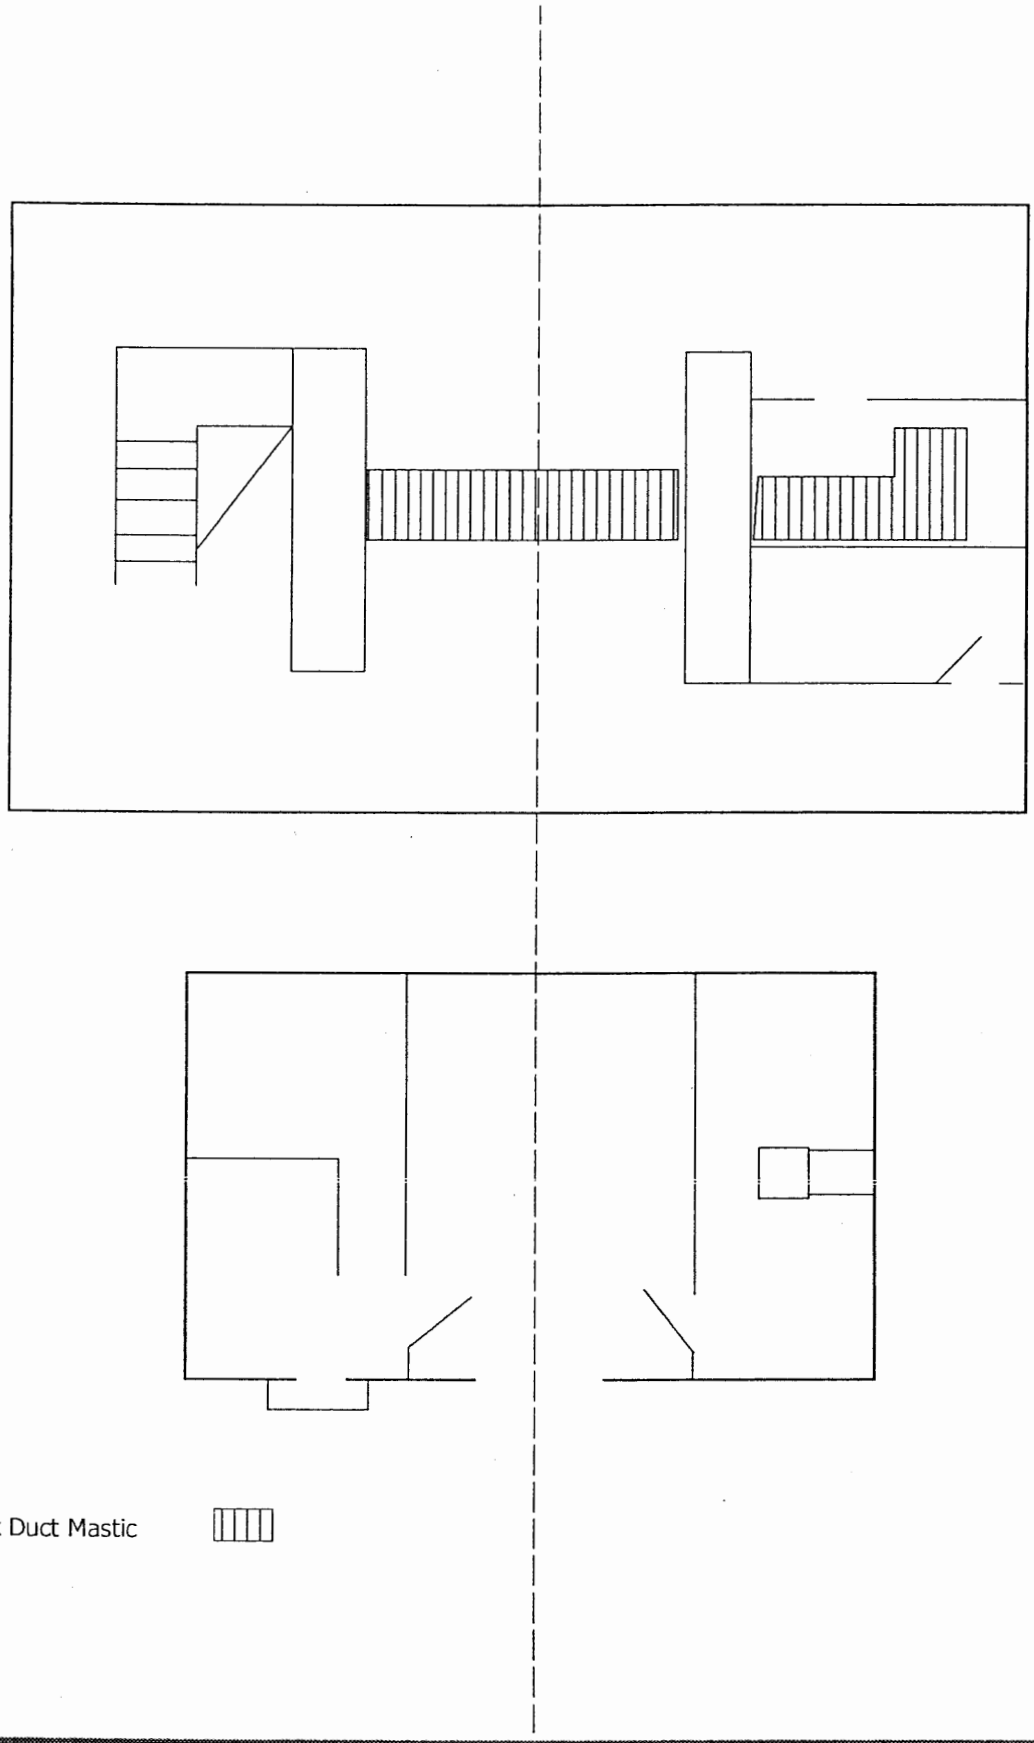
Legend:
HVAC Black Duct Mastic

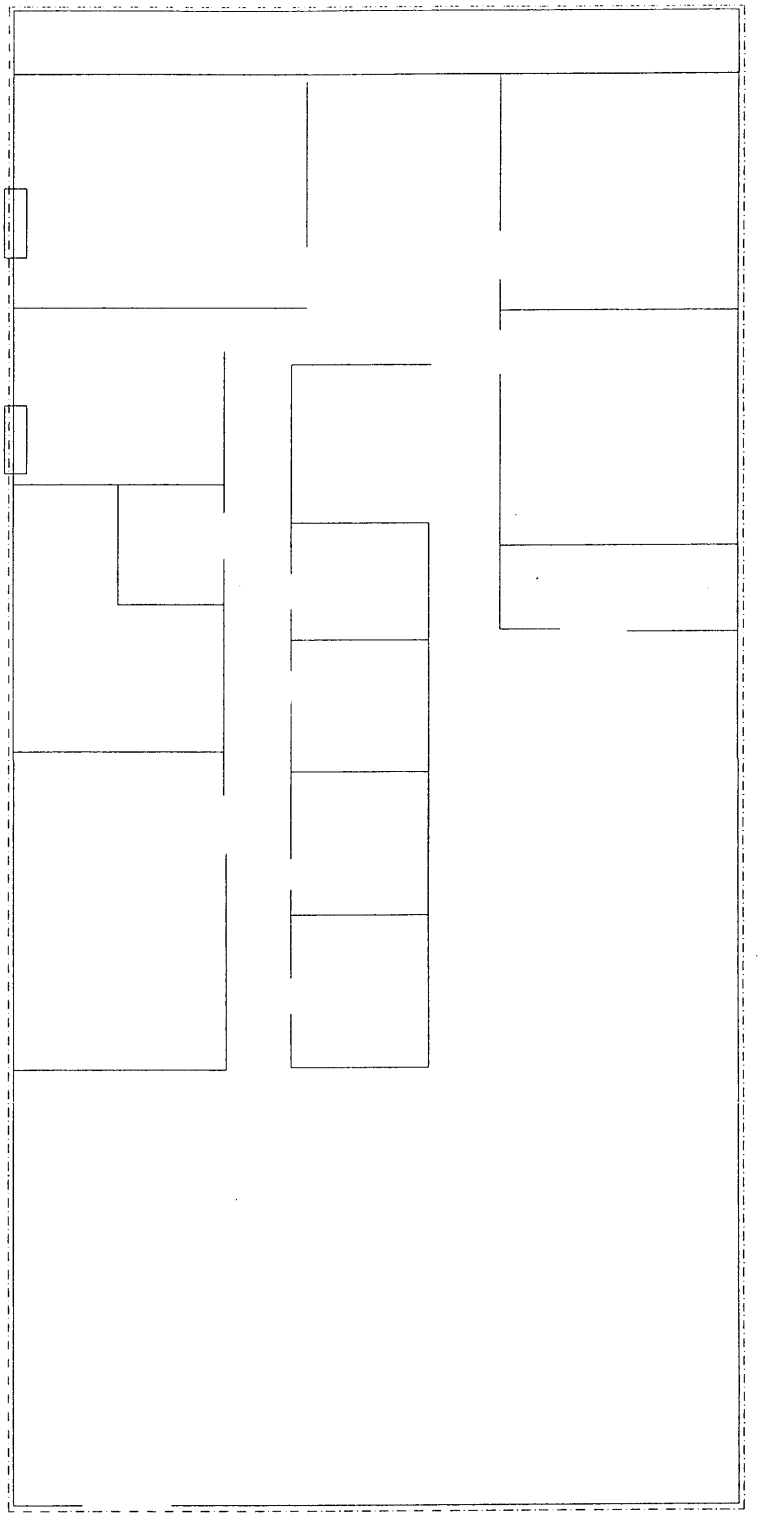
Legend:

White Wood Trim - - - - -

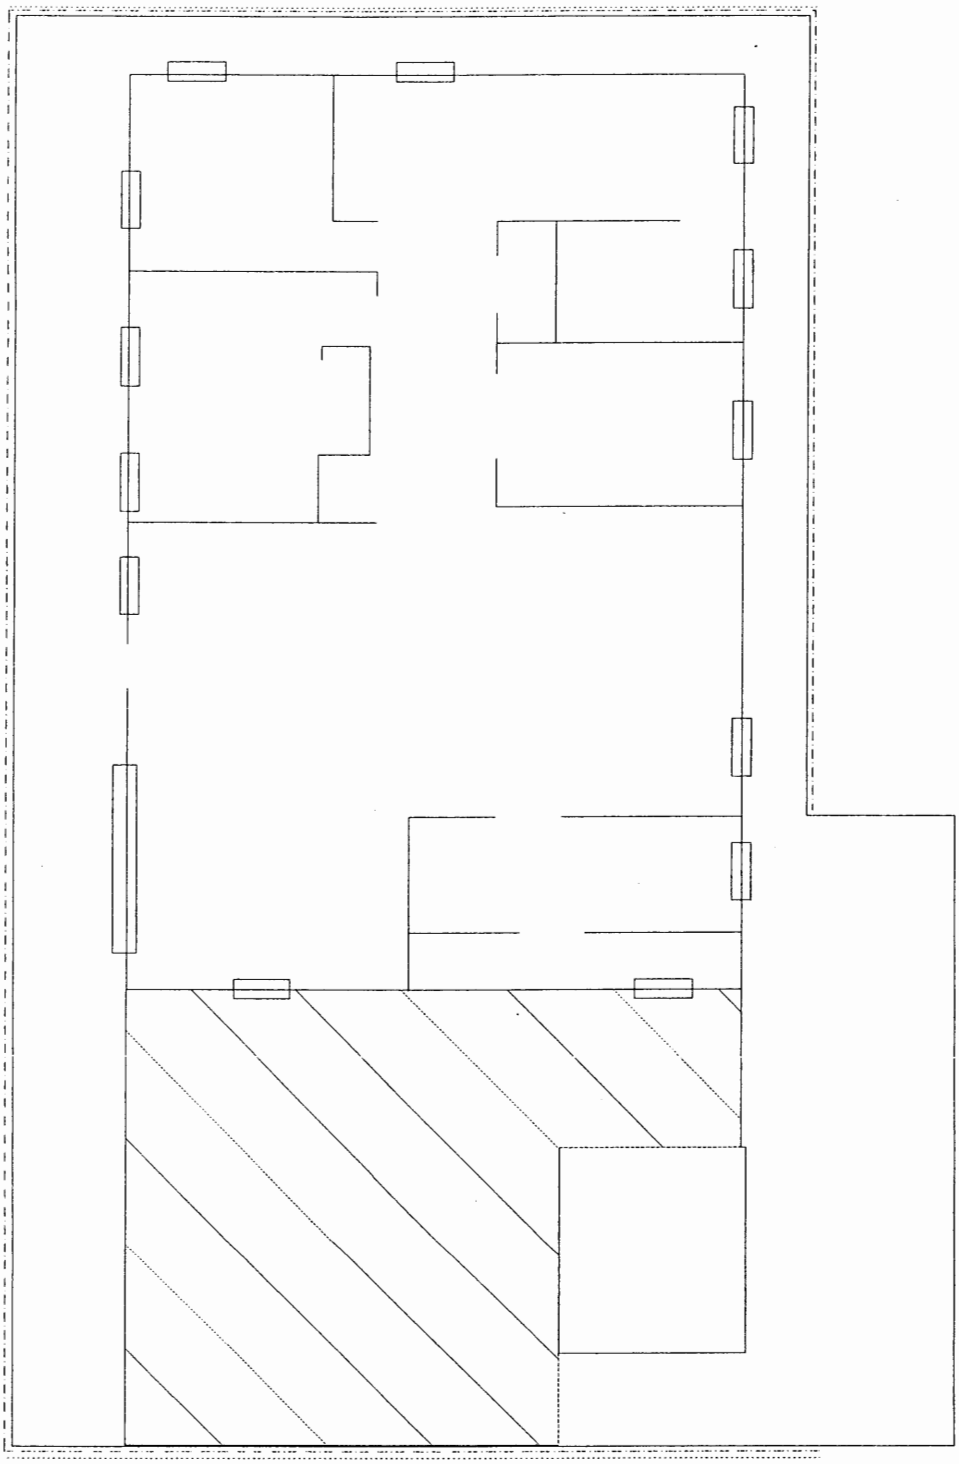
Legend:

Wood Trim White

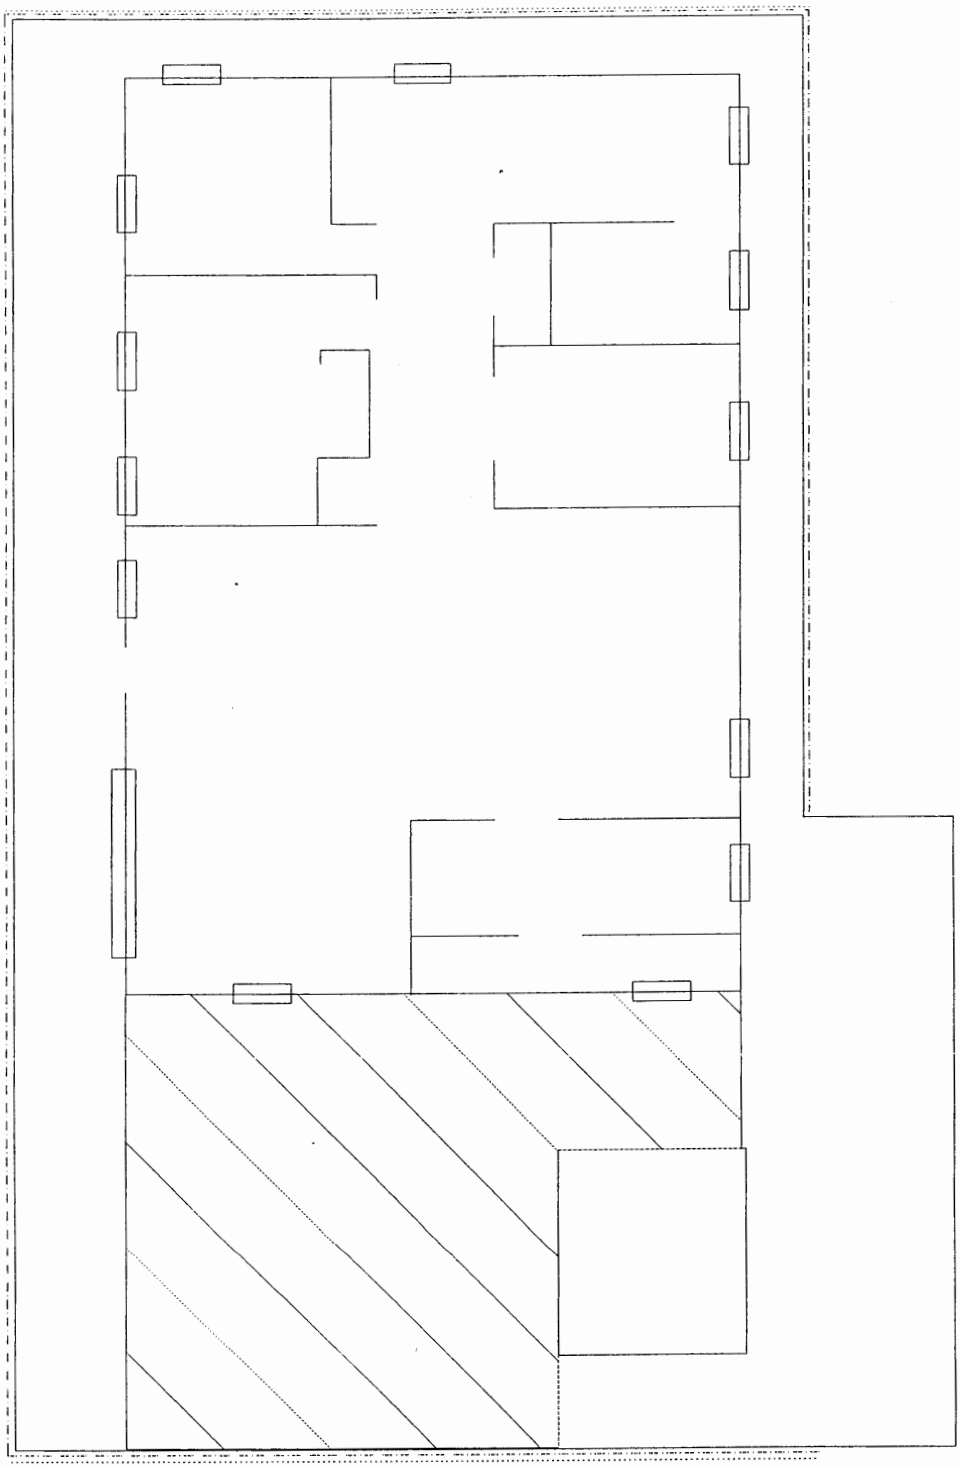
Legend:

Wood Trim White

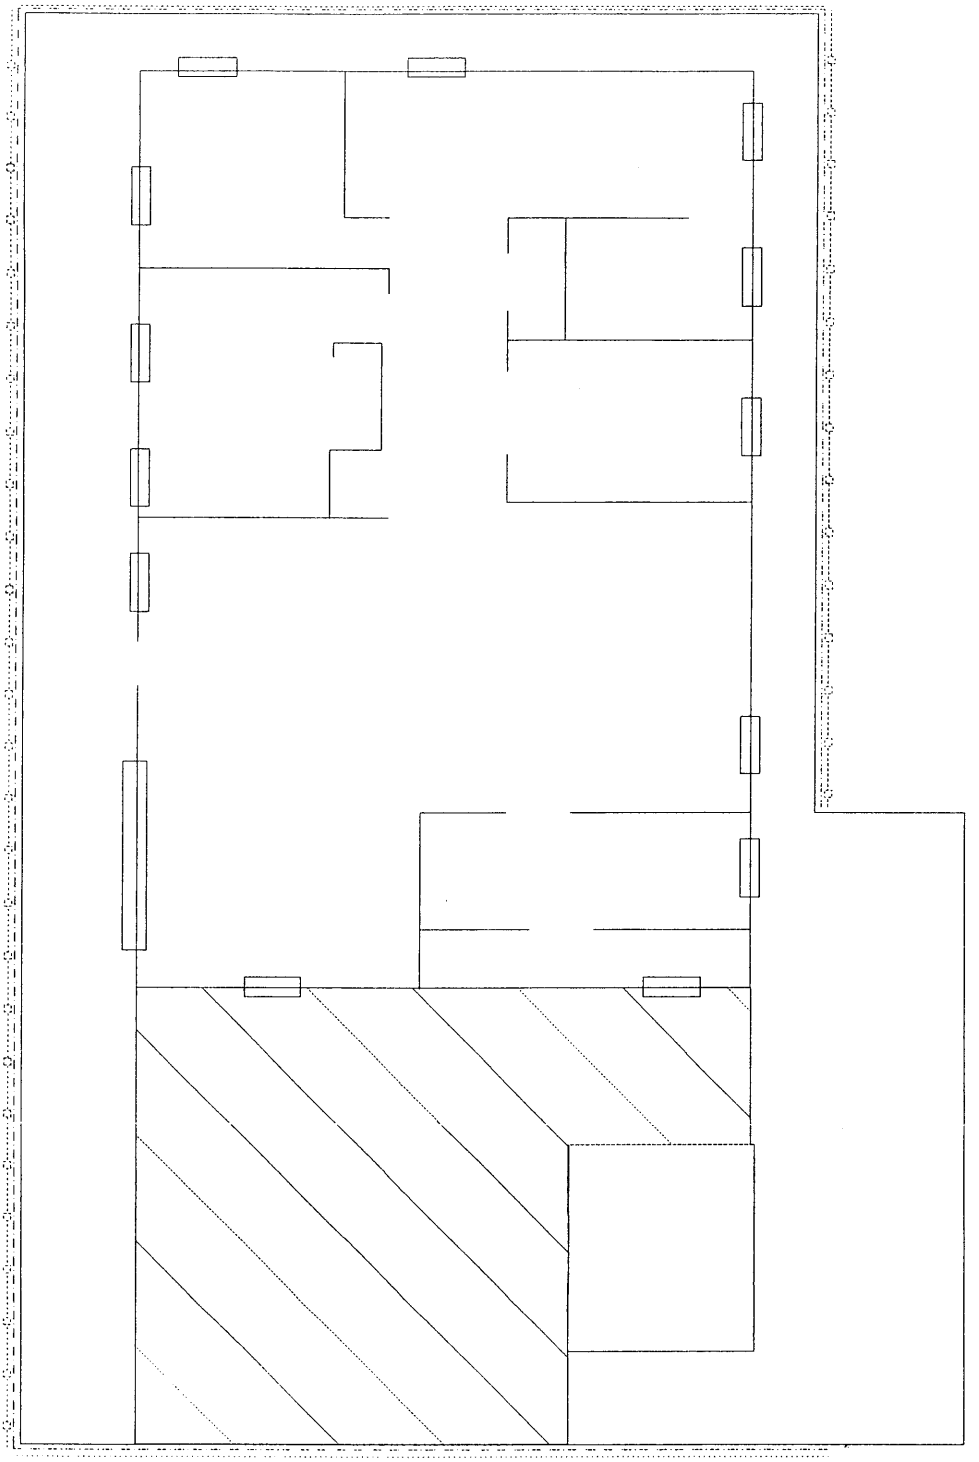
Legend:

Wood Trim White

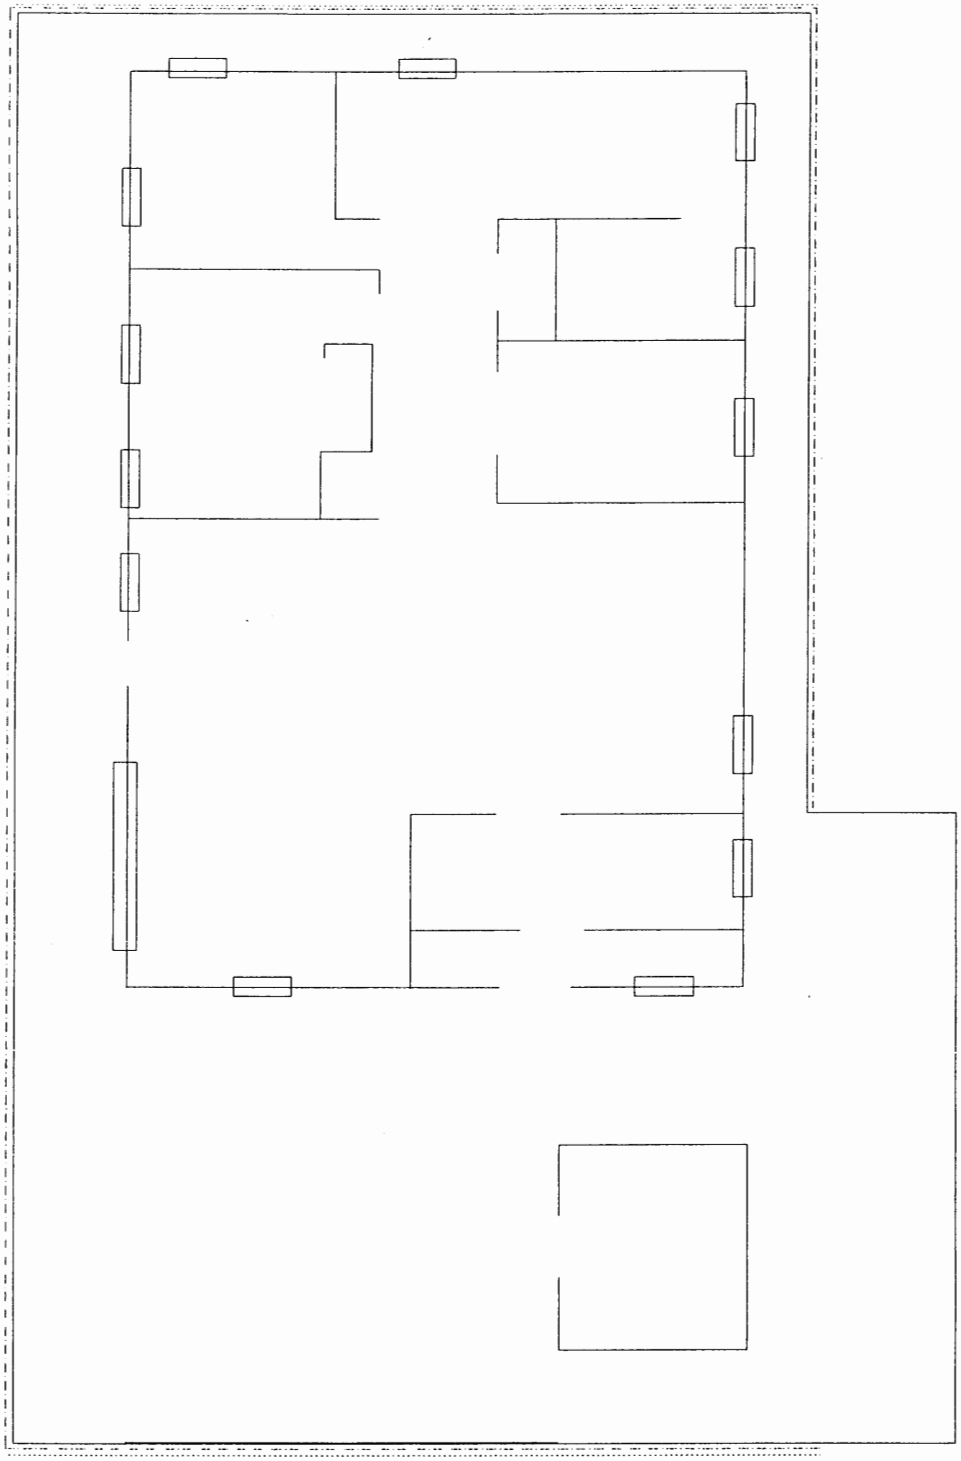
Legend:

Wood Trim White

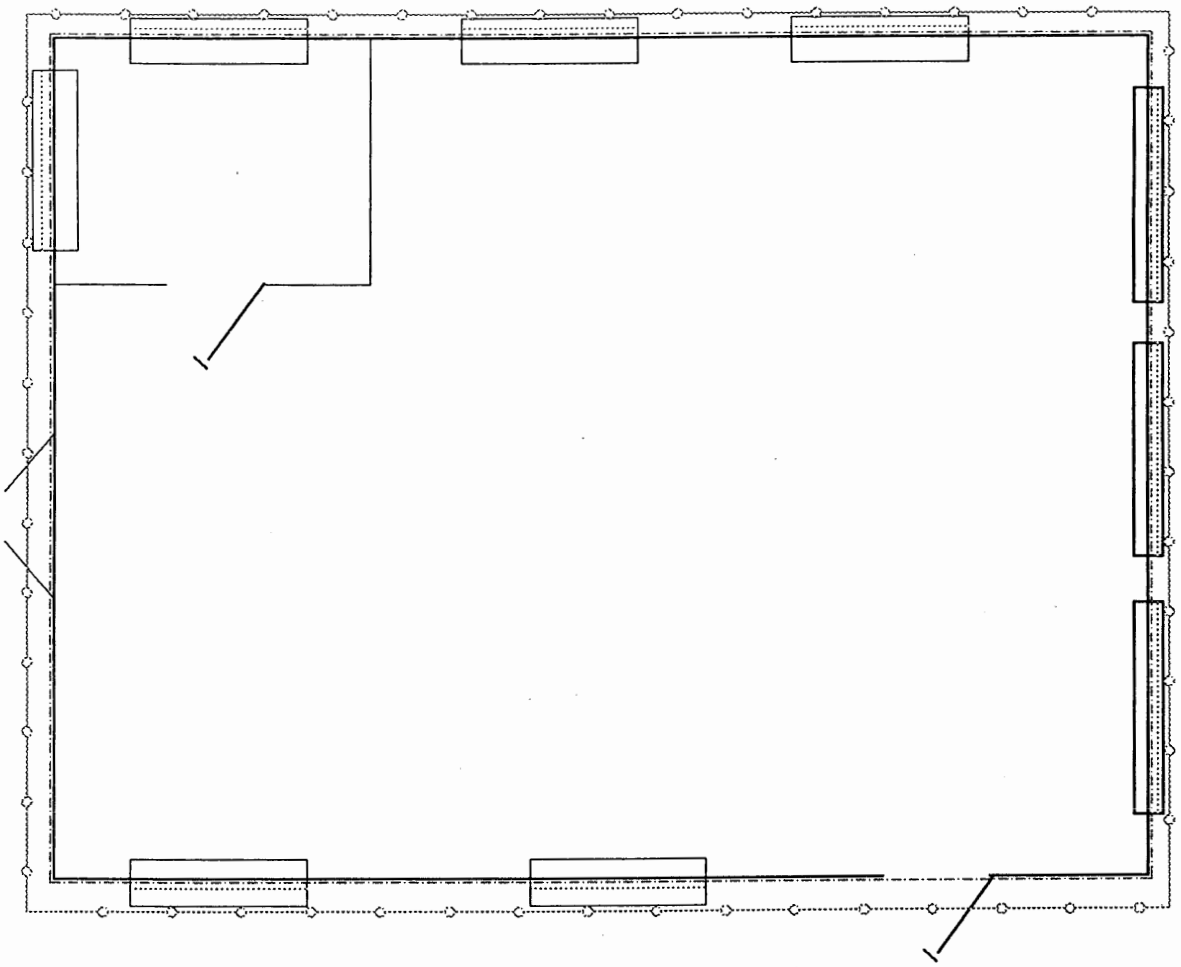
Legend:

Wood Siding Exterior

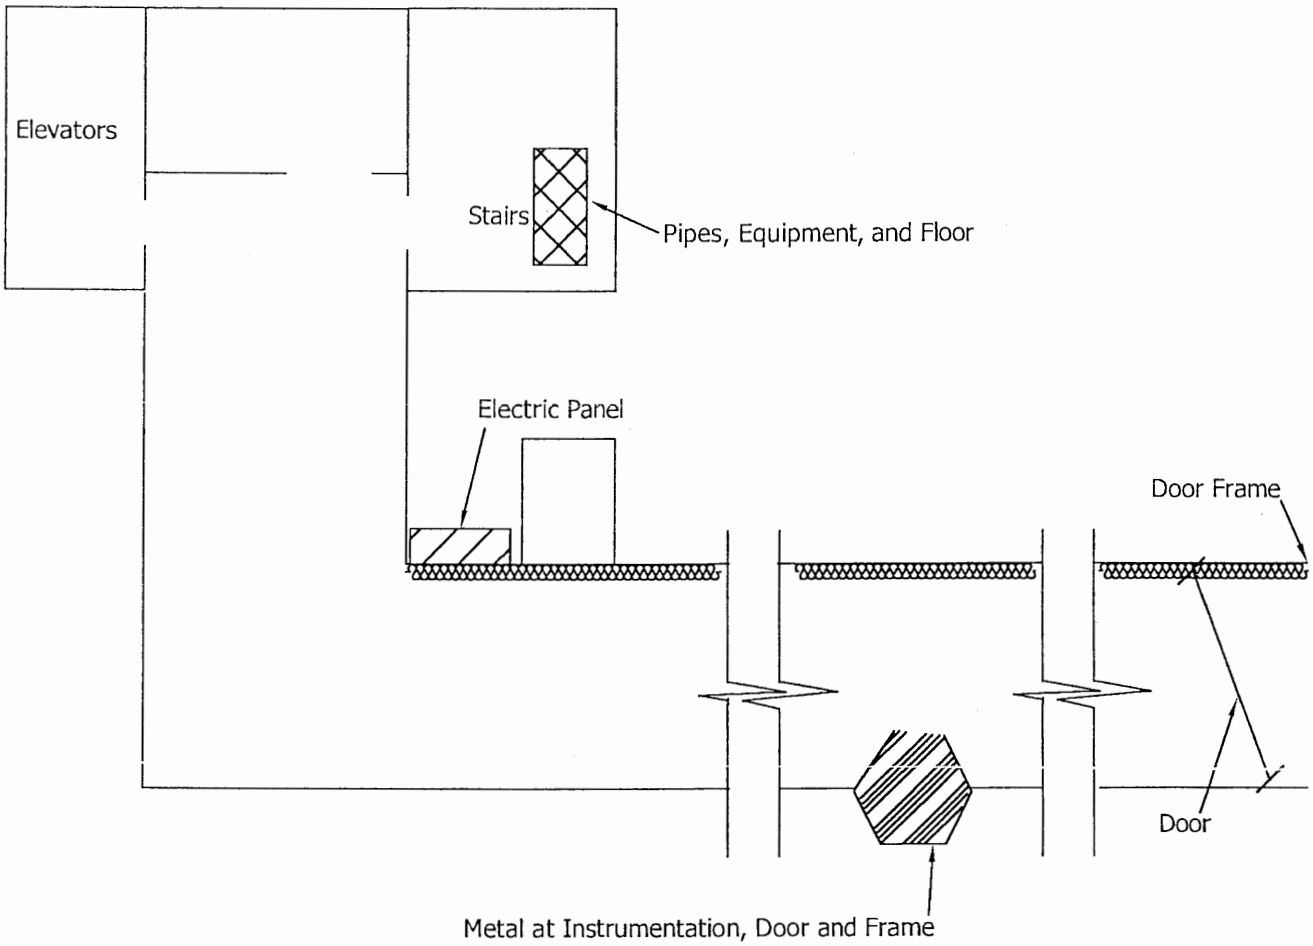
Legend:

Floor Grated Frame

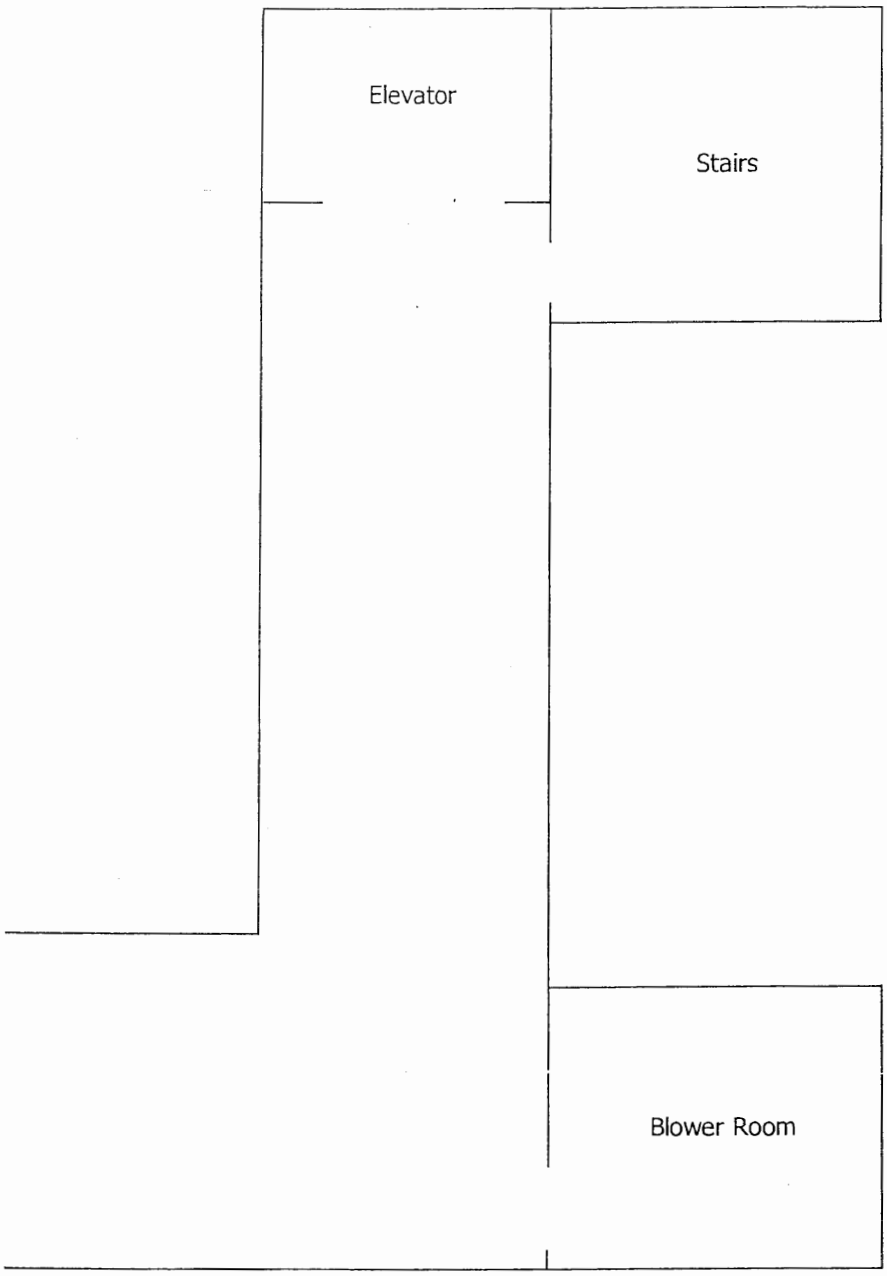
Note: Indentified Material Contain Lead-Based Paint

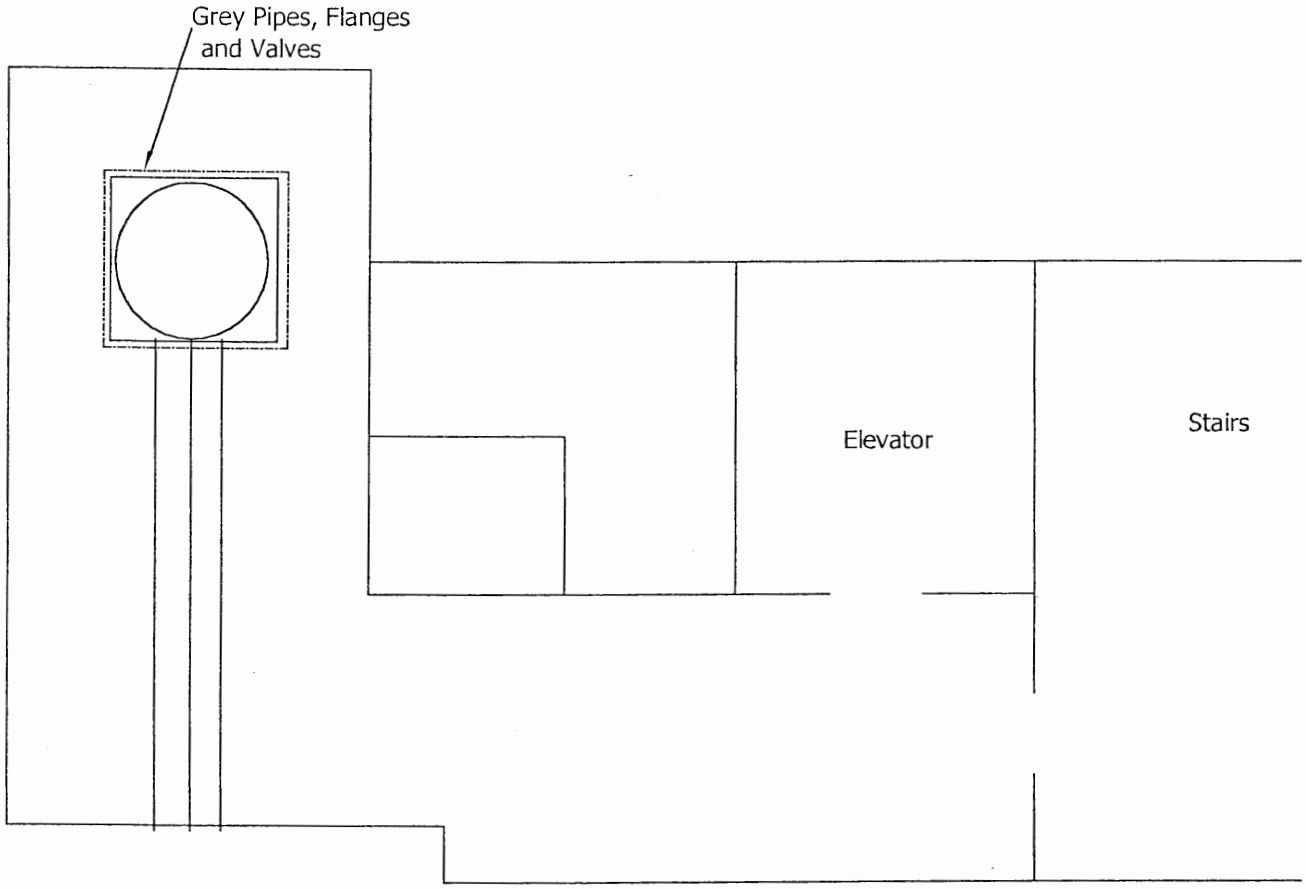
Note: Indentified Material Contain Lead-Based Paint
