AMISTAD DAM

ASBESTOS and LEAD-BASED PAINT SURVEY

United States Section, International Boundary and Water Commission
Amistad Dam Facility

Issue Date: December 17, 2004

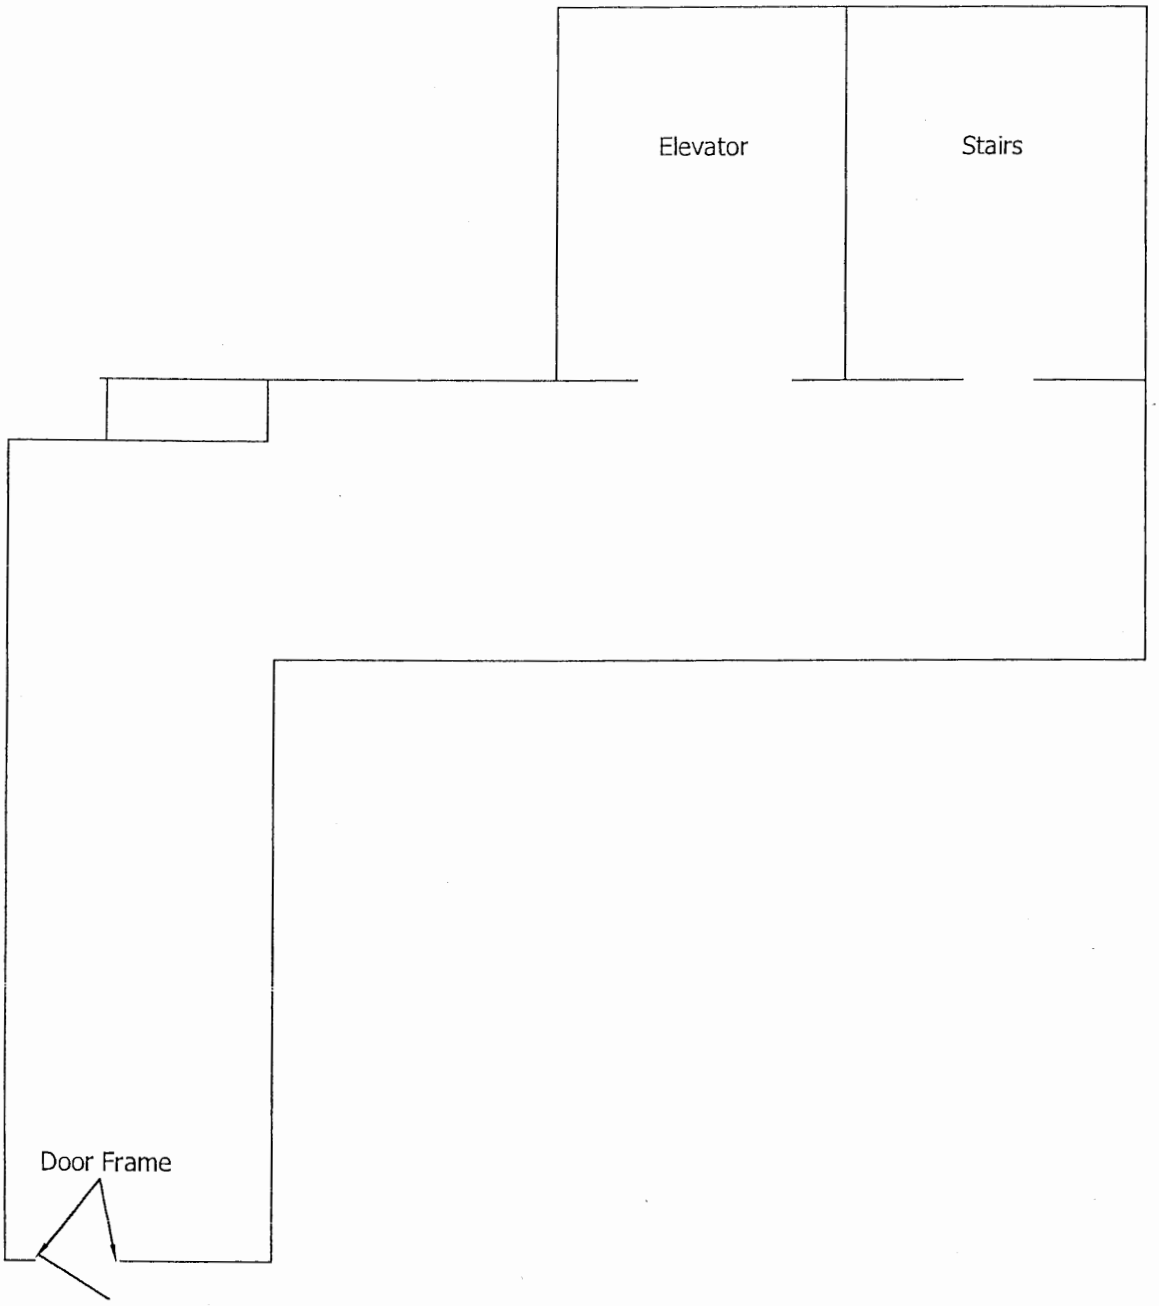
Note: Indentified Material Contain Lead-Based Paint

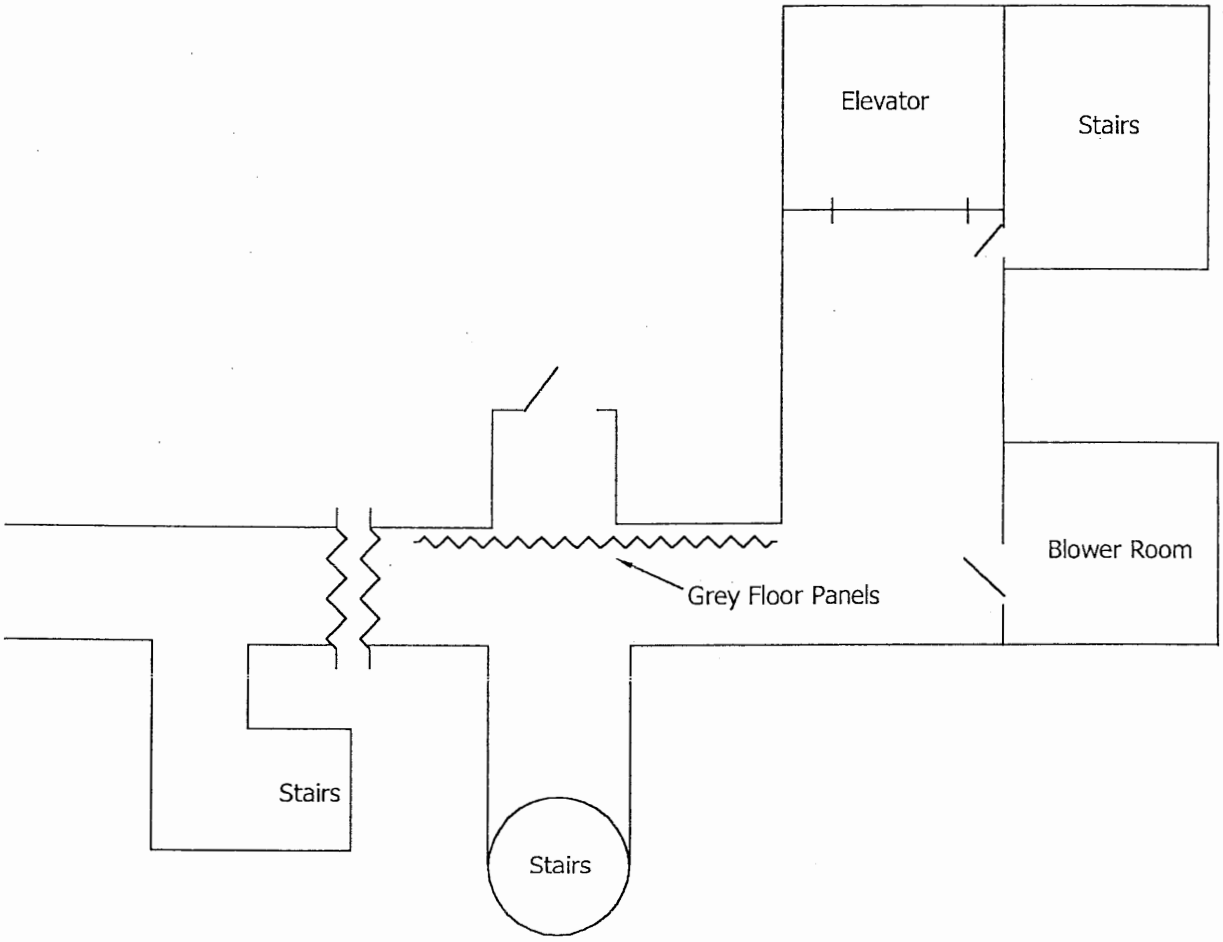
Note: Indentified Material Contain Lead-Based Paint

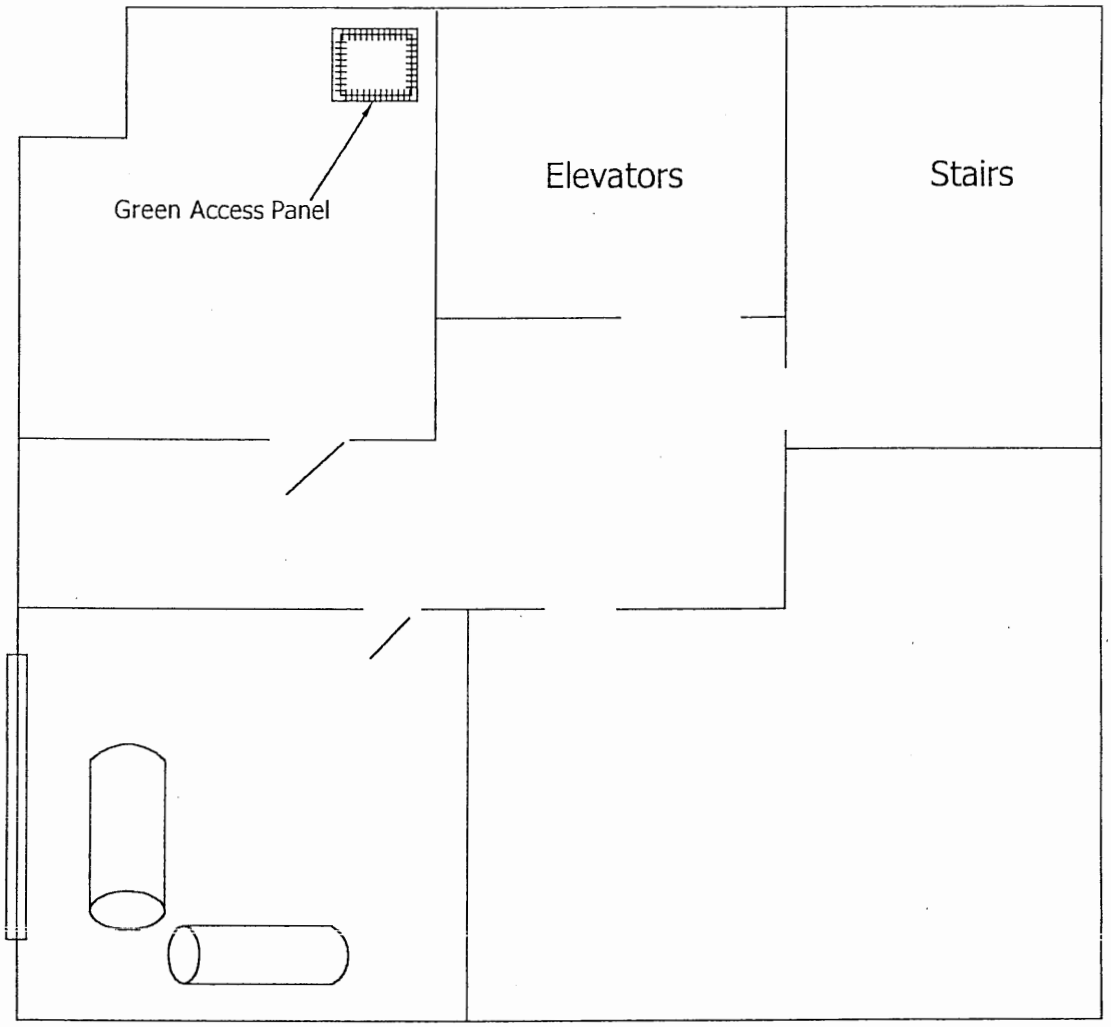
Note: Indentified Material Contain Lead-Based Paint

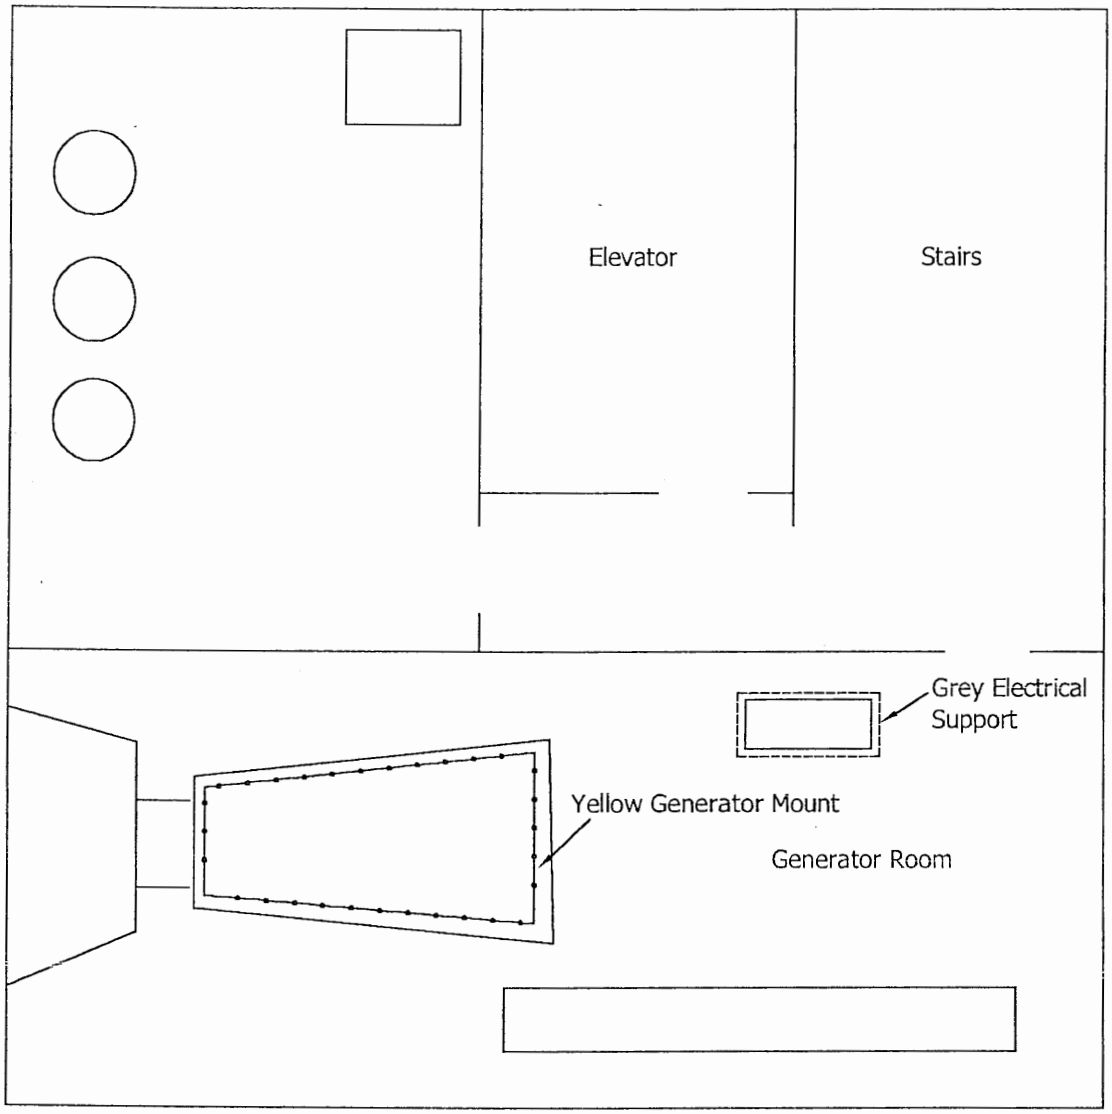
Note: Indentified Material Contain Lead-Based Paint

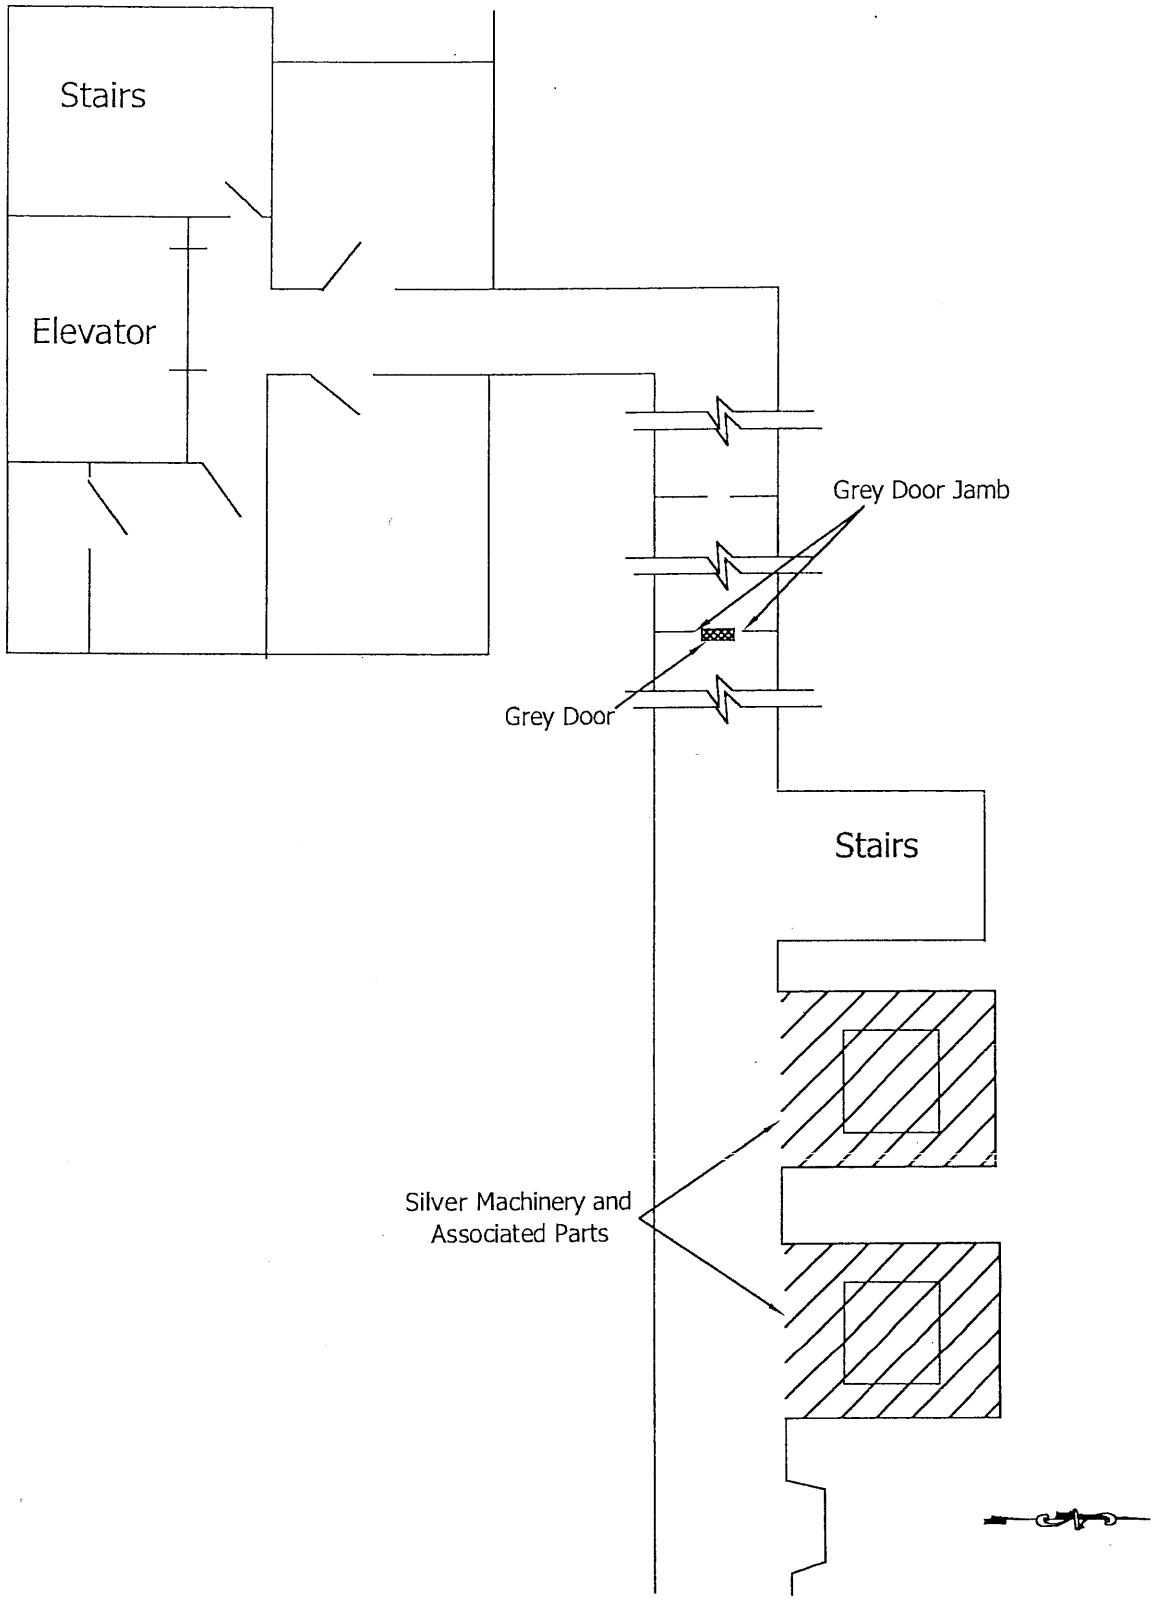
Note: Indentified Material Contain Lead-Based Paint

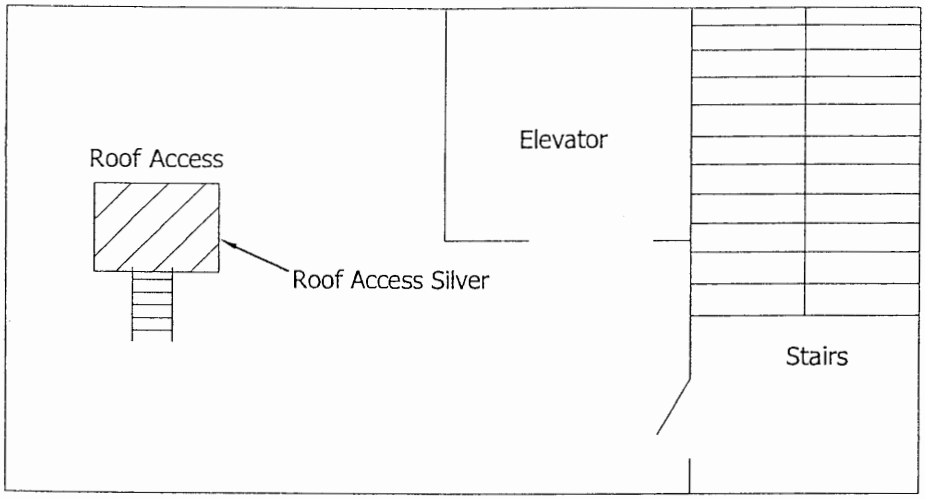
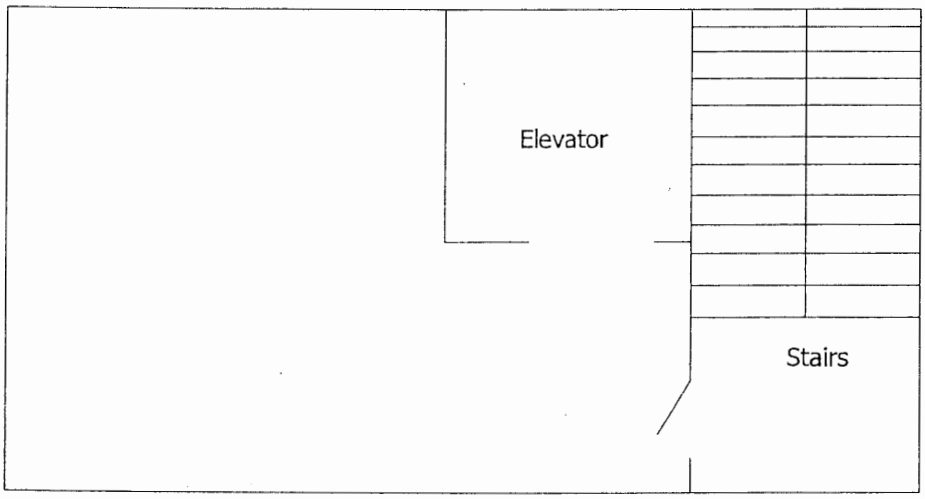
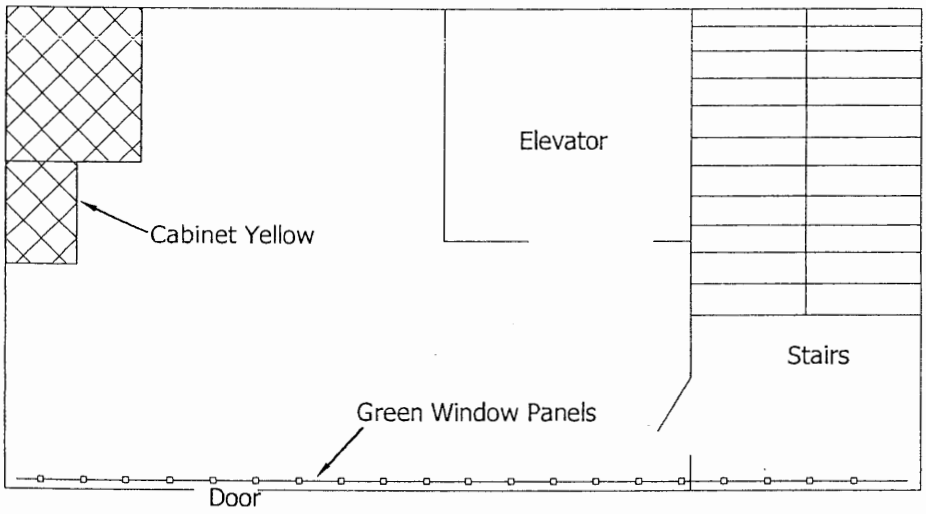
Note: Indentified Material Contain Lead-Based Paint
