ASBESTOS AND LEAD SURVEY

BEQ FC555

MARINE CORPS BASE (MCB) CAMP LEJEUNE
JACKSONVILLE, NORTH CAROLINA 28547

DECEMBER 17, 2025

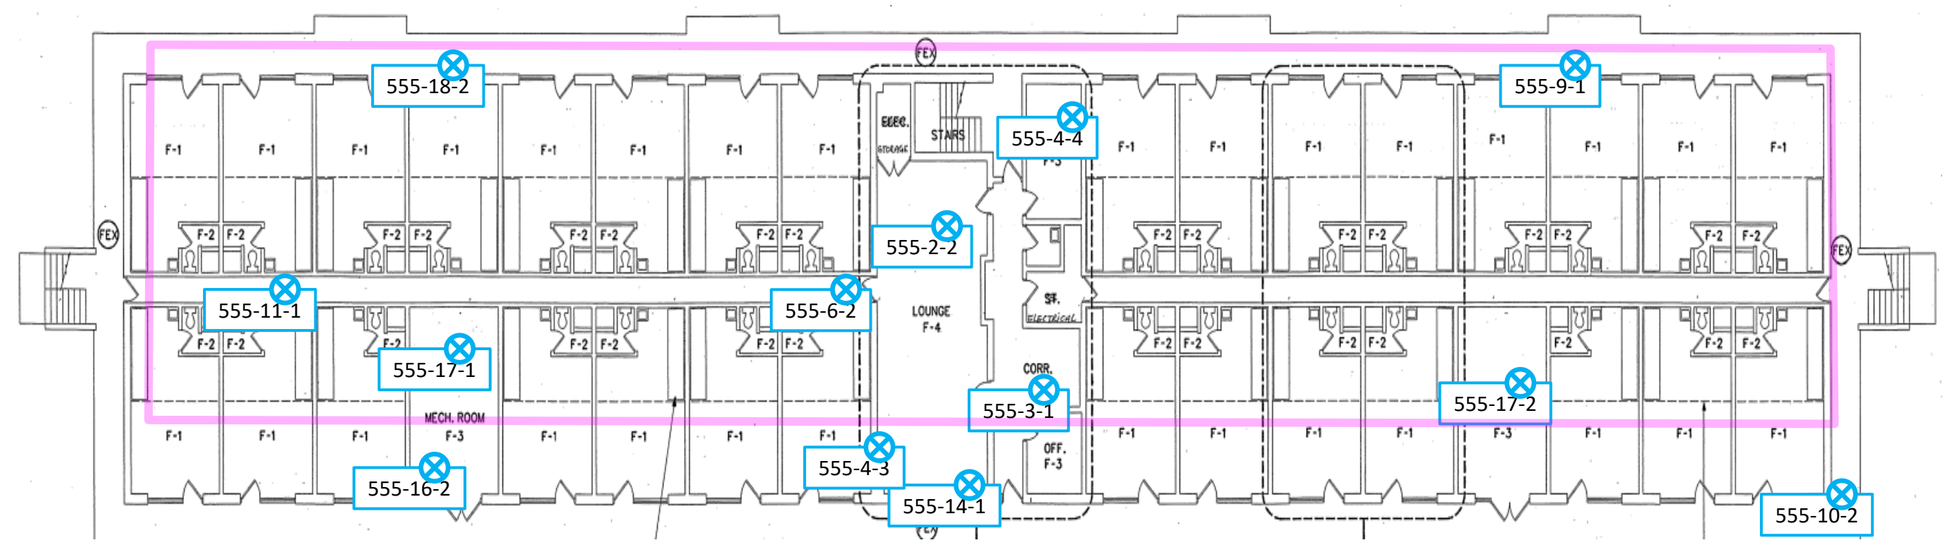
2nd Floor

ACM Damp Proofing

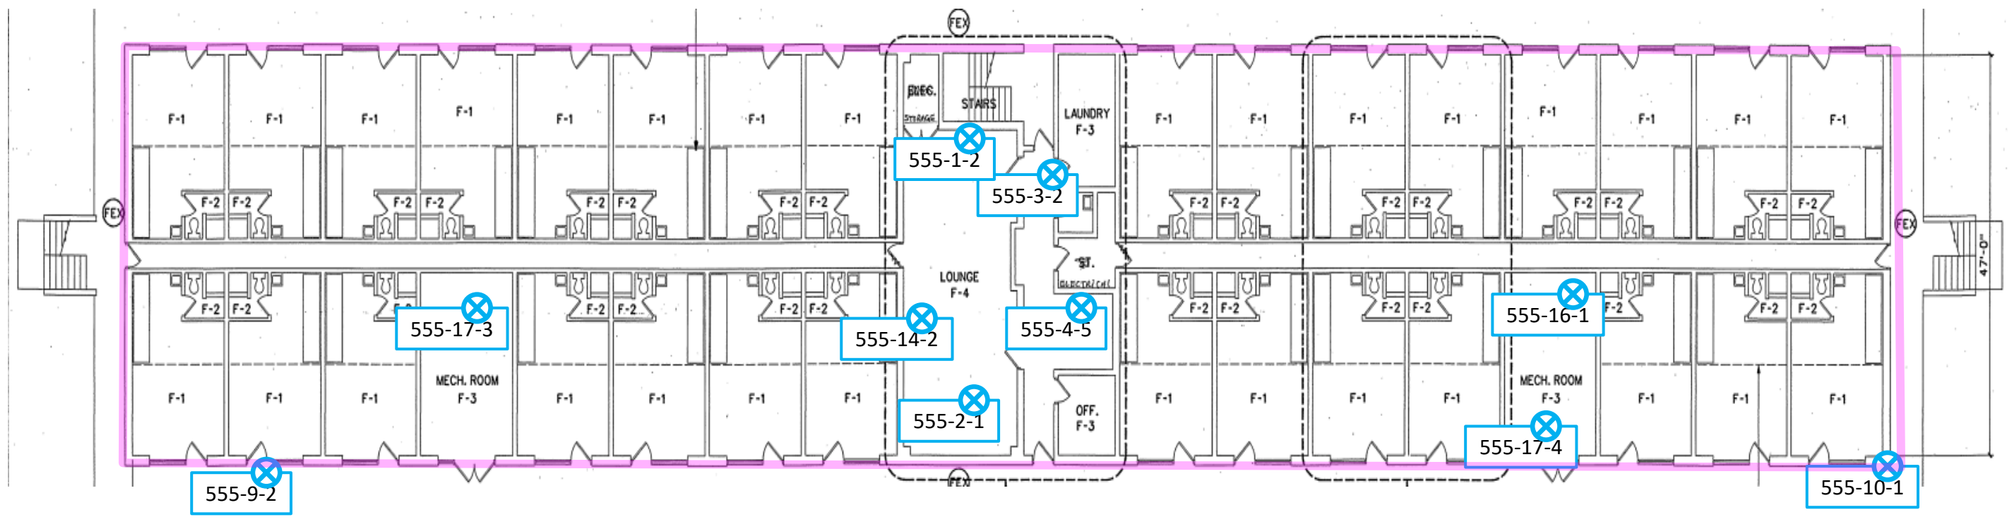
3rd Floor

ACM Damp Proofing

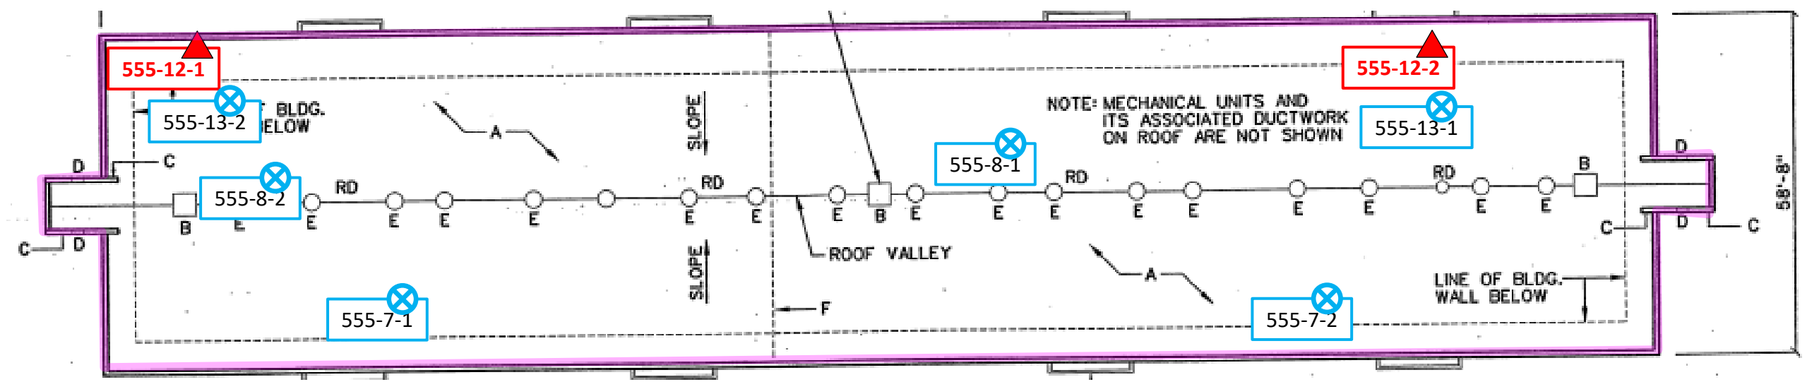
Roof/Attic

ACM Flashing

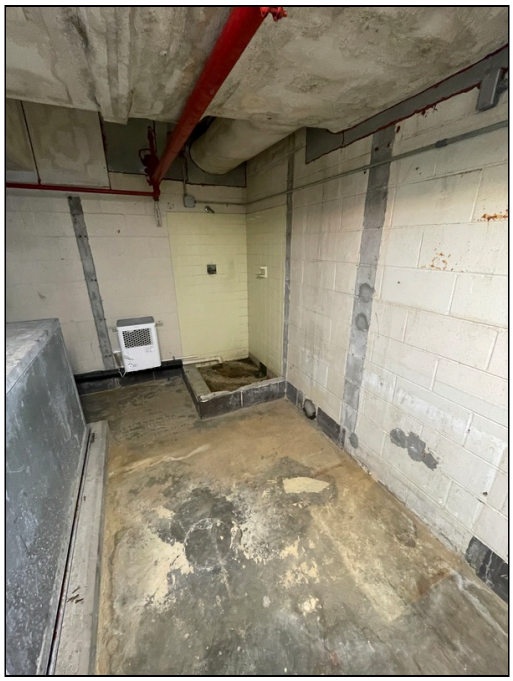
- Visible mold growth was observed on the mechanical building's fiberglass insulation, drywall ceiling, and piping.
- Occupants reported signs of visible mold growth in the bathrooms.

4 - View of Visible Mold
