PRE-DEMOLITION ASBESTOS AND LEAD-BASED PAINT SURVEY REPORT

Federal Aviation Administration – Houma, LA
10264 East Main Street
Houma, Louisiana 70363

Report Date
September 5, 2025

Partner Project No.
25-504452.1

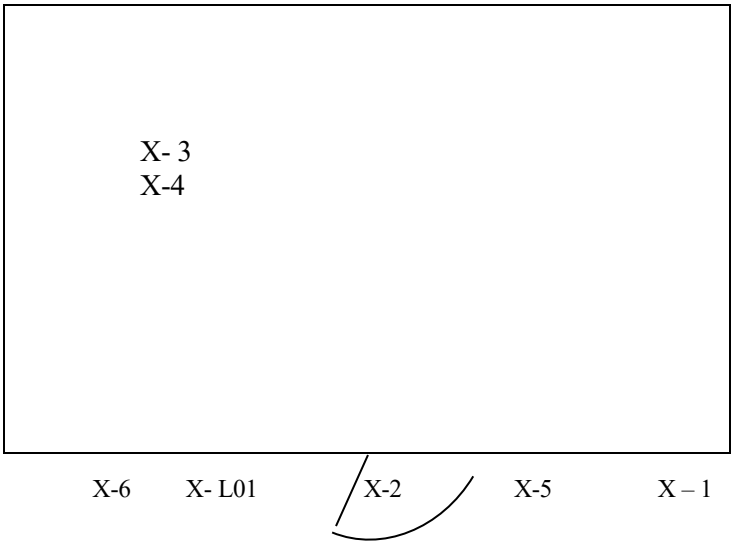
APPENDIX B: SAMPLE LOCATON DIAGRAM

*Sample numbers abbreviated from sample number 25-50445.1 – XX
