LEAD-BASED PAINT SAMPLING REPORT
GALLUP SERVICE UNIT – GALLUP INDIAN MEDICAL HOSPITAL CAMPUS
GALLUP, MCKINLEY COUNTY, NEW MEXICO

FEBRUARY 22, 2012

iiná bá, Inc. Project No. IHS0000-00019
IHS Contract No. HHSI161201100001C

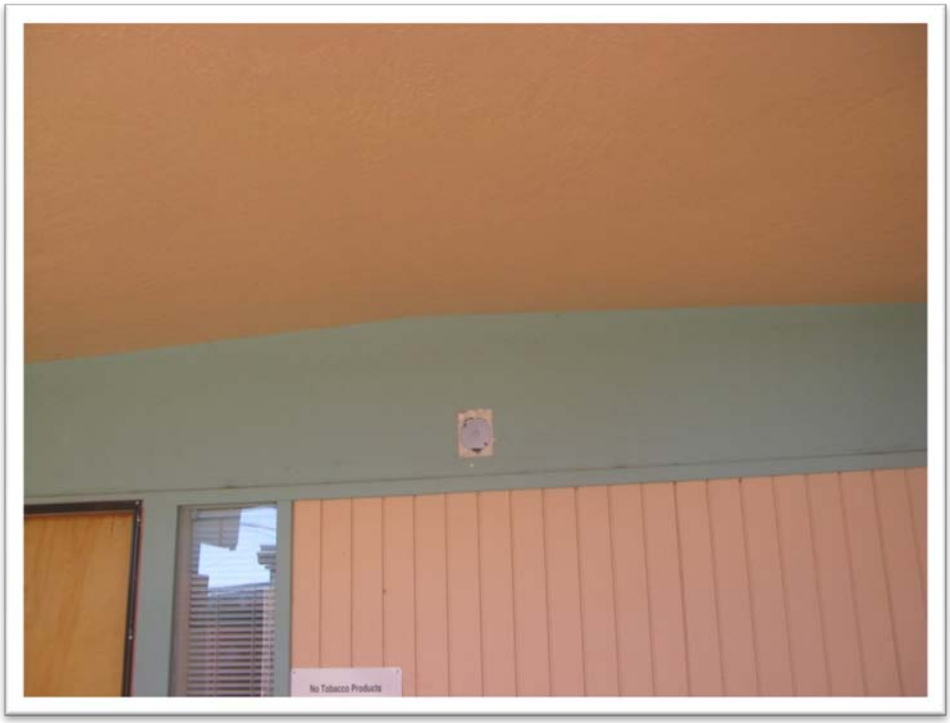
Photograph 16: View of Building 2009 LBP green window trim, wall trim and header.
