INSIGHT
Environmental Inc.

October 14, 2022

Re: Limited Assessment of Pipe Fitting Condition- Building 200, Sub-basement, Crawlspace
79 Middleville Road, Bldg 200, Northport, NY 11768

Project#22-0656

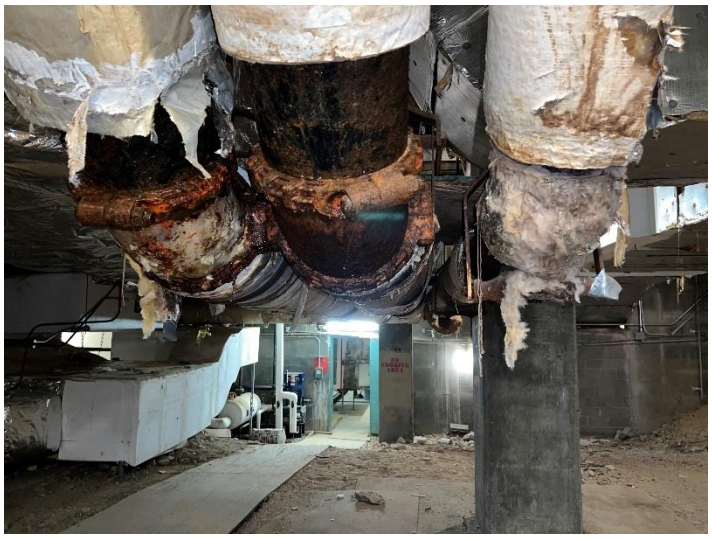
The majority of the pipe fittings throughout the crawlspace appear to be in intact condition. However, we did have occasion to observe damaged, or significantly damaged fittings, which must be abated as early as practical. These fitting pipe diameters and locations are as follows:

Column Markers/Location	Pipe Size	Notes
R8-R9	3 fittings 10"-12"	Sig. Damage, Water Damage
12K-12J	1 fitting 1"-2"	Sig Damage, Water Damage
Open-Air Exhaust Area	2 fittings 10"-12"	Sig. Damage, Debris at floor

Damaged Fittings at R8-R9

Disturbance of any quantity of asbestos is regulated in NYS under 12 NYCRR Part 56 “Asbestos”. Summarily this work requires a removal by licensed abatement firm and proper disposal and manifesting of waste, etc. Only NYS licensed personnel may enter, contain, remove and dispose of these materials. Dependent on the size of the asbestos abatement, air sampling may be required. You can contact our office for further clarification once the full scope of work is determined.

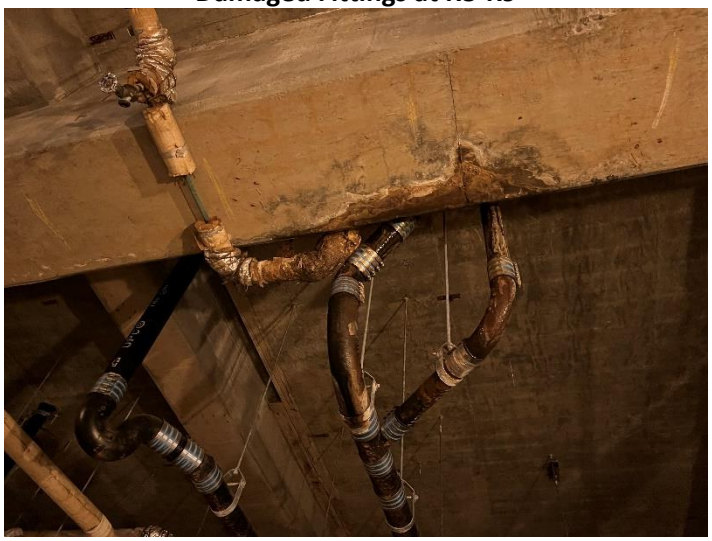
Damaged Fittings at 12K-12J
