ASBESTOS AND LEAD-PAINT SURVEY

REPAIR BEQ G703

CAMP GEIGER
MCB CAMP LEJEUNE, NORTH CAROLINA 28542
ECS PROJECT NO. 49:26342

JANUARY 9, 2026

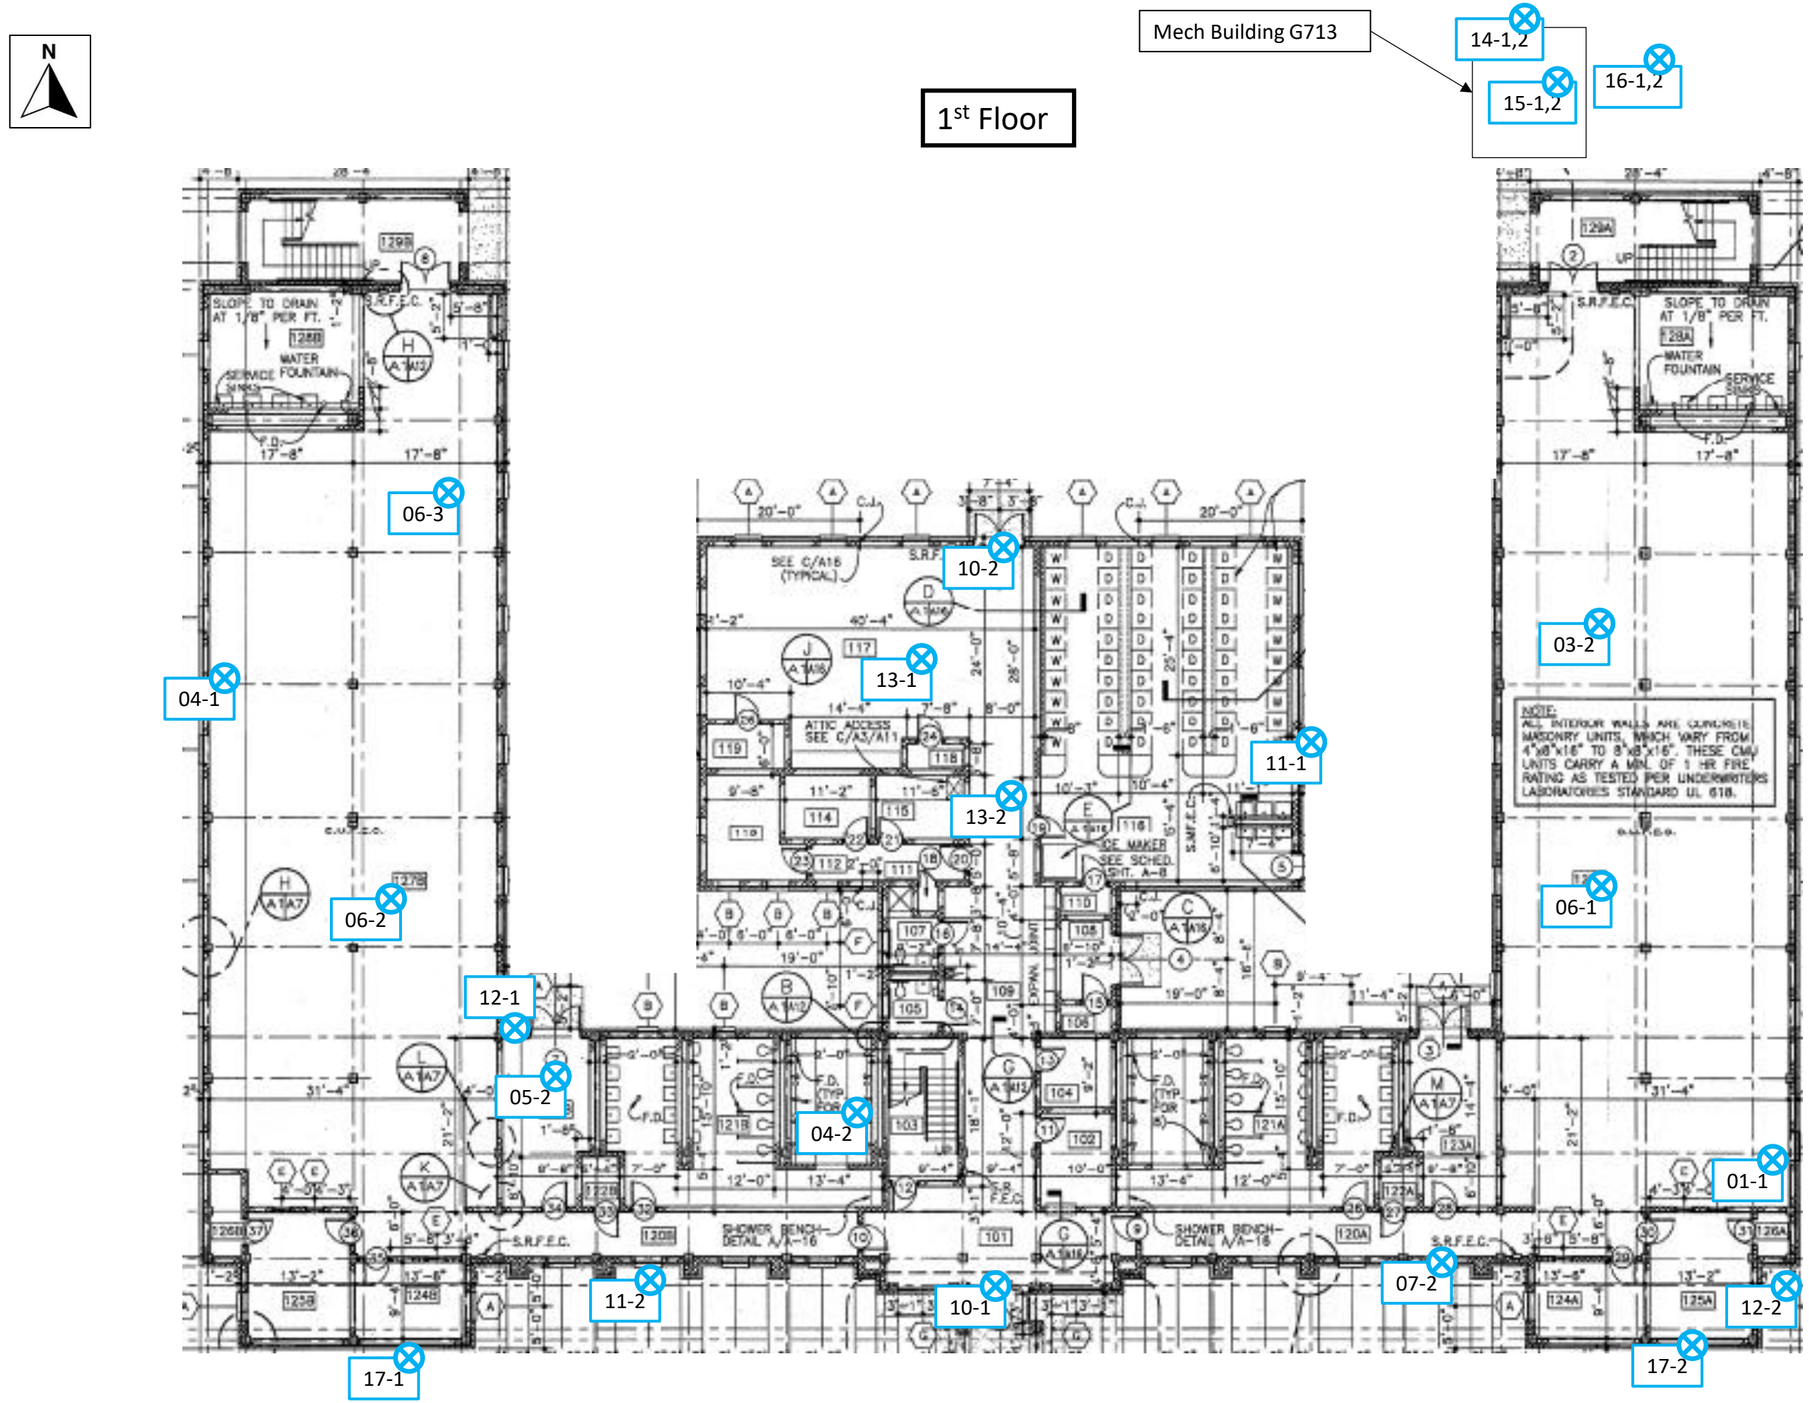
Figure 2

Asbestos Sample Locations

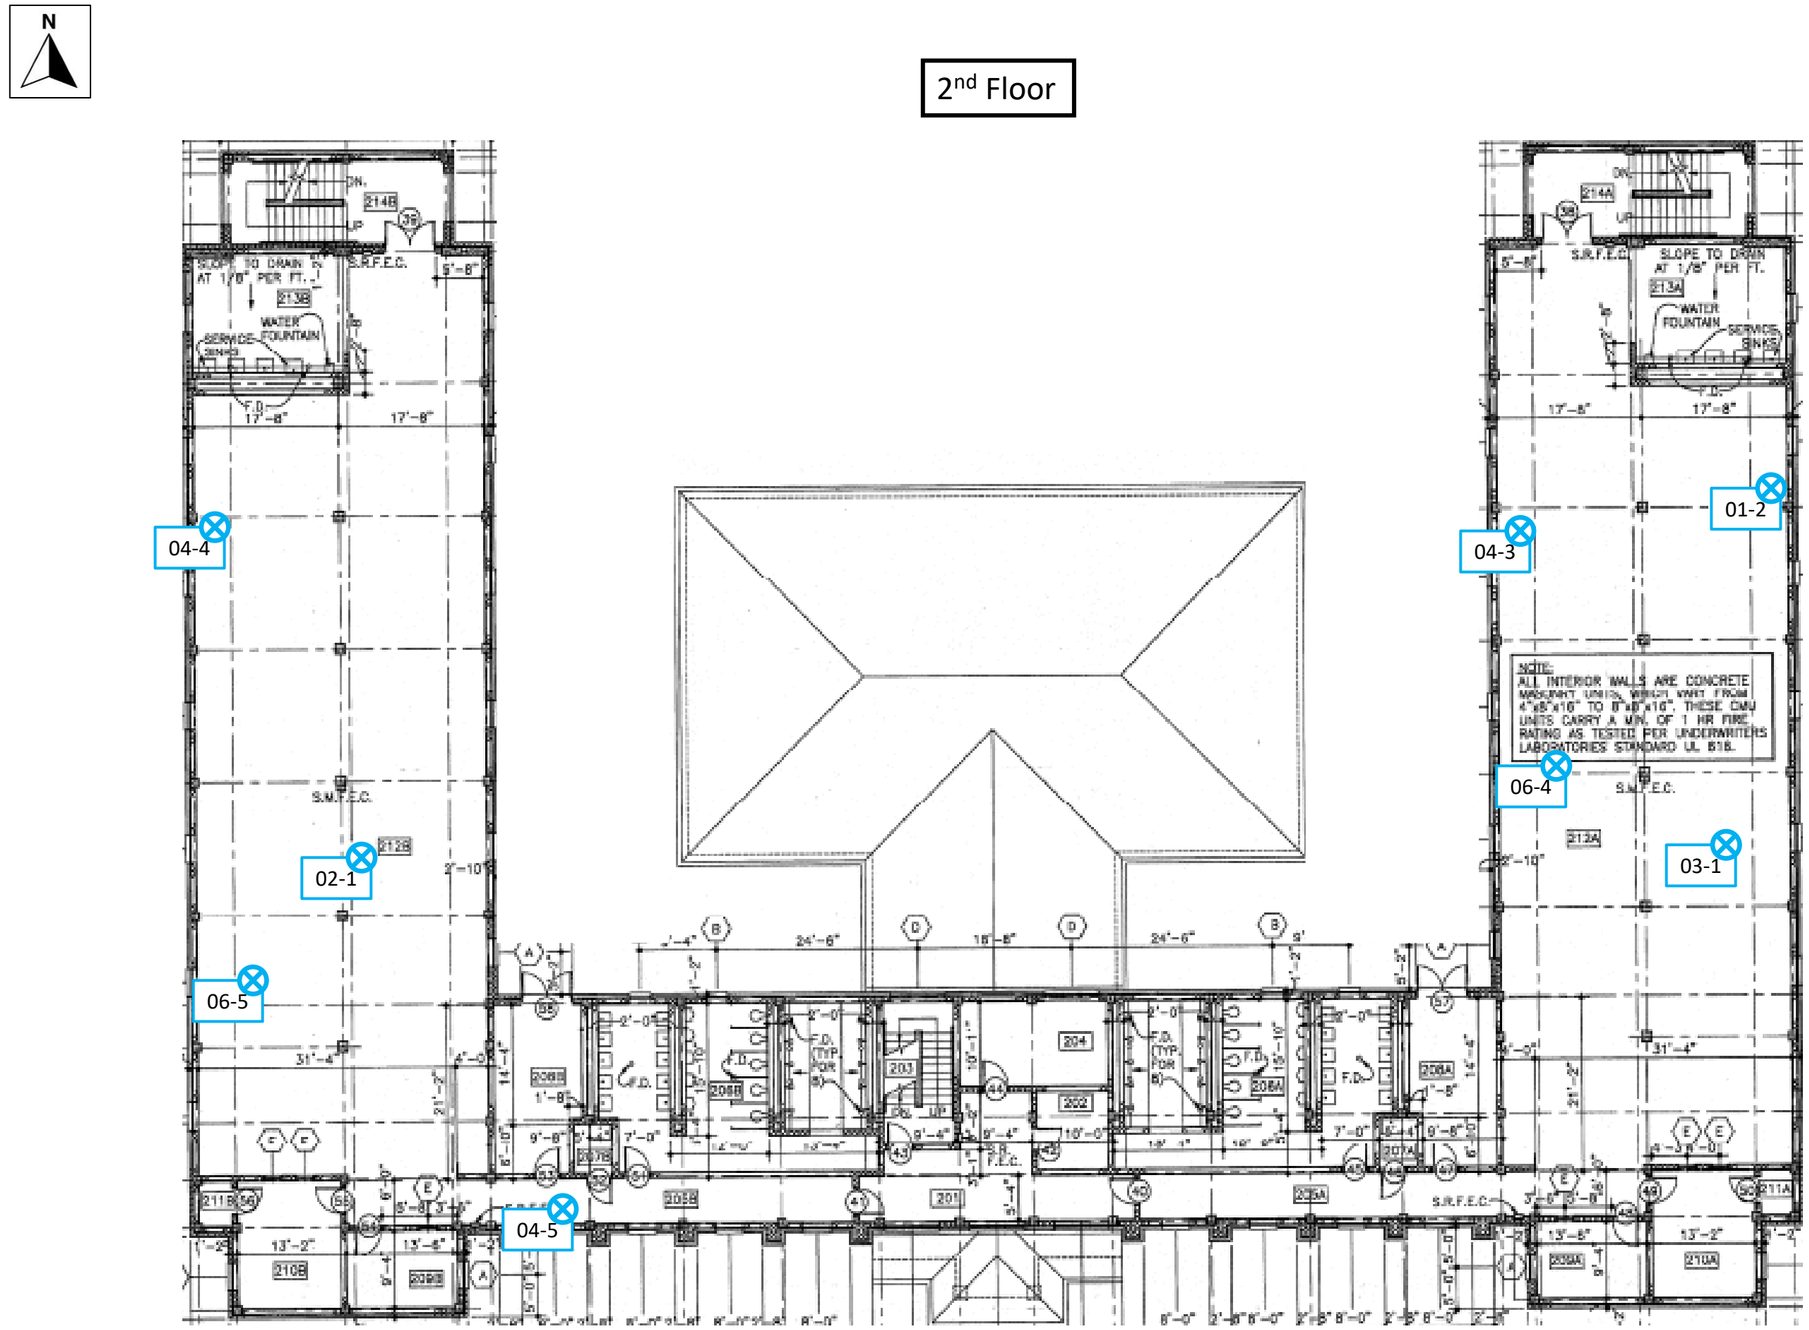
Figure 3

Asbestos Sample Locations

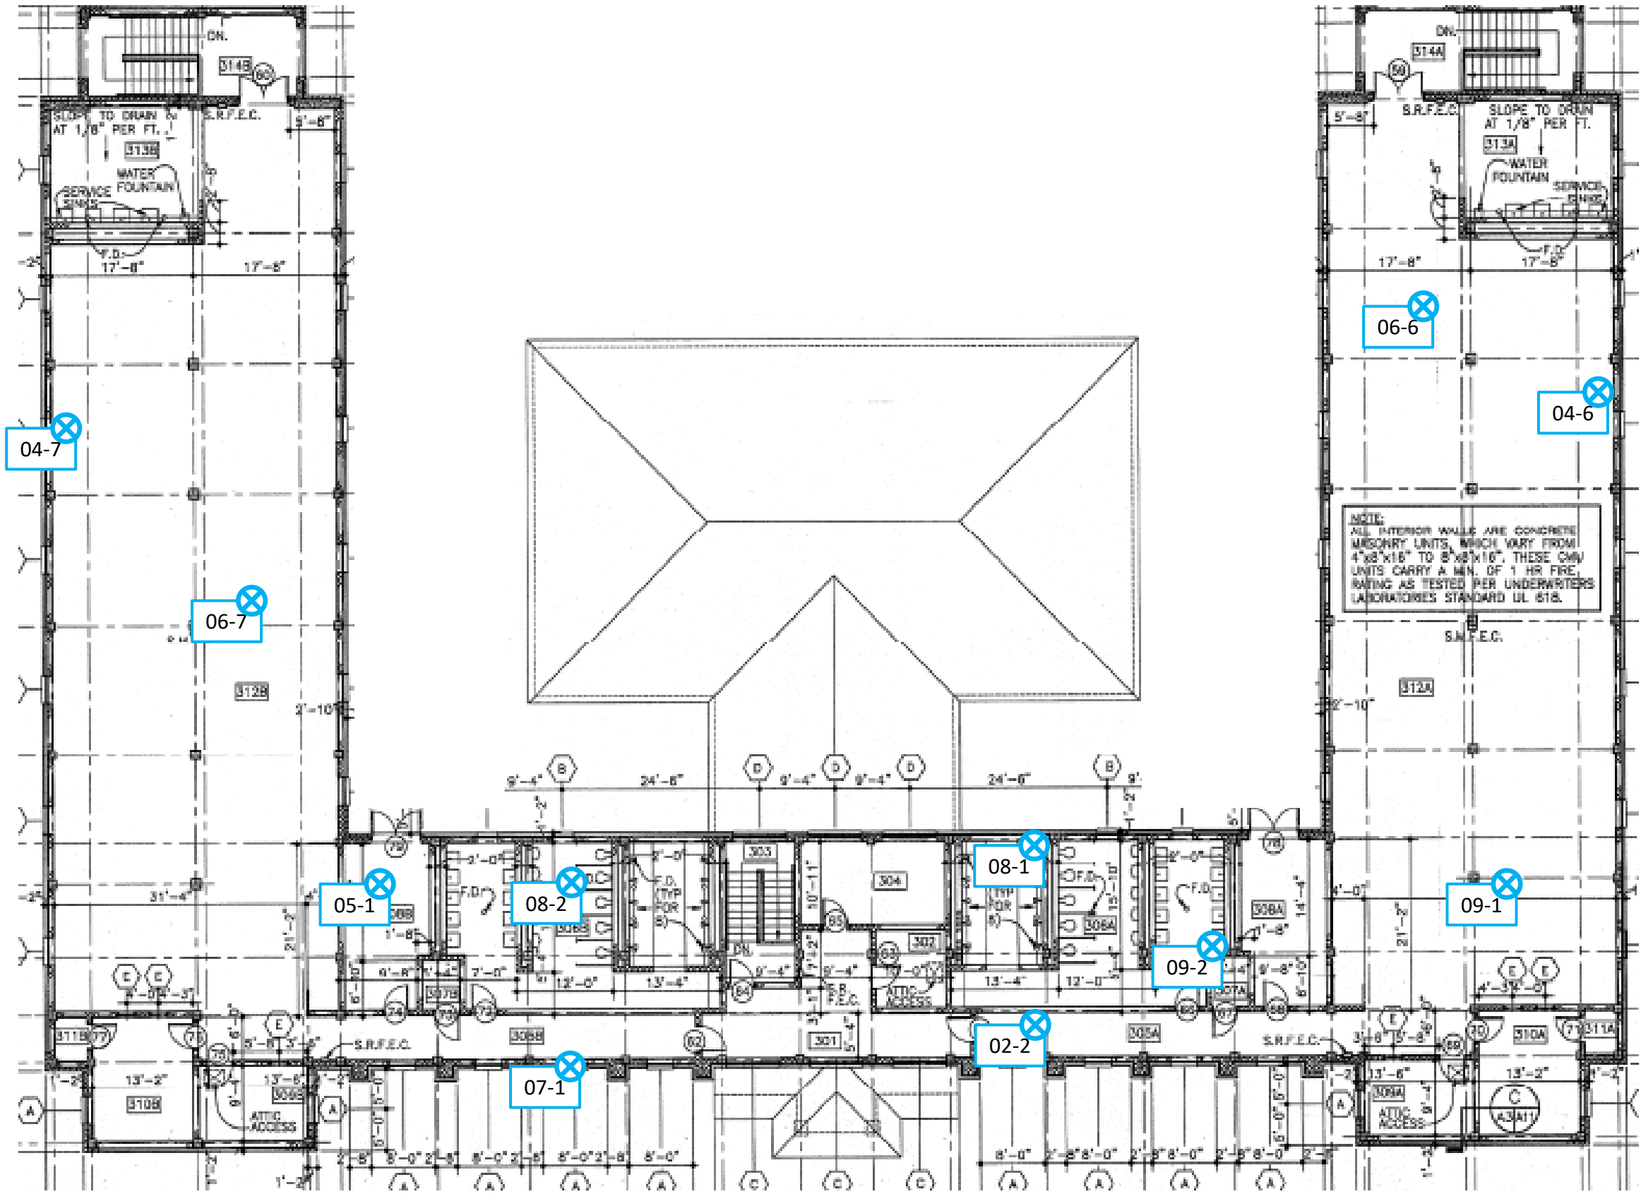
Figure 4

Asbestos Sample Locations

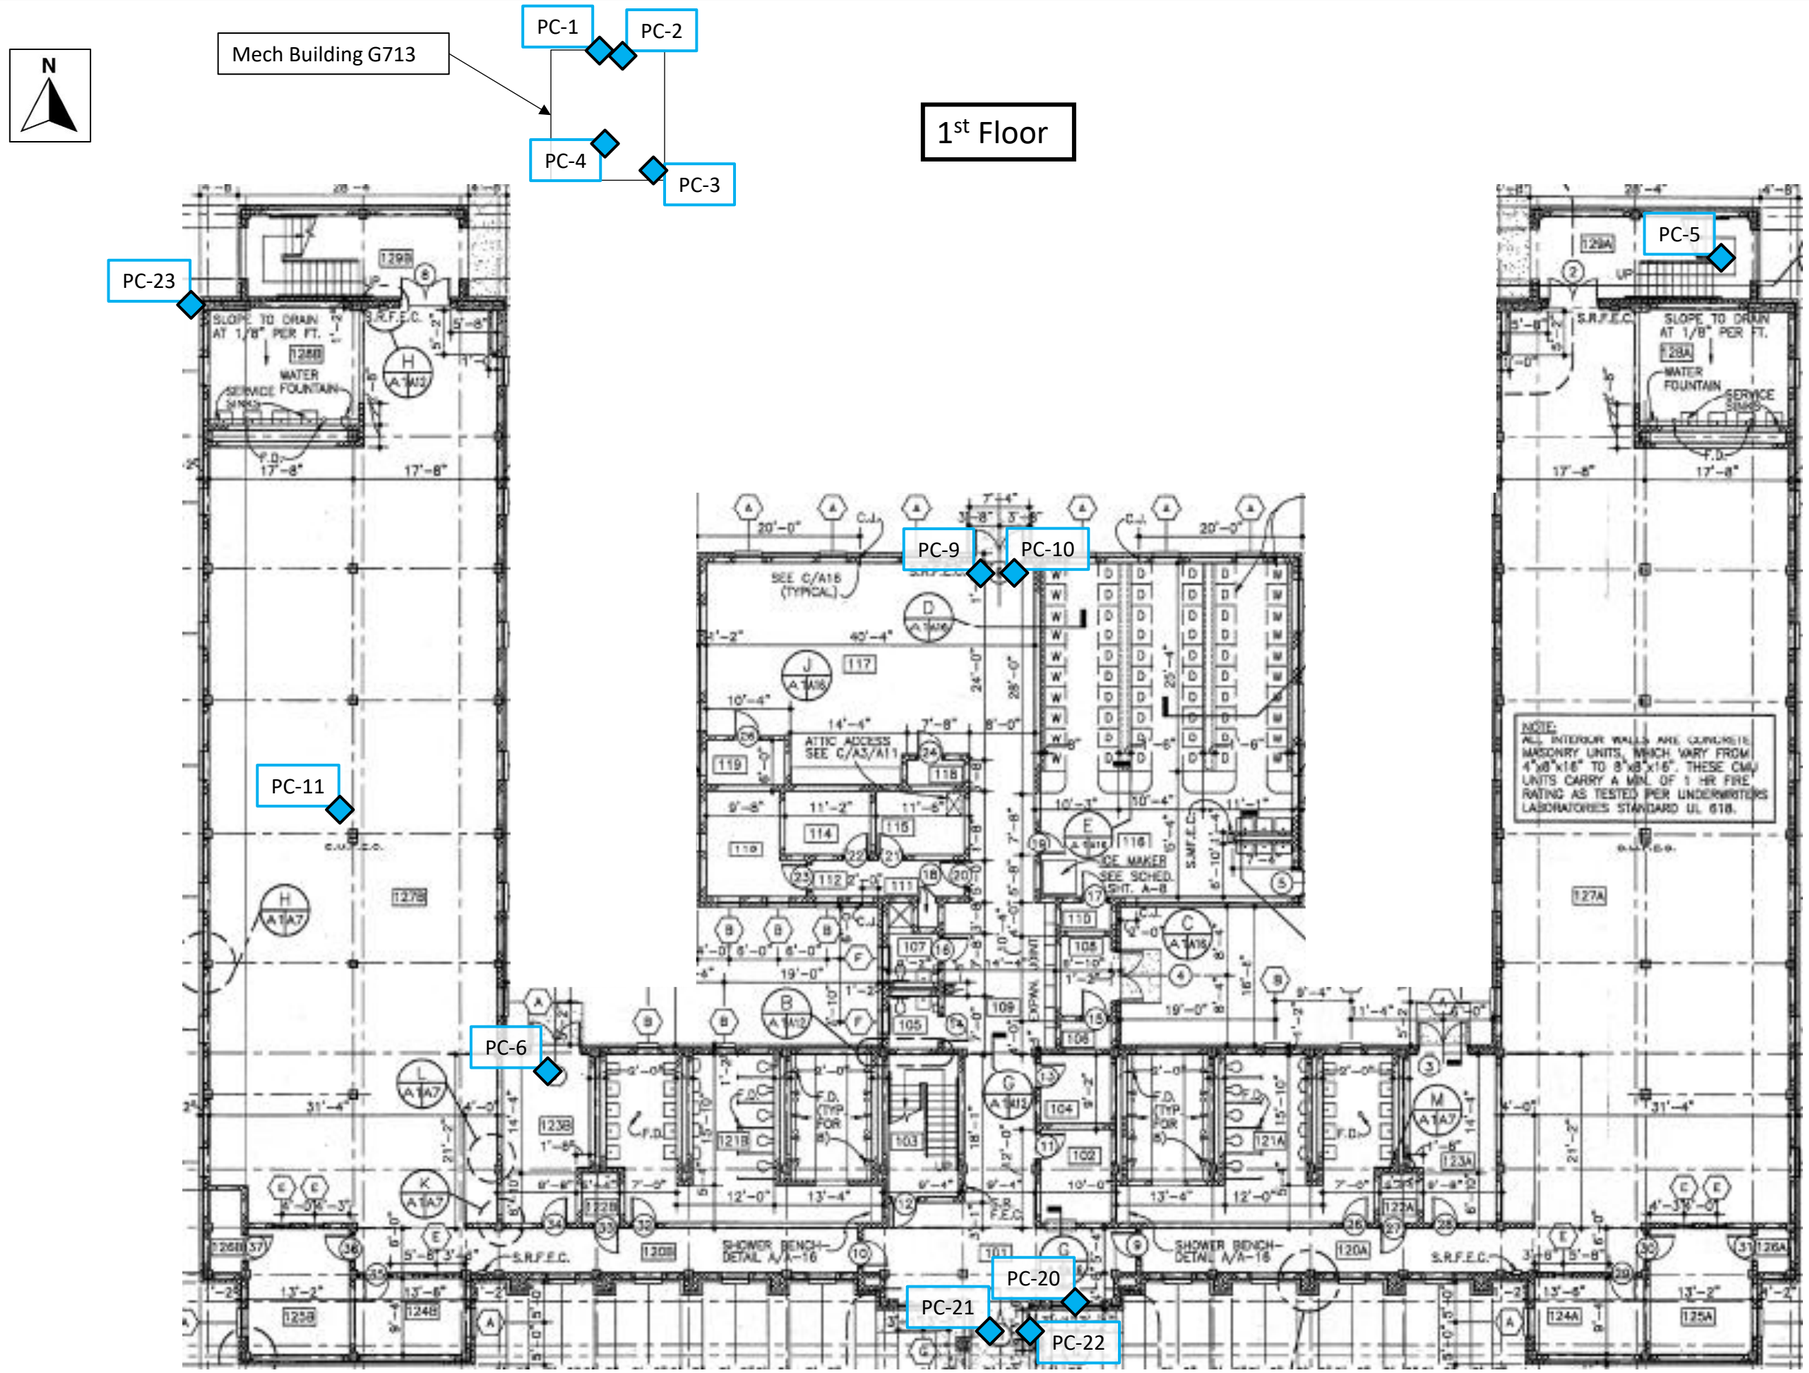
Figure 5

Lead Sample Locations

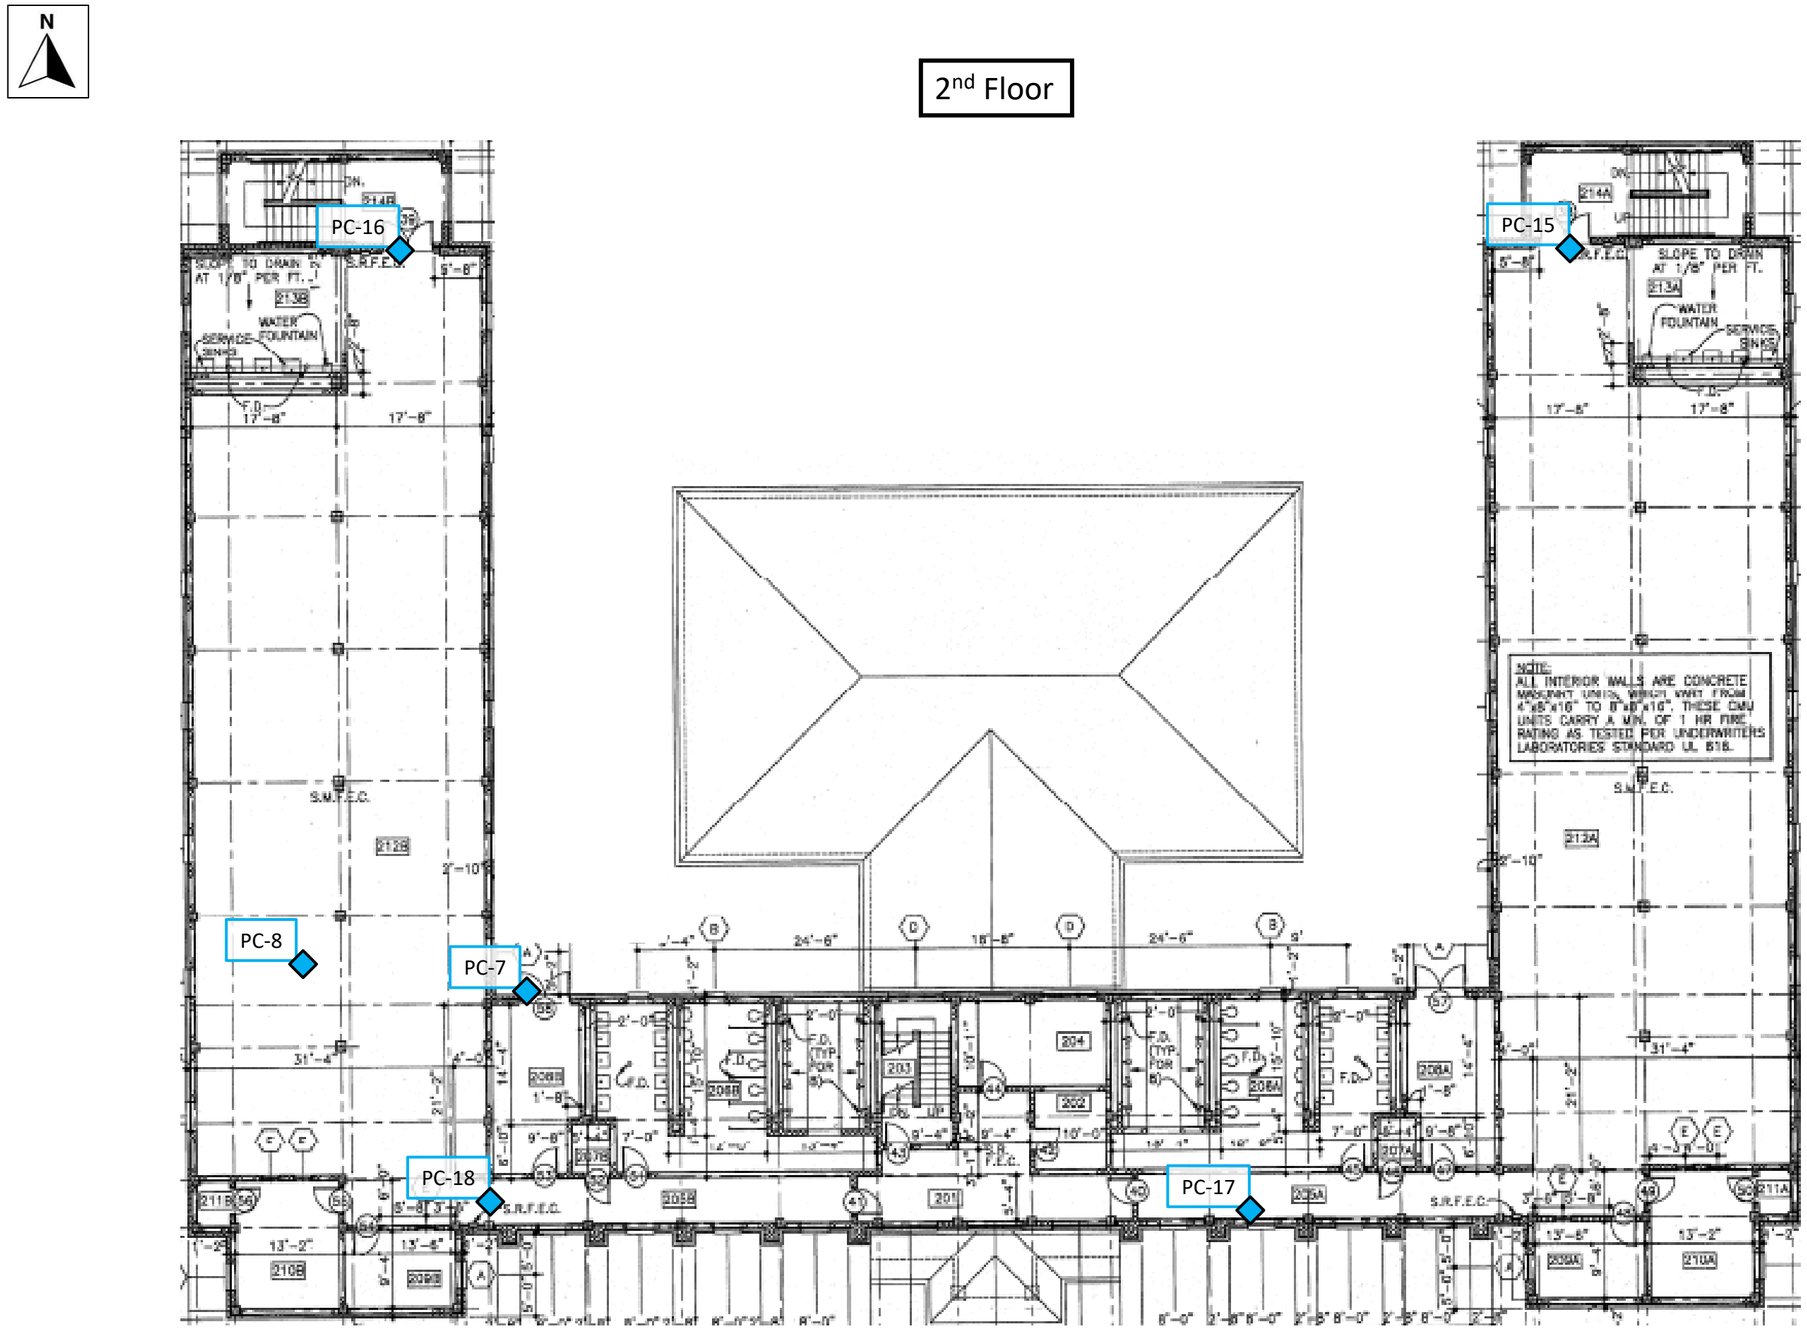
Figure 6

Lead Sample Locations

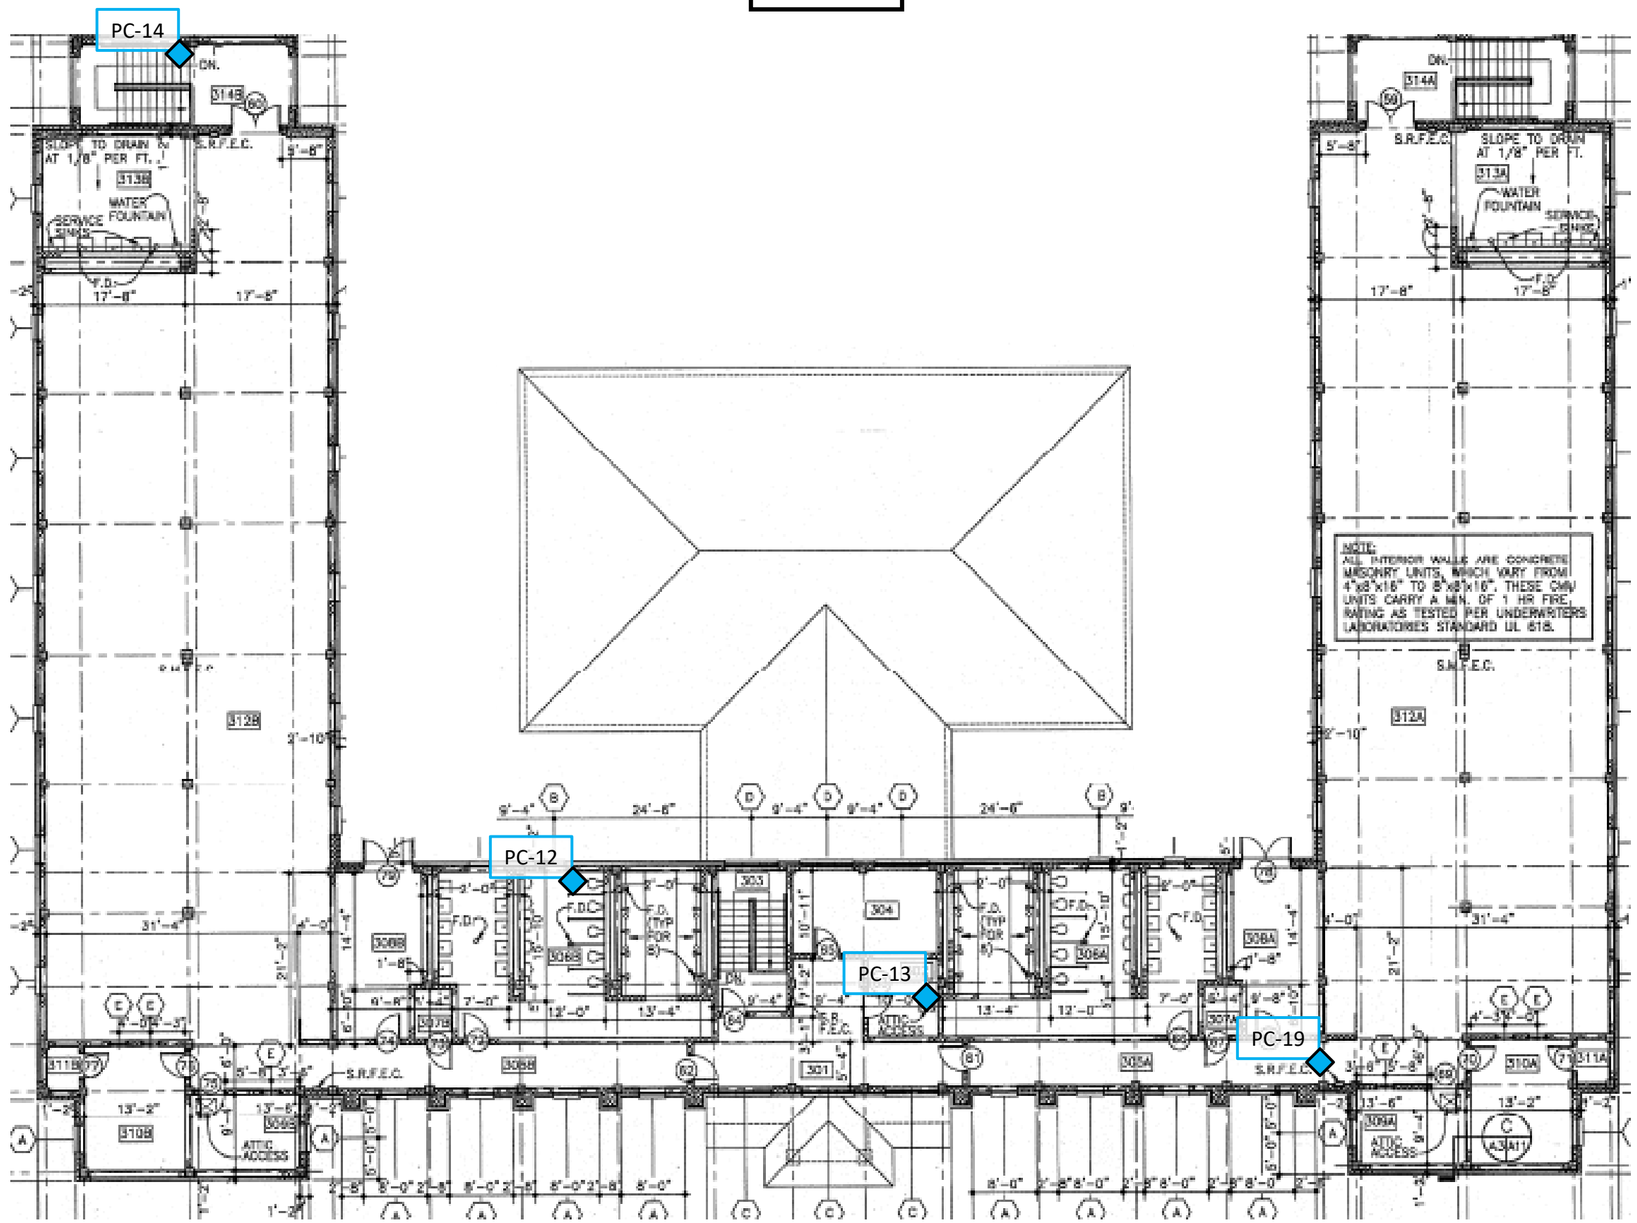
Figure 7

Lead Sample Locations

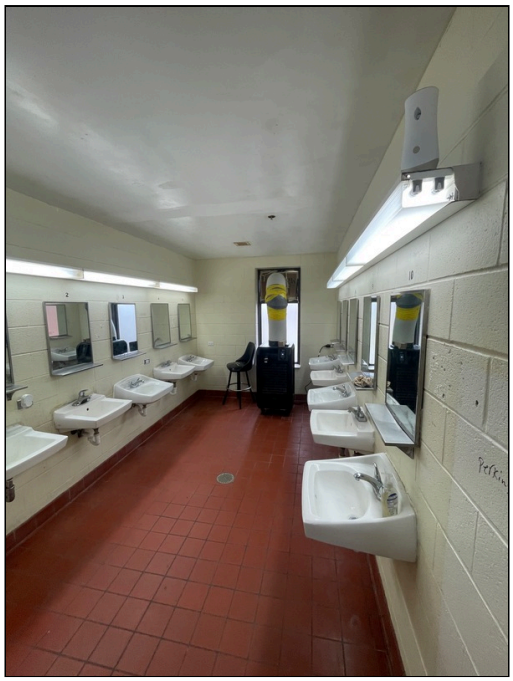
6 - View of the squadron bathrooms

7 - Additional view of bathrooms

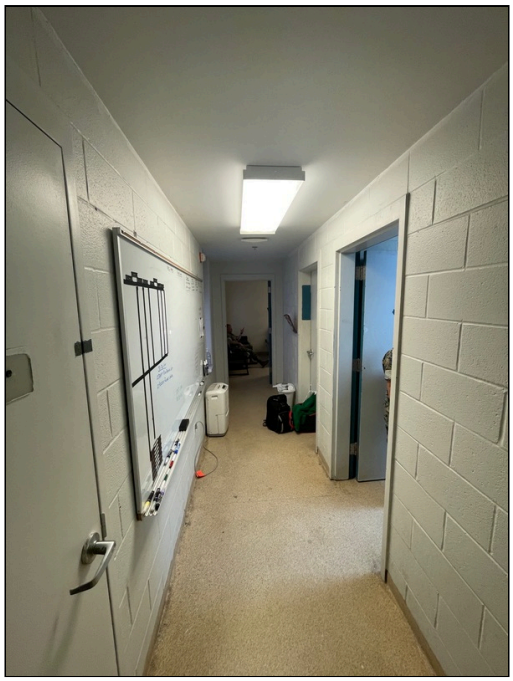
8 - View of the first floor offices

9 - View of the typical mechanical rooms

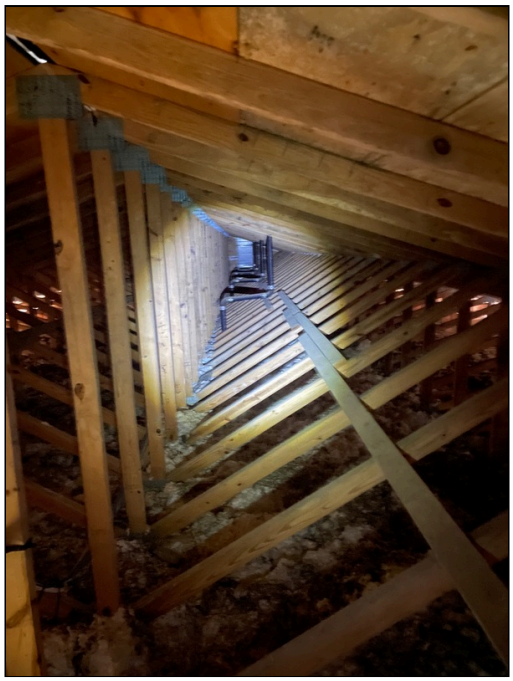
10 - View of the attic

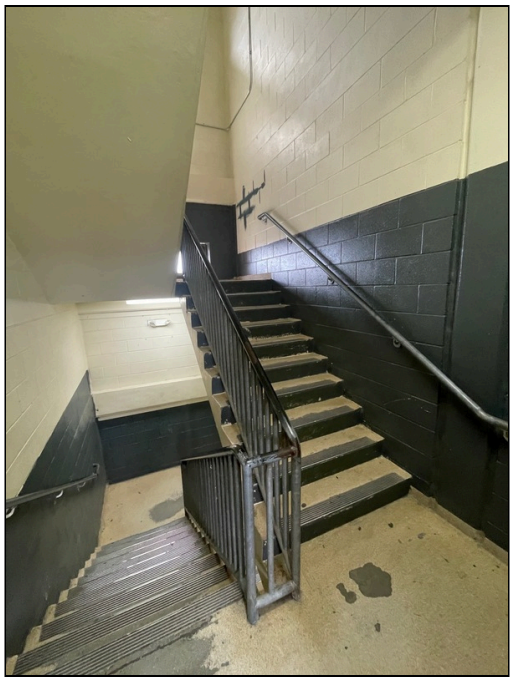
11 - View of stairwells

12 - View of exterior stairwells

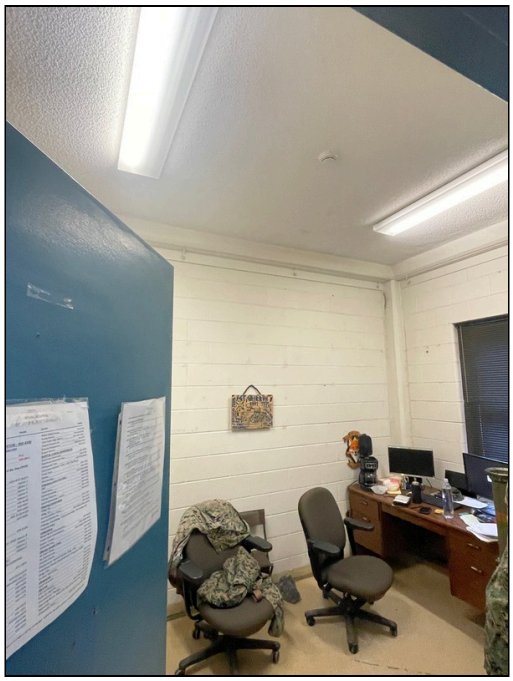
13 - View of the duty office

14 - View of typical vanity mirrors mechanically fastened
