U.S. Department of Veterans Affairs

ATTACHMENT C.
Campus Hydrants, PIVs and Hydrant Flow Testing

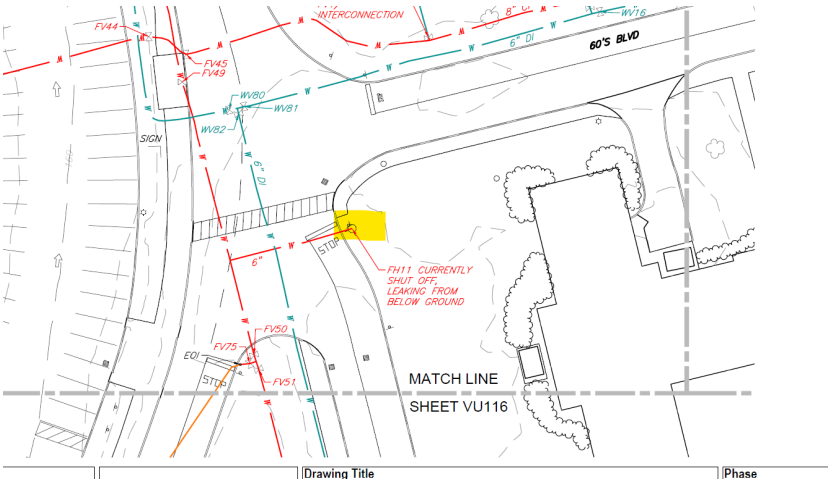
FH11 - Previously known as Hydrant # 10 (Corner of Bldg 61)

MAINTENANCE			DEFICIENCIES
		Debris removed from the hydrant	Hydrant OUT OF SERVICE Leaking from the base. Previous WO EW220414-005
		Full flow of hydrant until clear	
		Operation nut exercised full range	
		Number of turns to open:	
		All outlet threads lubricated	**WORK ORDER**
		Hydrant number present	Work Order submitted ✓
		Hydrant paint condition	Work Order Number: EW230413-016

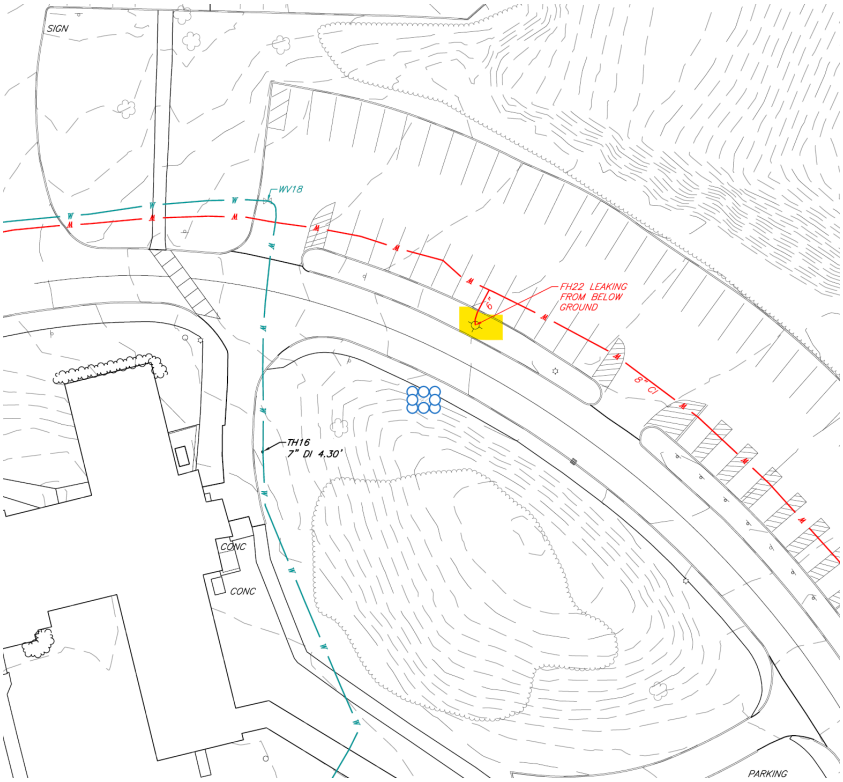
FH22 - Previously known as Hydrant # 11 (Between Bldg 62, 63)

MAINTENANCE			DEFICIENCIES
		Debris removed from the hydrant	Hydrant OUT OF SERVICE will not shut down. Previous WO EW220414-006
		Full flow of hydrant until clear	
		Operation nut exercised full range	
		Number of turns to open: _____	
		All outlet threads lubricated	**WORK ORDER**
		Hydrant number present	Work Order submitted ✓
		Hydrant paint condition	Work Order Number: EW230413-015 s

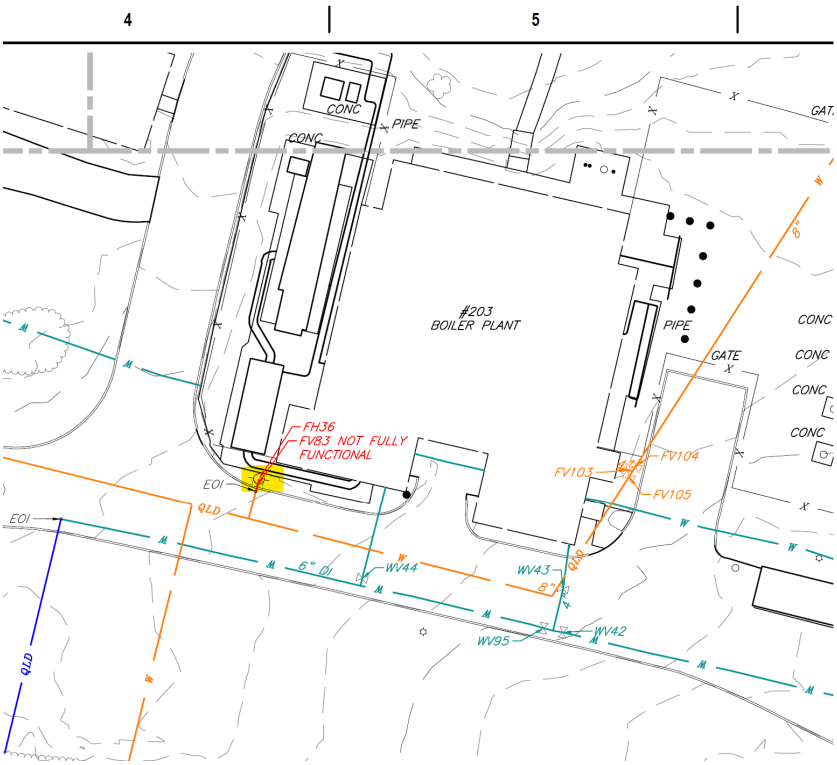
FH36 - Previously known as Hydrant # 35 (Rear corner of Bldg 203)

INSPECTION			LOCATION ON MAP
☐	☐	Visible and Accessible	
☐	☐	Barrel is free from water/ice/debris	
☐	☐	Free from leaks and cracks	
☐	☐	Outlet threads in good condition	
☐	☐	Outlet caps in place	
☐	☐	Outlet cap gaskets in good condition	
☐	✓	Operation nut in good condition	
☐	☐	Barrel drained after use

MAINTENANCE			DEFICIENCIES
☐	☐	Debris removed from the hydrant	Hydrant OOS will not shut down closed at street valve
☐	☐	Full flow of hydrant until clear	
☐	☐	Operation nut exercised full range	
		Number of turns to open:	
☐	☐	All outlet threads lubricated	**WORK ORDER**
☐	☐	Hydrant number present	Work Order submitted ✓
☐	☐	Hydrant paint condition	Work Order Number: EW230413-014

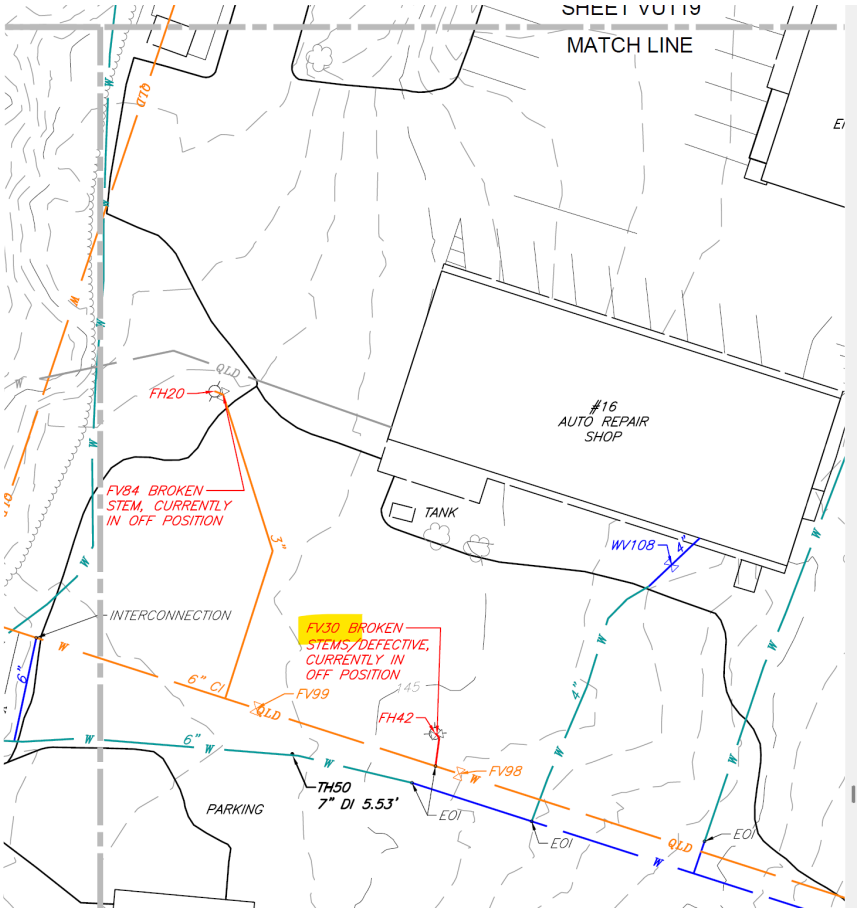
FV30 – Fire Valve serving Fire Hydrant 42 needs to be replaced. Adjacent to Bldg 16

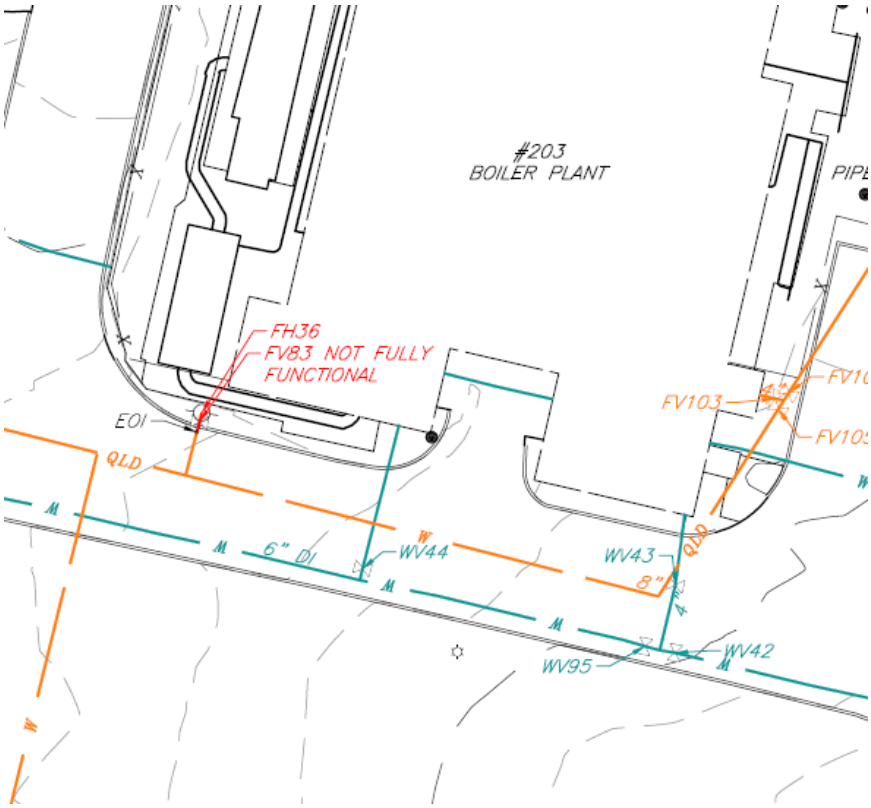
FV83 – Fire Valve serving Fire Hydrant 36 needs to be replaced. Adjacent to Bldg 203

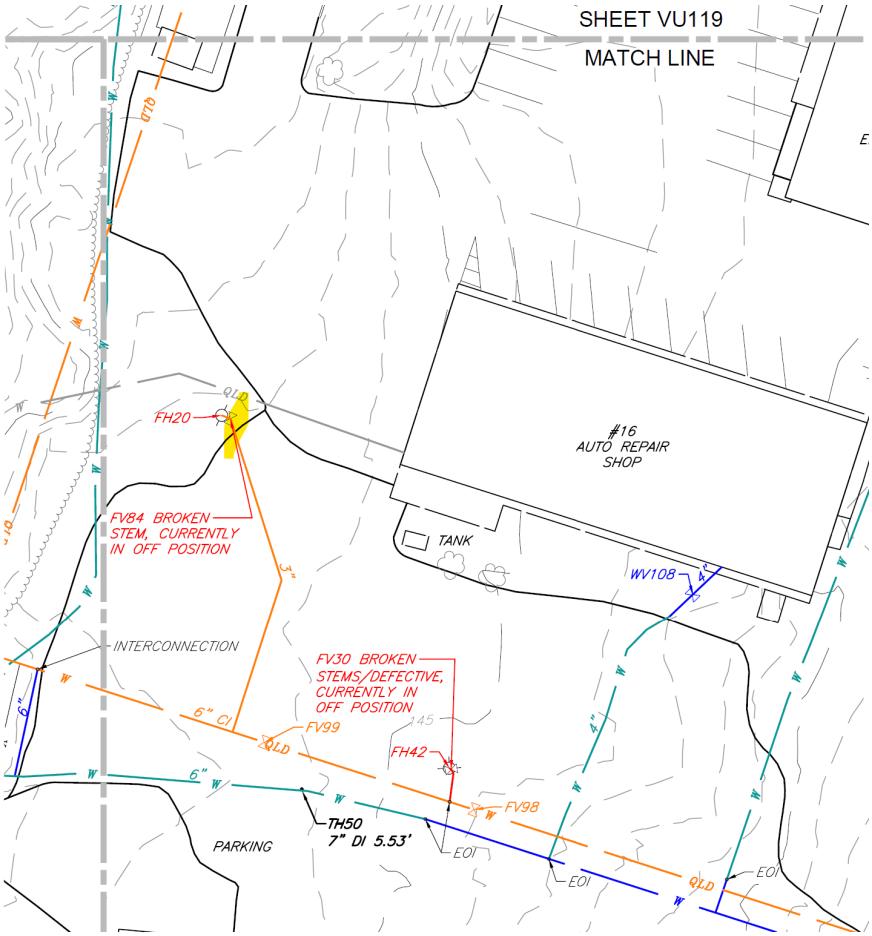
FV84 – Fire valve serving Fire Hydrant 20 needs to be replace. Adjacent to Bldg 16.
