ASBESTOS AIR MONITORING CLOSE-OUT REPORT
BUILDING 2474
FORT BLISS, TEXAS 79916

Date of Completion:
October 23, 2009

ENCON Project No. 117-09-029

RE: ASBESTOS AIR MONITORING CLEARANCE LETTER
Building 2474
Fort Bliss, TX 79916

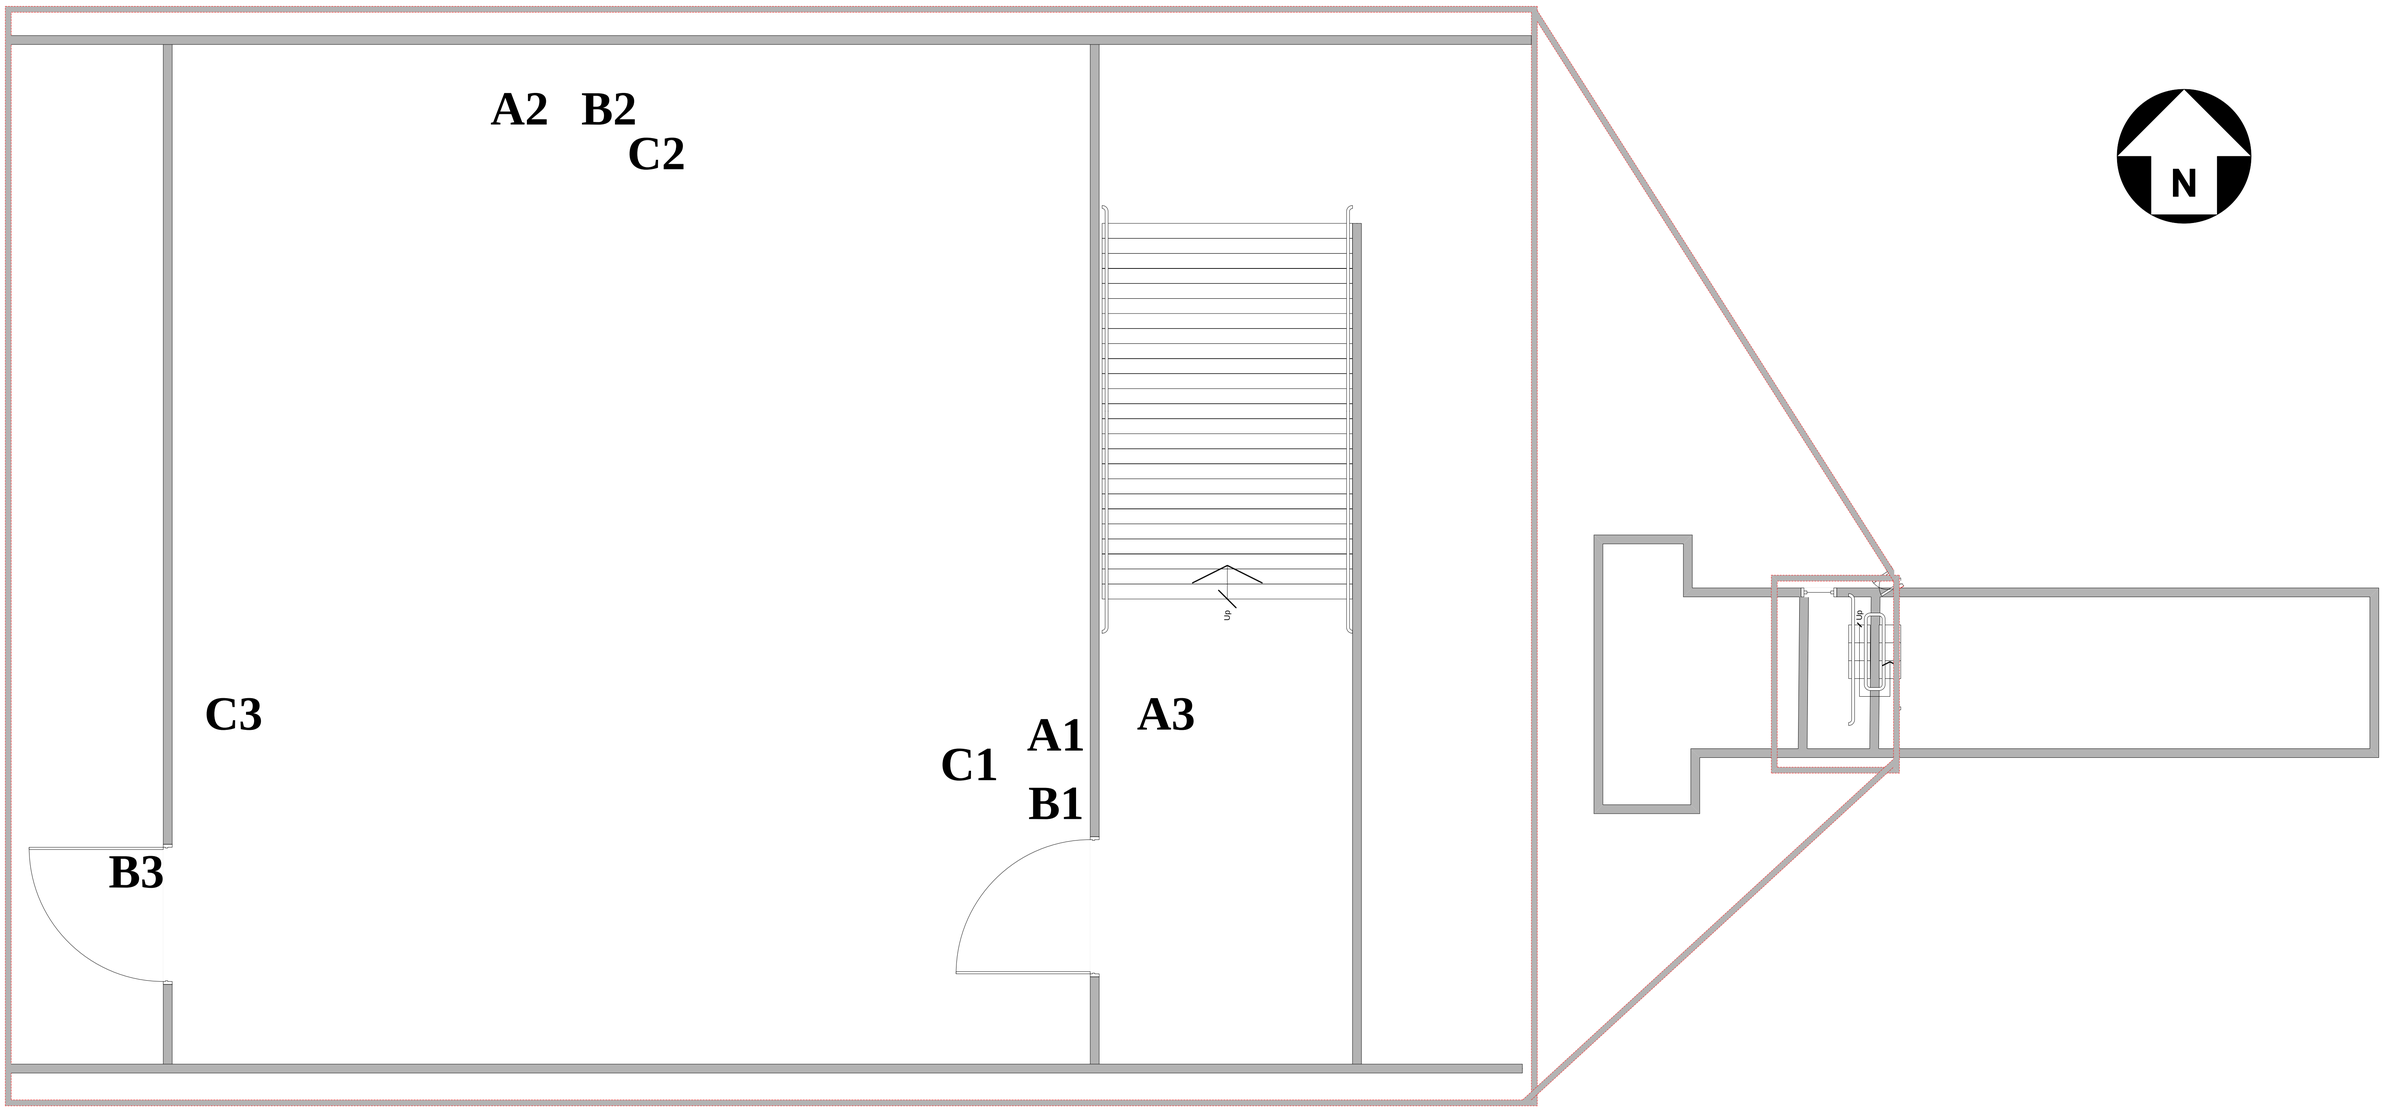
Air Sample Locations ENCON #: 117-09-029 Date: 10/27/09	A = Area Samples B = Baseline Samples C=Clearances Samples	Bldg. 2474 Basement Air Sample Location Drawing	N.T.S

***Please Note: A4 is at the 1st Floor Stairway Entrance**
