RE: SUBMITTAL OF ASBESTOS & LEAD SURVEY REPORTS
Ft. Bliss Bldg. # 2474
ENCON Project #103-08-094

ASBESTOS SURVEY REPORT
BUILDING 2474
FORT BLISS, TEXAS 79916

ENCON Project No. 103-08-094

ASBESTOS SURVEY REPORT
Ft. Bliss, Bldg. 2474

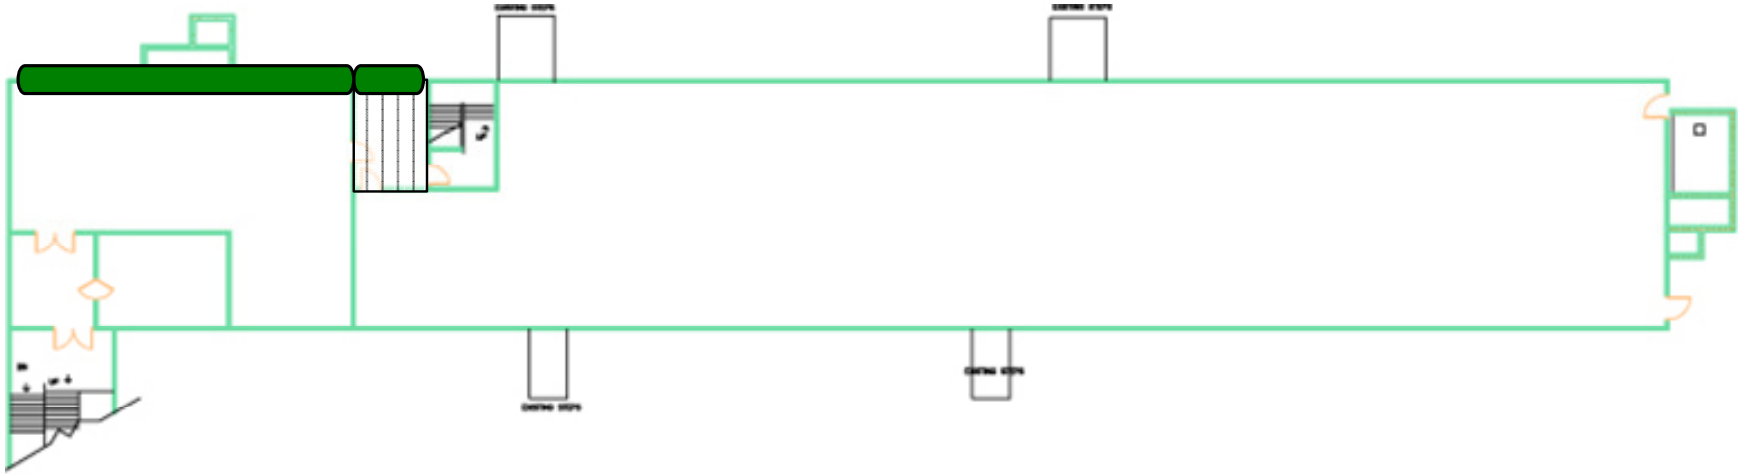
Asbestos Homogeneous Areas **ENCON #: 103-08-094** **Date: 6/13/2008**	**# = Asbestos Sample Location** **# = Positive Asbestos Sample Location**	**Bldg. 2474** **Asbestos Homogeneous Areas Drawing**	**N.T.S**

12" x 12" floor tile & mastic

Window glazing & window caulking

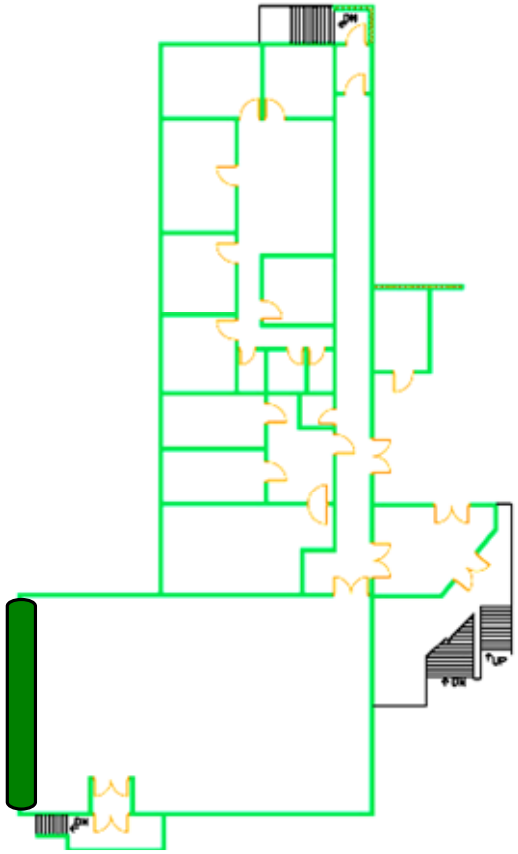
Asbestos Homogeneous Areas **ENCON #: 103-08-094** **Date: 6/13/2008**	**# = Asbestos Sample Location** **# = Positive Asbestos Sample Location**	**Bldg. 2474** **Asbestos Homogeneous Areas Drawing**	**N.T.S**

Window glazing & window caulking
