RE: Limited Asbestos Survey — ProTeX Job# 17332
Luke Air Force Base
Building 1365
Glendale, Arizona 85309

FIGURE 1

ACM Sample Location Map

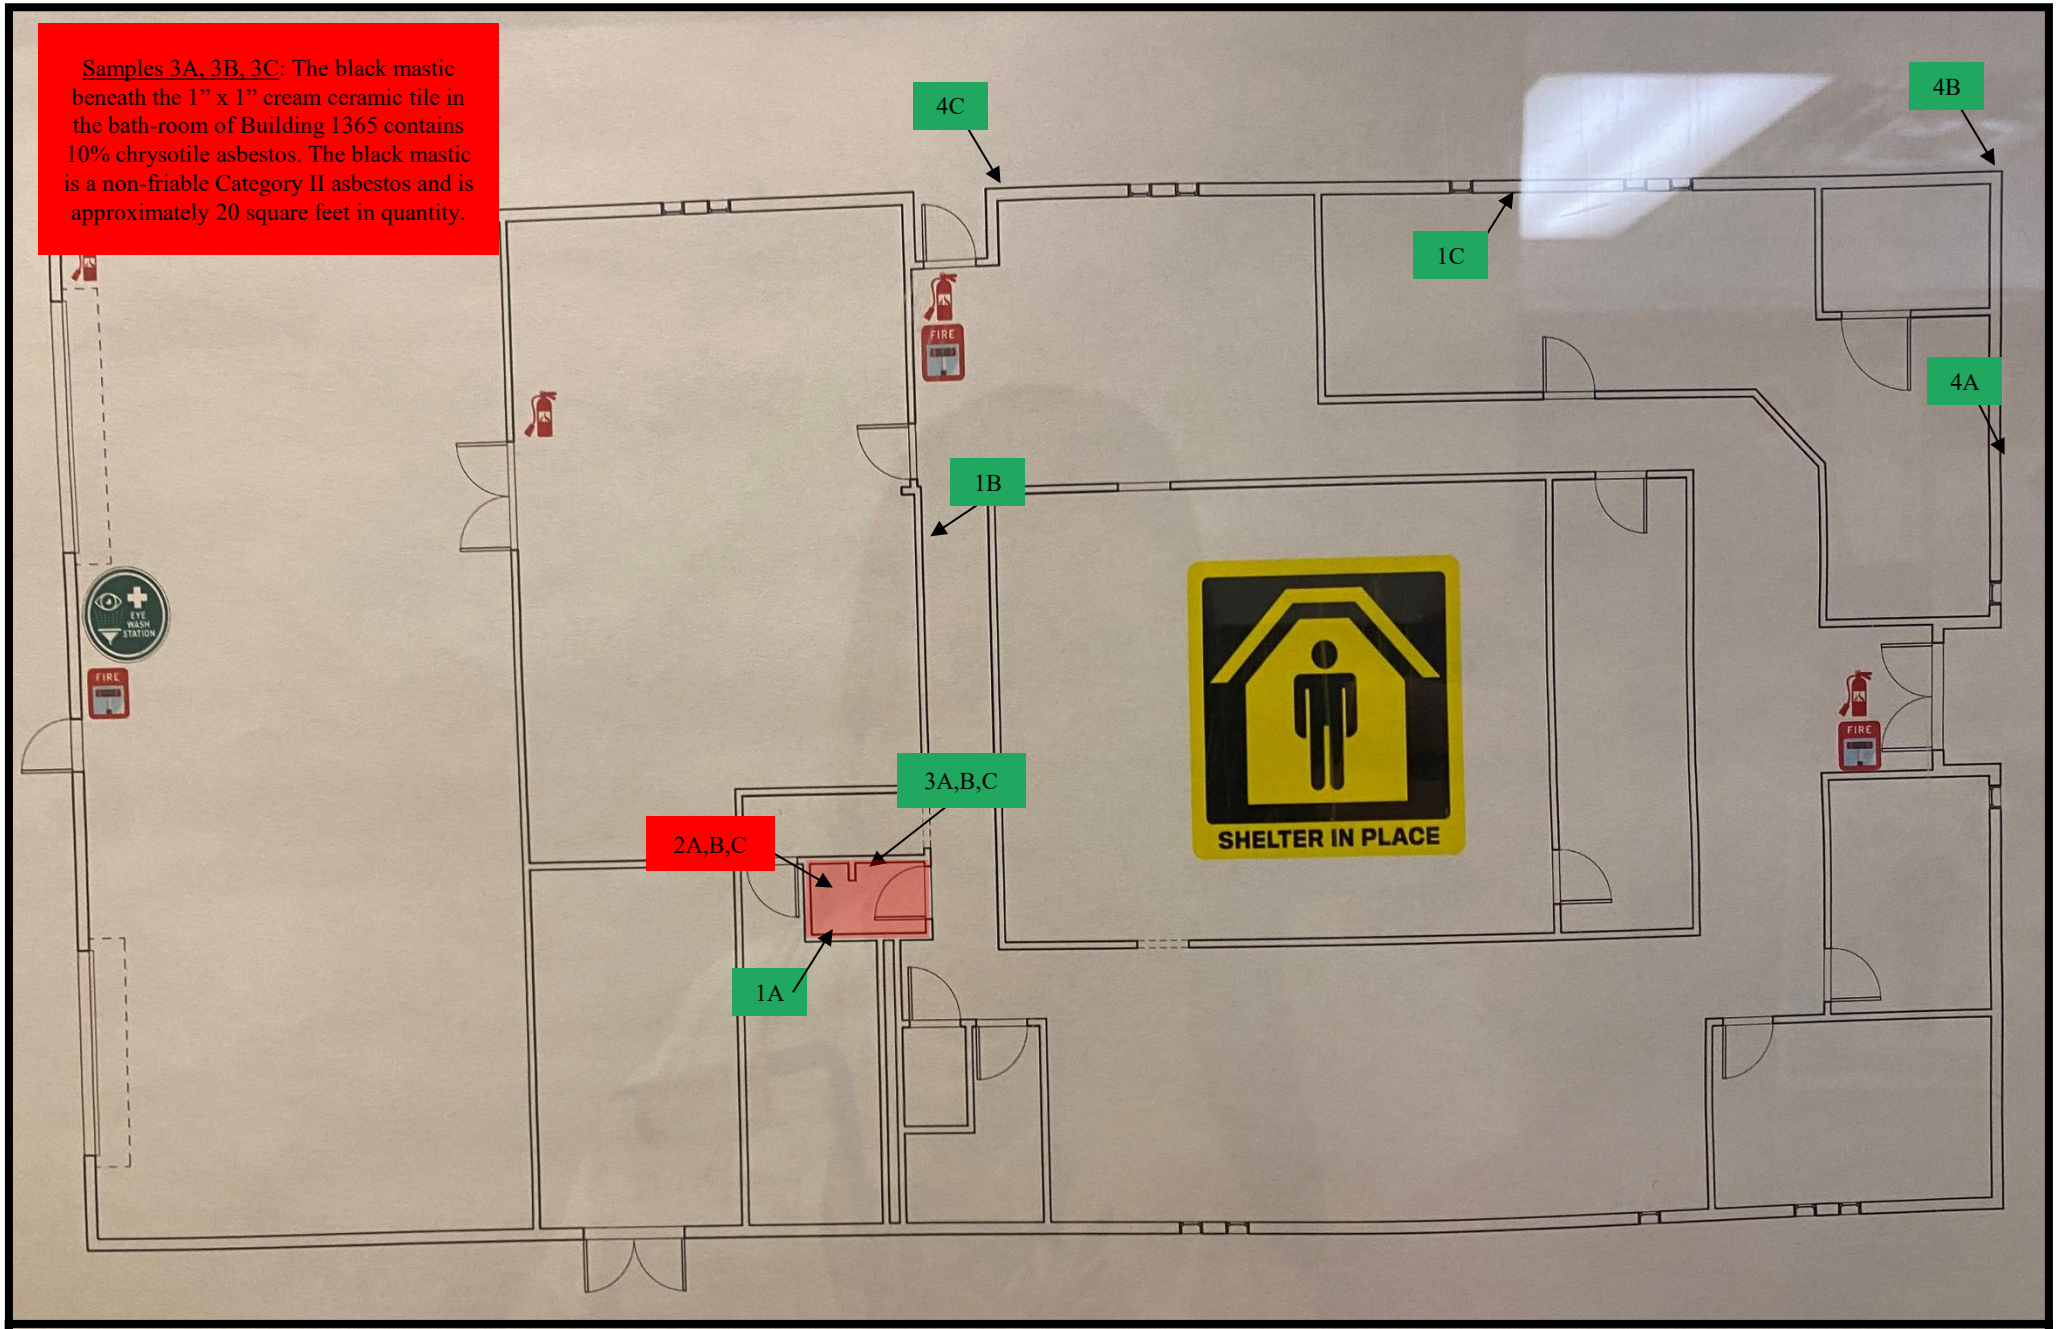
- *Samples 3A, 3B, 3C: The black mastic beneath the 1" x 1" cream ceramic tile in the bathroom of Building 1365 contains 10% chrysotile asbestos. The black mastic is a non-friable Category II asbestos and is approximately 20 square feet in quantity.*

Fig. 1 (ACM Interior Sample Location)

If additional suspect building materials are discovered during renovation/demolition activities, the materials should be sampled and analyzed for asbestos content prior to disturbance or should be assumed ACM and handled as such.

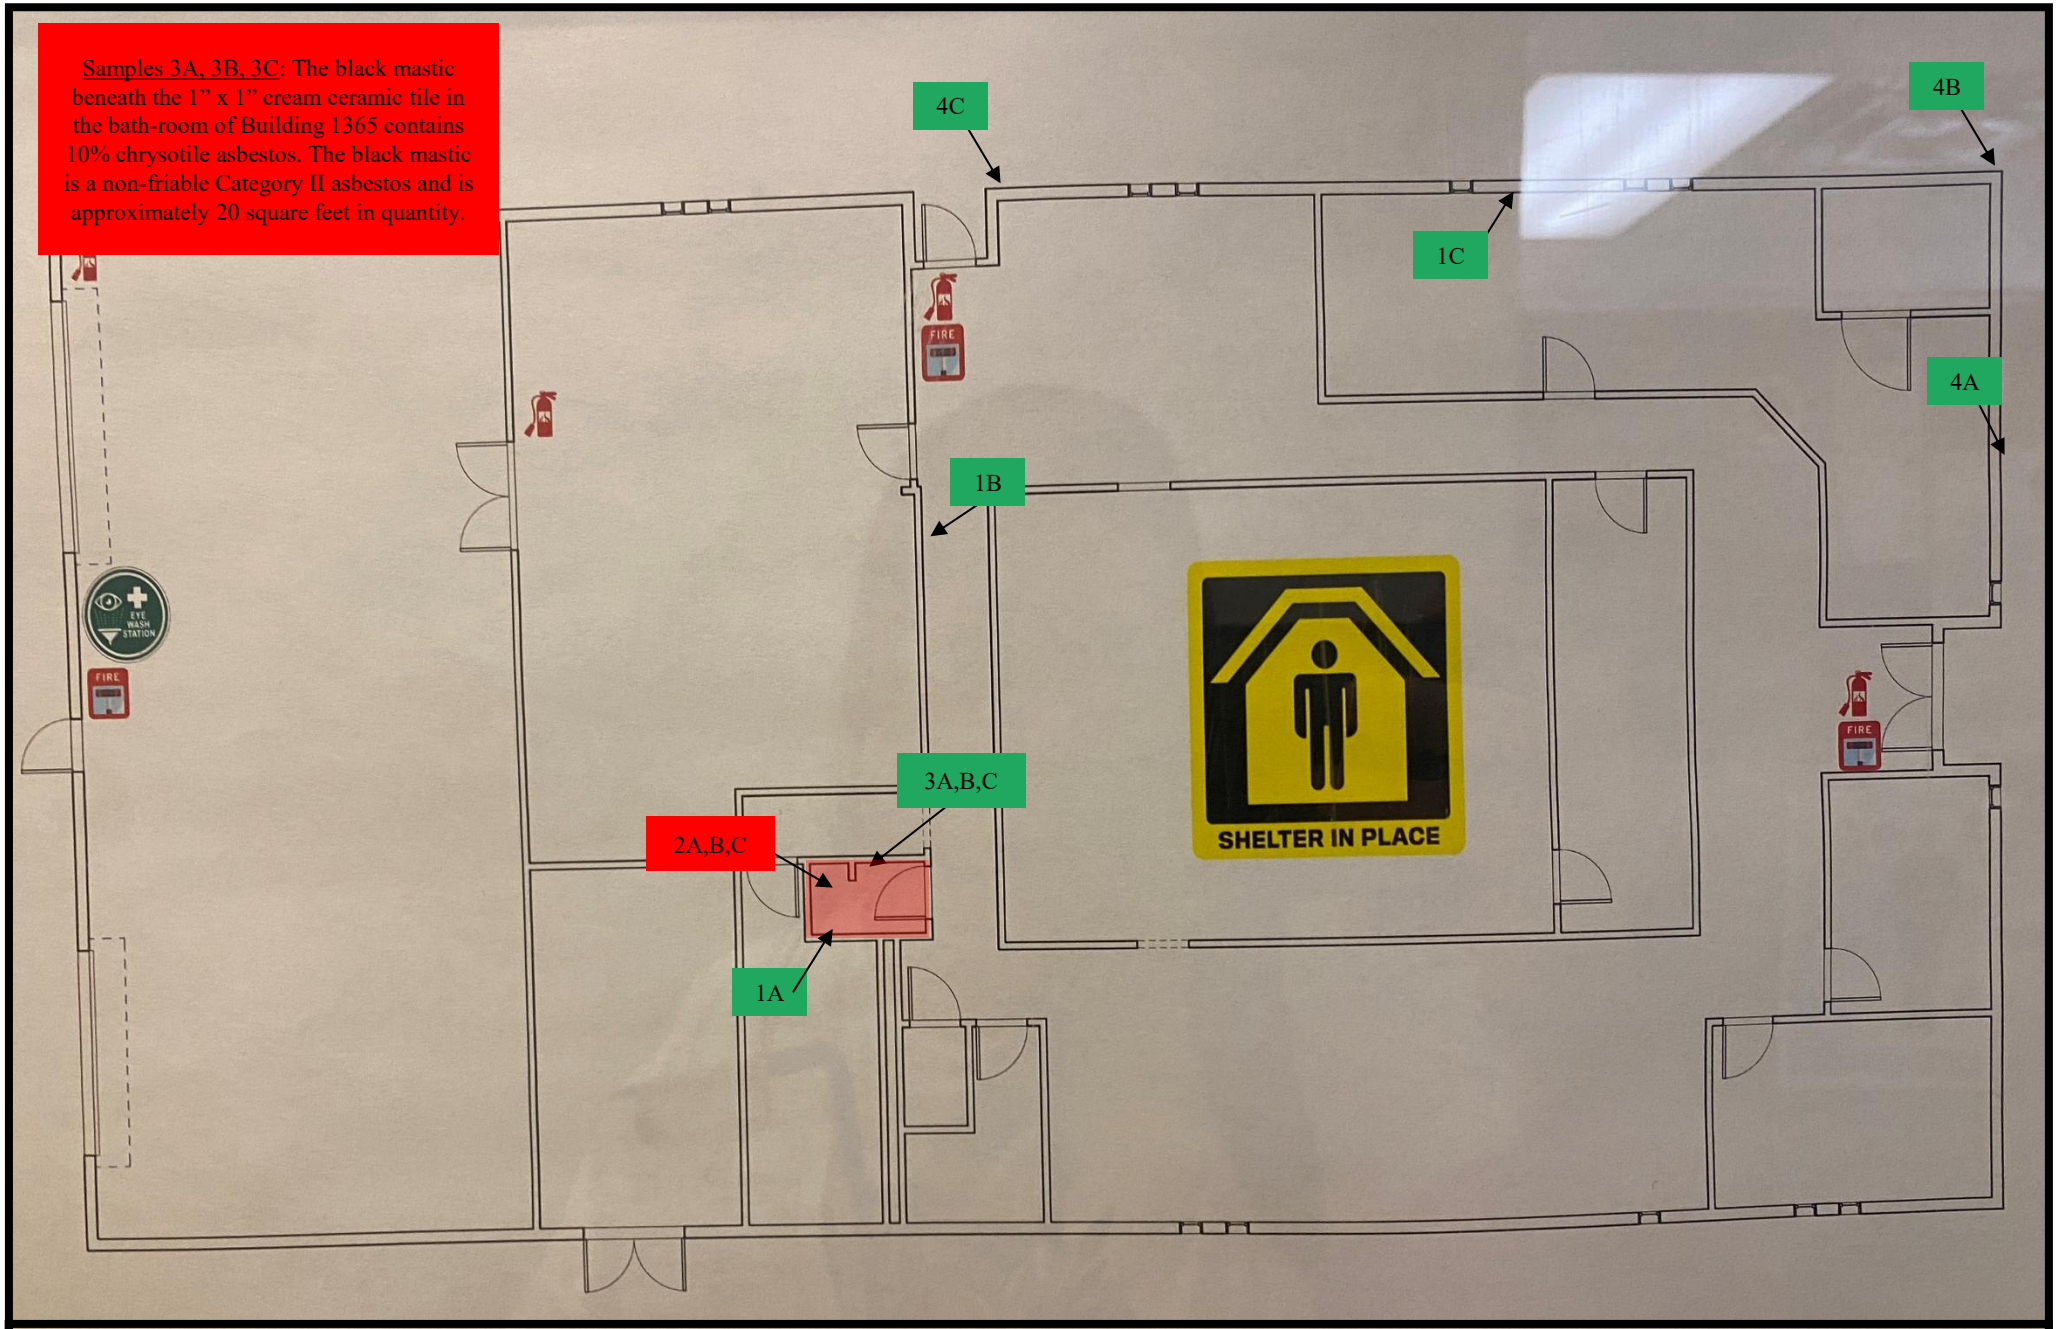
FIGURE 1

- *Samples 3A, 3B, 3C: The black mastic beneath the 1" x 1" cream ceramic tile in the bathroom of Building 1365 contains 10% chrysotile asbestos. The black mastic is a non-friable Category II asbestos and is approximately 20 square feet in quantity.*

Fig. 1 (ACM Interior Sample Location)

If additional suspect building materials are discovered during renovation/demolition activities, the materials should be sampled and analyzed for asbestos content prior to disturbance or should be assumed ACM and handled as such.
