Re: Limited Hazardous Materials Report
James H. Quillen Veterans Administration Medical Center (VAMC)
Building 35 Theatre Restoration
Lamont Street and Veterans Way
Johnson City, Tennessee 37604
Terracon Project No. KF247037
VA Project No. 621-24-103

Limited Hazardous Materials Survey Report

Building 35 Theatre Restoration

July 24, 2024 | Terracon Project No. KF247037

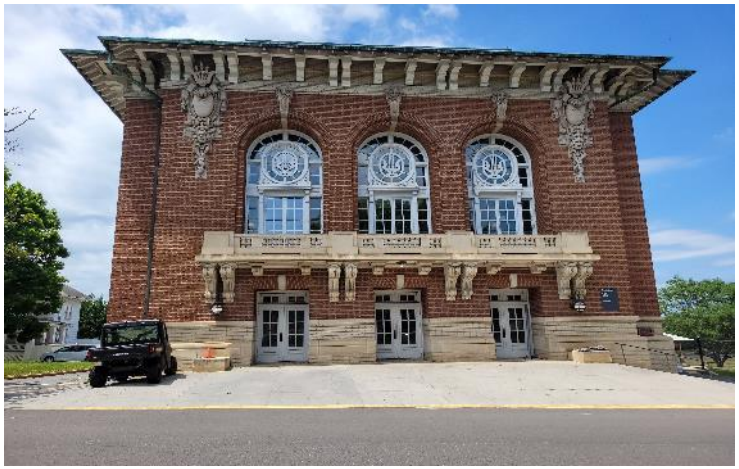
Photo 1: General view of the front of Building 35.

Photo 2: General view of the rear of Building 35.

Photo 3: General view of the right side of Building 35.

Photo 4: General view of the left side of Building 35.

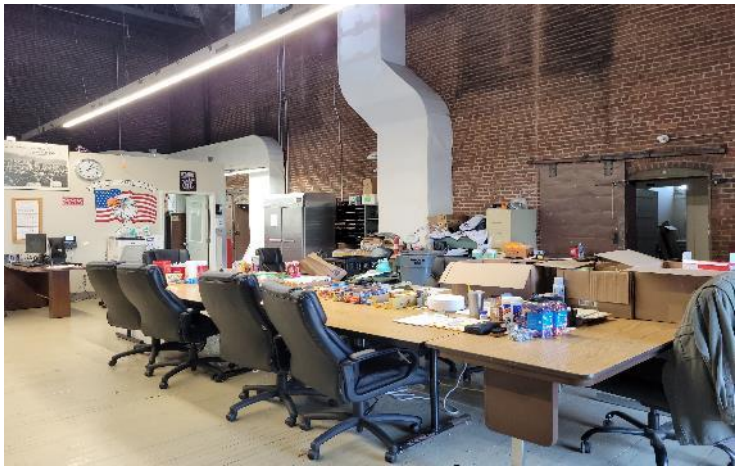
Photo 5: General view of the former stage area.

Photo 6: General view of the auditorium.

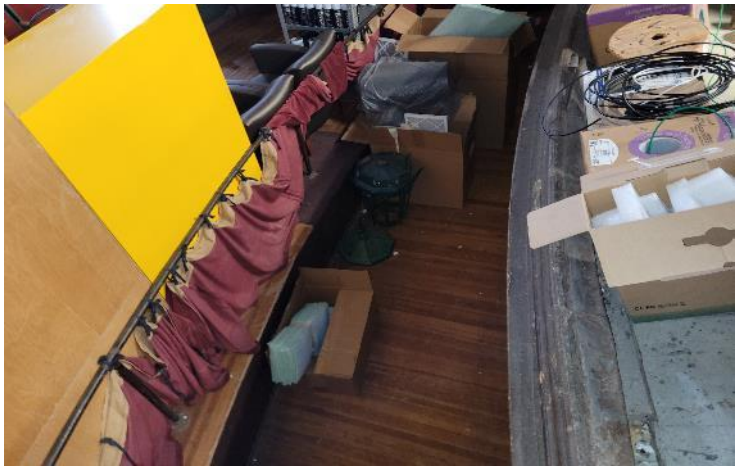
Photo 7: General view of the orchestra pit.

Photo 8: General view of the men's restroom at the rear of the auditorium. Typical of both restrooms.

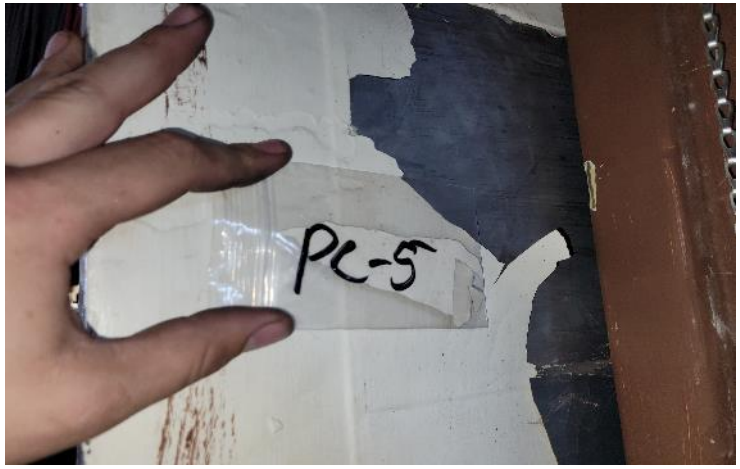
- White paint on metal door and frame on the roof access door from the stage attic;
- Silver paint on metal ventilator on the flat roof;
- White paint on metal fire doors on the stage;
- White paint on plaster walls in the stage back hallway;
- White paint on wooden baseboard in the stage 2nd floor back hallway;
- White paint on wooden beadboard ceiling in the orchestra pit;
- Brown paint on metal fire door frame in the orchestra pit;
- Gray paint on wooden stair riser in the stage stairwell;
- Peach paint on plaster walls in the auditorium men's restroom storage space; and,
- White paint on wooden door and frame on the exterior balcony fire escape.

Photo 28: View of white paint on metal fire door in the stage area. Sample PC-5 collected here.

Photo 29: View of white paint on plaster walls in the stage back hallway. Sample PC-6 collected here.

With regard to disposal of painted waste, LBP-coated materials may generally be disposed at a construction and demolition (C&D) landfill provided that the paint remains intact on the substrate. Paint that is delaminated or paint waste that will be generated as a result of renovation/demolition activities must undergo a hazardous waste determination by collecting one or more representative samples of the waste material for laboratory analysis. The specific laboratory test methods necessary may be prescribed by the prospective disposal facility but should, at a minimum, include lead analysis via TCLP.
