RE: U.S. Department of Veterans Affairs (VA)
Captain James A. Lovell Federal Health Care Center
Building # 188

This report addresses the asbestos survey completed for Building #188.

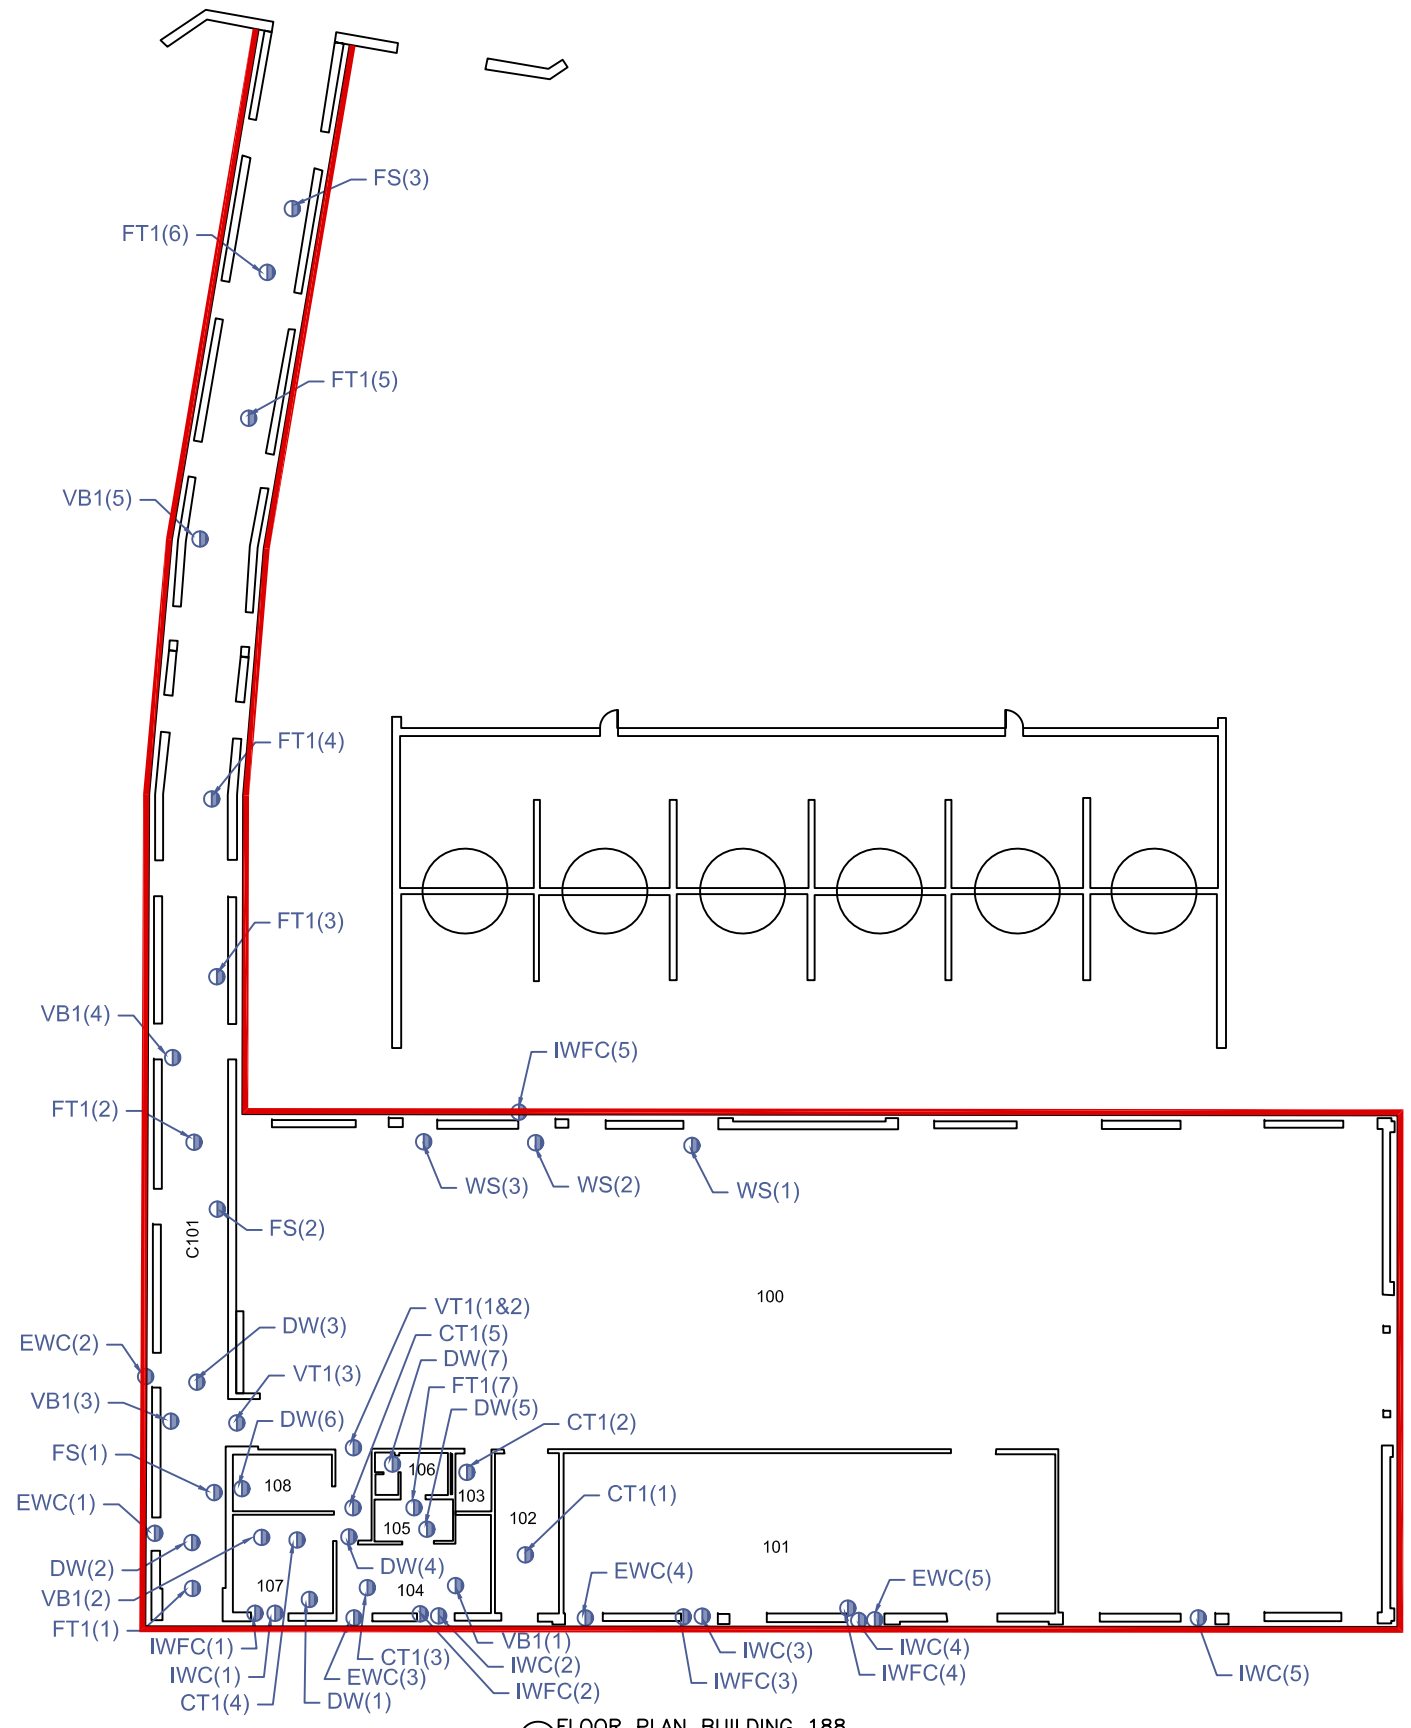
1 FLOOR PLAN BUILDING 188
SCALE: NOT TO SCALE

HSA Sample #	Material Description	Material Condition	Material Quantity	Material Location	Laboratory Results
EWC	EXTERIOR WINDOW CAULK	NONFRIABLE	700 LF	EXTERIOR WINDOWS	**PC 2.1%-4.0% CHRYSOTILE**
