RE: U.S. Department of Veterans Affairs (VA)
Captain James A. Lovell Federal Health Care Center
Building # 3

CAPTAIN JAMES A. LOVELL
FEDERAL HEALTH CARE CENTER
3001 NORTH GREEN BAY ROAD
NORTH CHICAGO, ILLINOIS 60064
2011 ASBESTOS INSPECTION
BUILDING # 3
SAMPLE # WG
08/19/2011

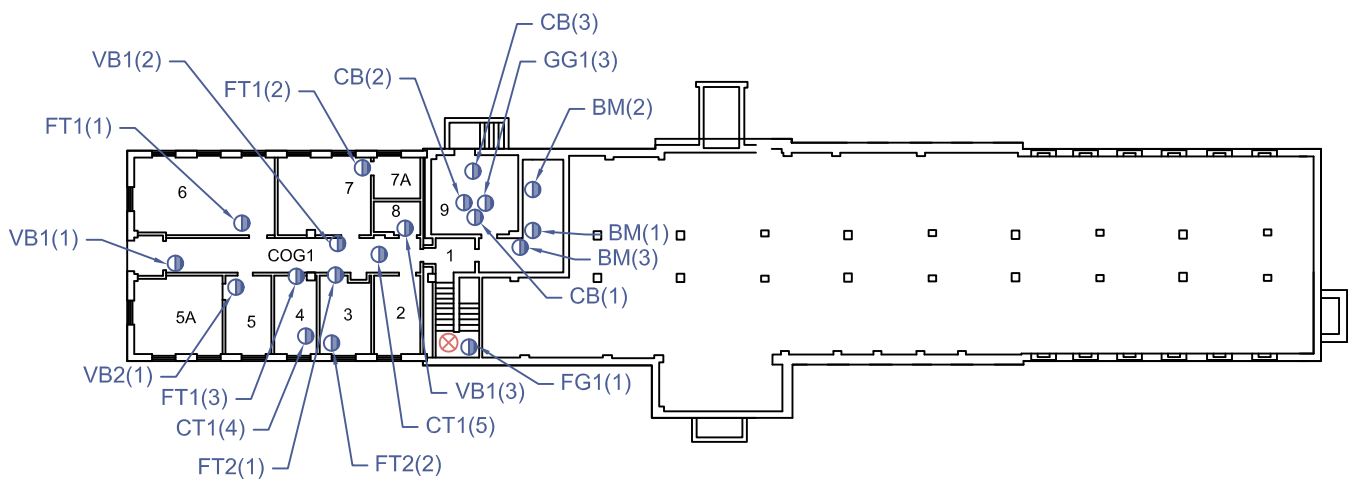
1 BASEMENT FLOOR PLAN BUILDING 3
SCALE: 1/32" = 1'-0"

LEGEND	
SYMBOL	**DESCRIPTION**
◑	SAMPLE LOCATION
ASBESTOS CONTAINING MATERIAL (ACM)	
⊗	PIPE FITTINGS ON FIBERGLASS LINES

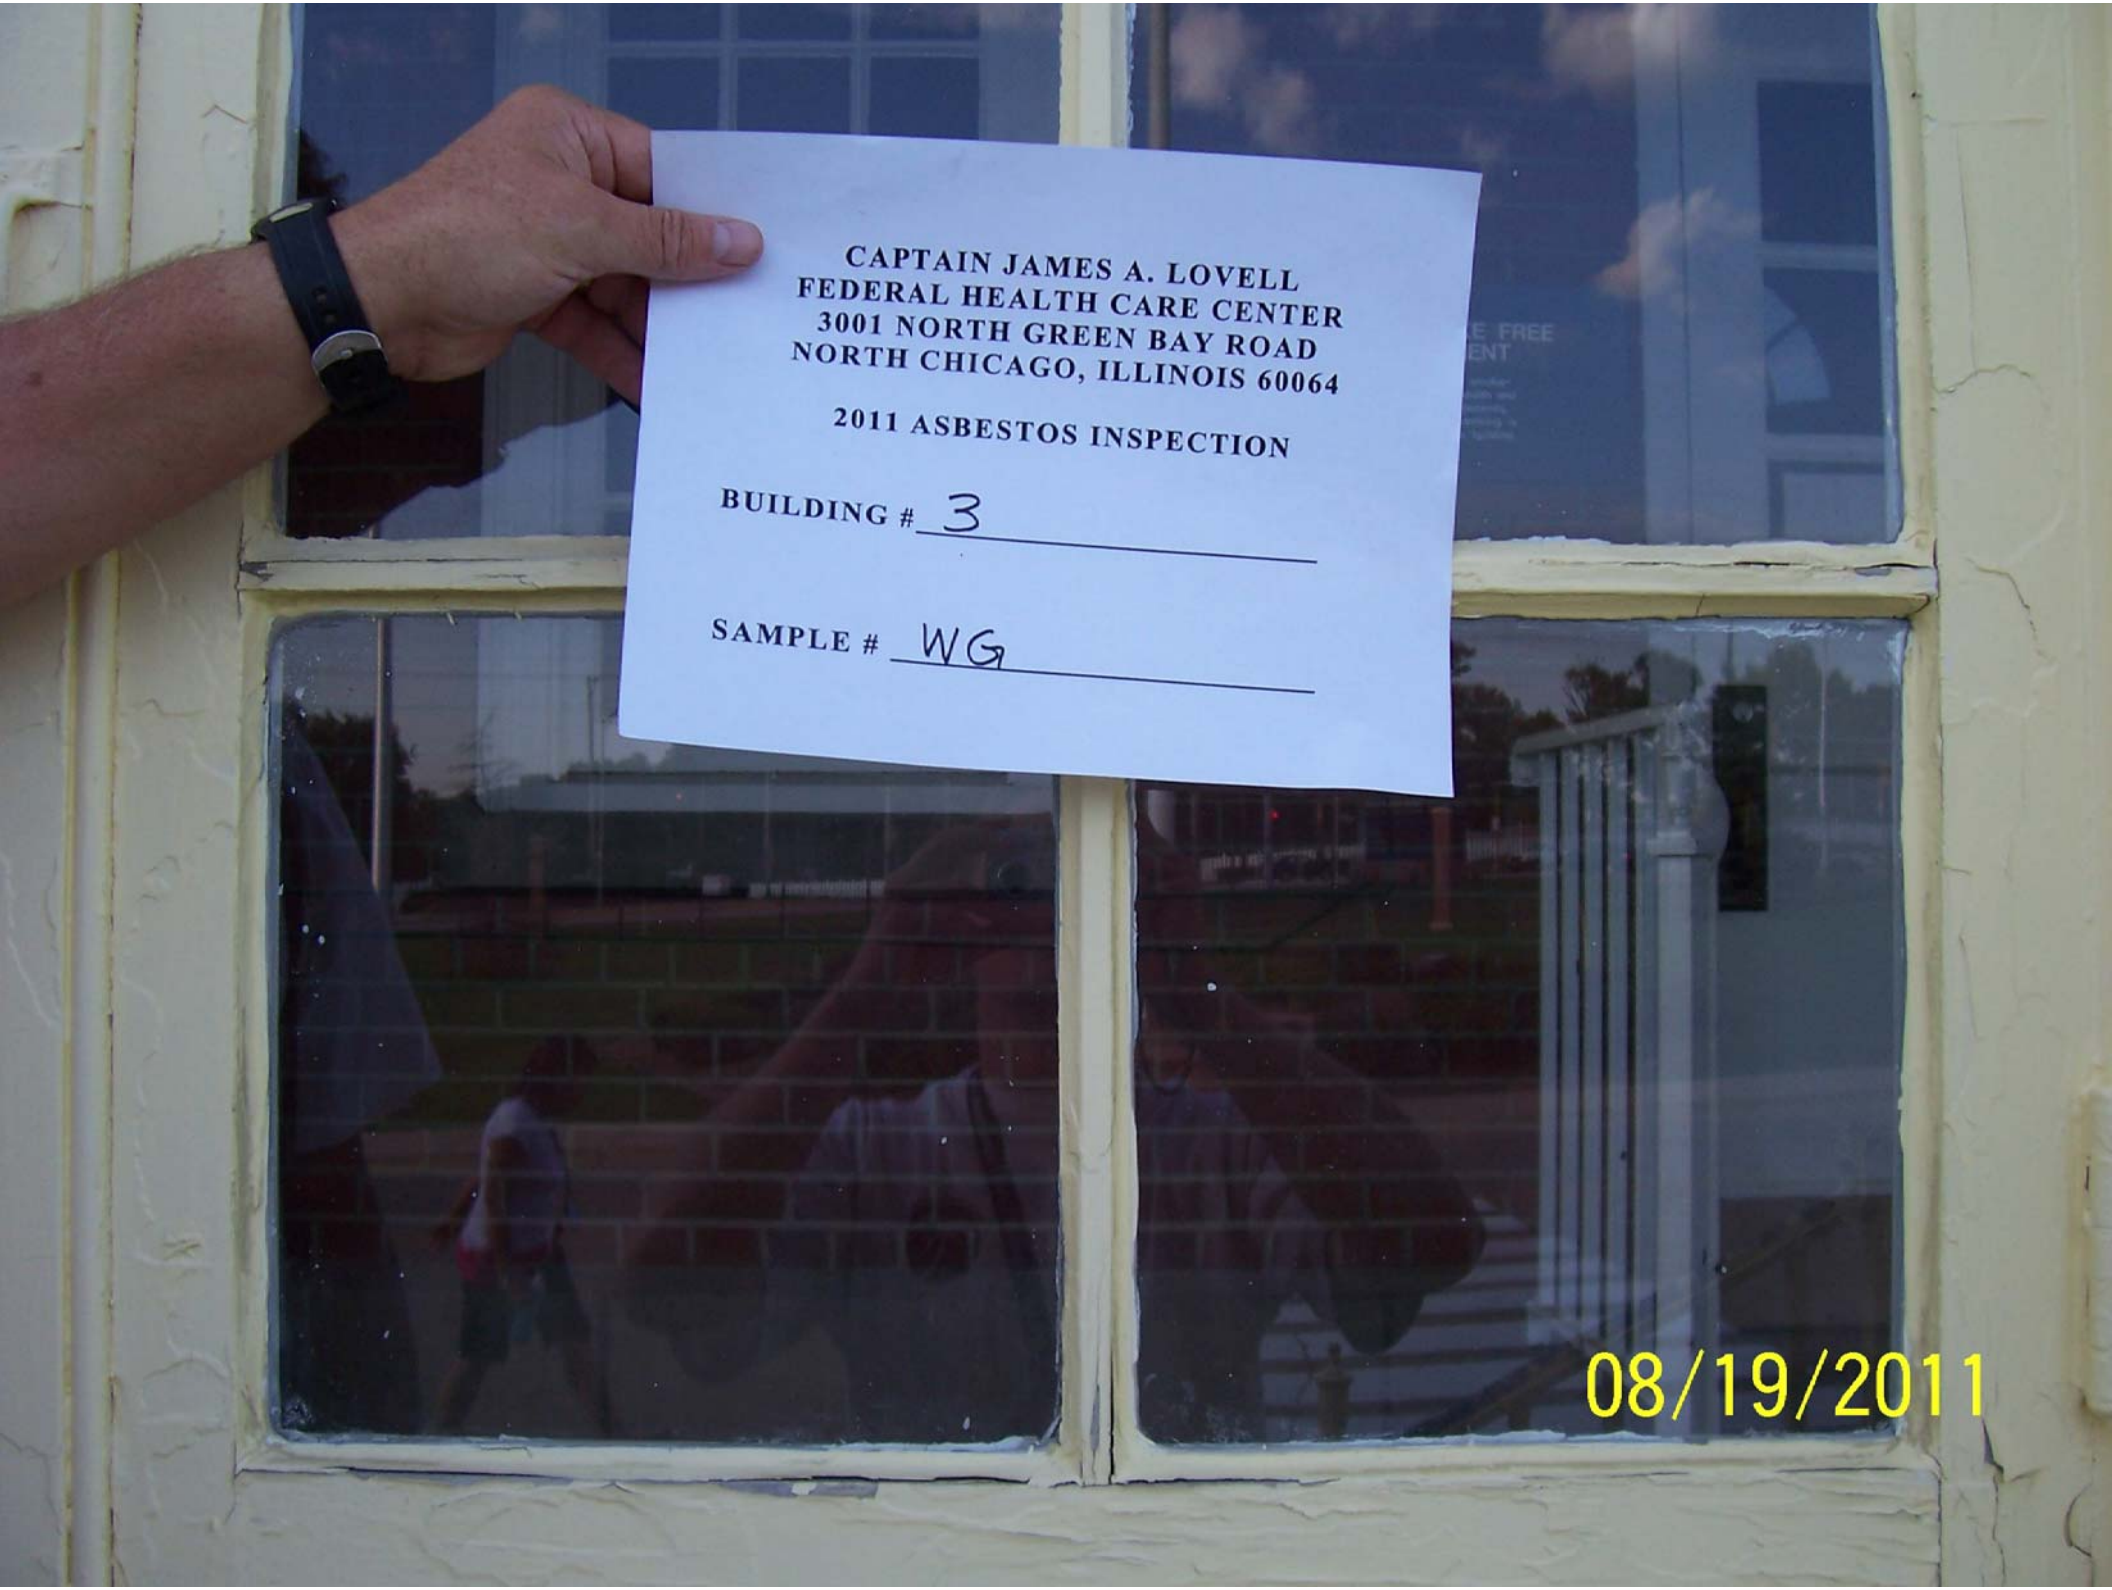
HSA Sample #	Material Description	Material Condition	Material Quantity	Material Location	Laboratory Results
GG3	GLUE GLOBS FOR CT7	NONFRIABLE	105 SF	ROOM 108	**1.1%-1.3% CHRYSOTILE**
WG	EXTERIOR WINDOW GLAZE	NONFRIABLE	600 LF	THROUGHOUT	**1.0%-1.8% CHRYSOTILE**

Tropical recommends the use of certified and licensed asbestos personnel for **all** planned disturbance of known and suspect asbestos containing products. In accordance with IDPH, IEPA, U.S.EPA and OSHA regulations asbestos containing materials must be removed by and disposed of by a certified/licensed asbestos abatement personnel/contractor.

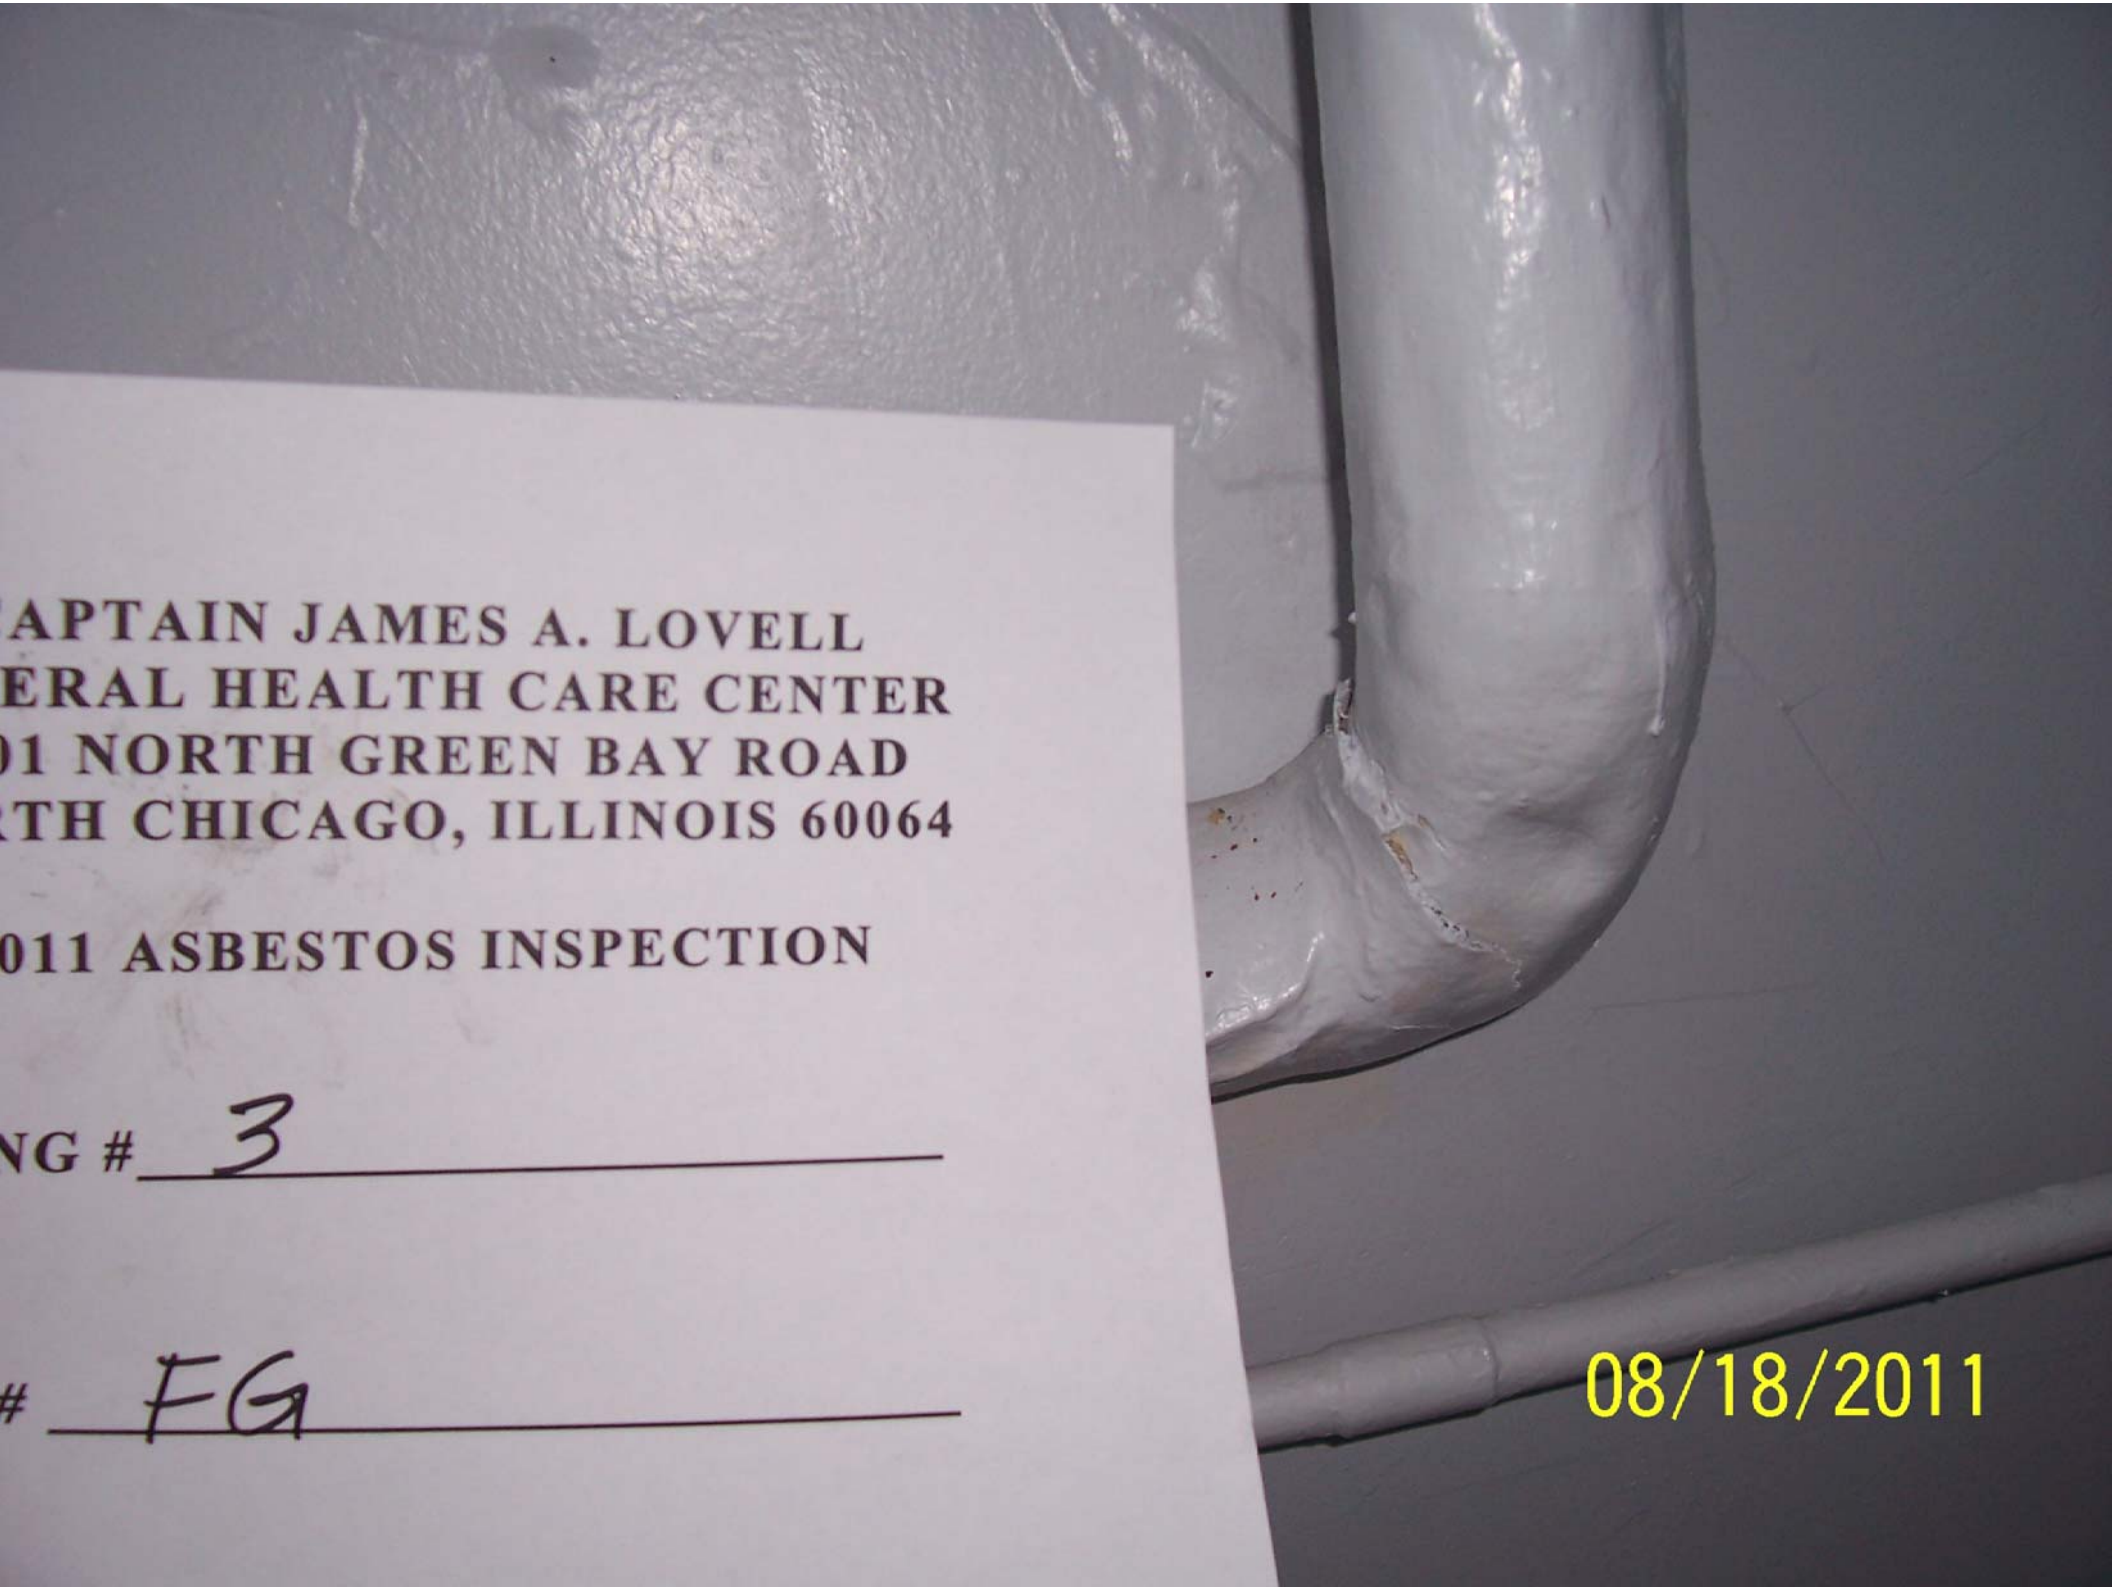
APTAIN JAMES A. LOVELL
ERAL HEALTH CARE CENTER
01 NORTH GREEN BAY ROAD
RTH CHICAGO, ILLINOIS 60064
011 ASBESTOS INSPECTION
NG # 3
FG
08/18/2011

HSA Sample #	Material Description	Material Condition	Material Quantity	Material Location	Laboratory Results
FG	FITTINGS ON FIBERGLASS RUNS	FRIABLE	~3000 FITTINGS	THROUGHOUT	**1.6%-10 % CHRYSOTILE 25% AMOSITE**
FT4 (MASTIC)	TAN MASTIC ASSOCIATED WITH 12”X12” LIGHT BROWN FLOOR TILE	NONFRIABLE	1500 SF	CORRIDOR 124	**2.8% CHRYSOTILE**
FT5 (MASTIC)	BLACK MASTIC ASSOCIATED WITH 12”X12” TAN FLOOR TILE	NONFRIABLE	186 SF	ROOMS 204, 205, 208	**10.6%-24.2% CHRYSOTILE**
