Date:	Wednesday, June 24, 2026
Project:	140A1626B0001 Bannock Pumping Plant Modernization and Rehabilitation
To:	Mark McNearney, P.E., Civil Engineer, BIA Office of Trust Services Division of Water and Power Branch of Irrigation and Power
From:	Jerry Otto, P.E.
Subject:	Bannock Pumping Plant Low and High-Lift 20-inch Steel Discharge Piping – Concrete Encasement

140A1622F0026 BANNOCK PUMPING PLANT MODERNIZATION
INVESTIGATION OF EXISTING 20-INCH-DIAMETER STEEL DISCHARGE PIPES
AUGUST 9, 2024

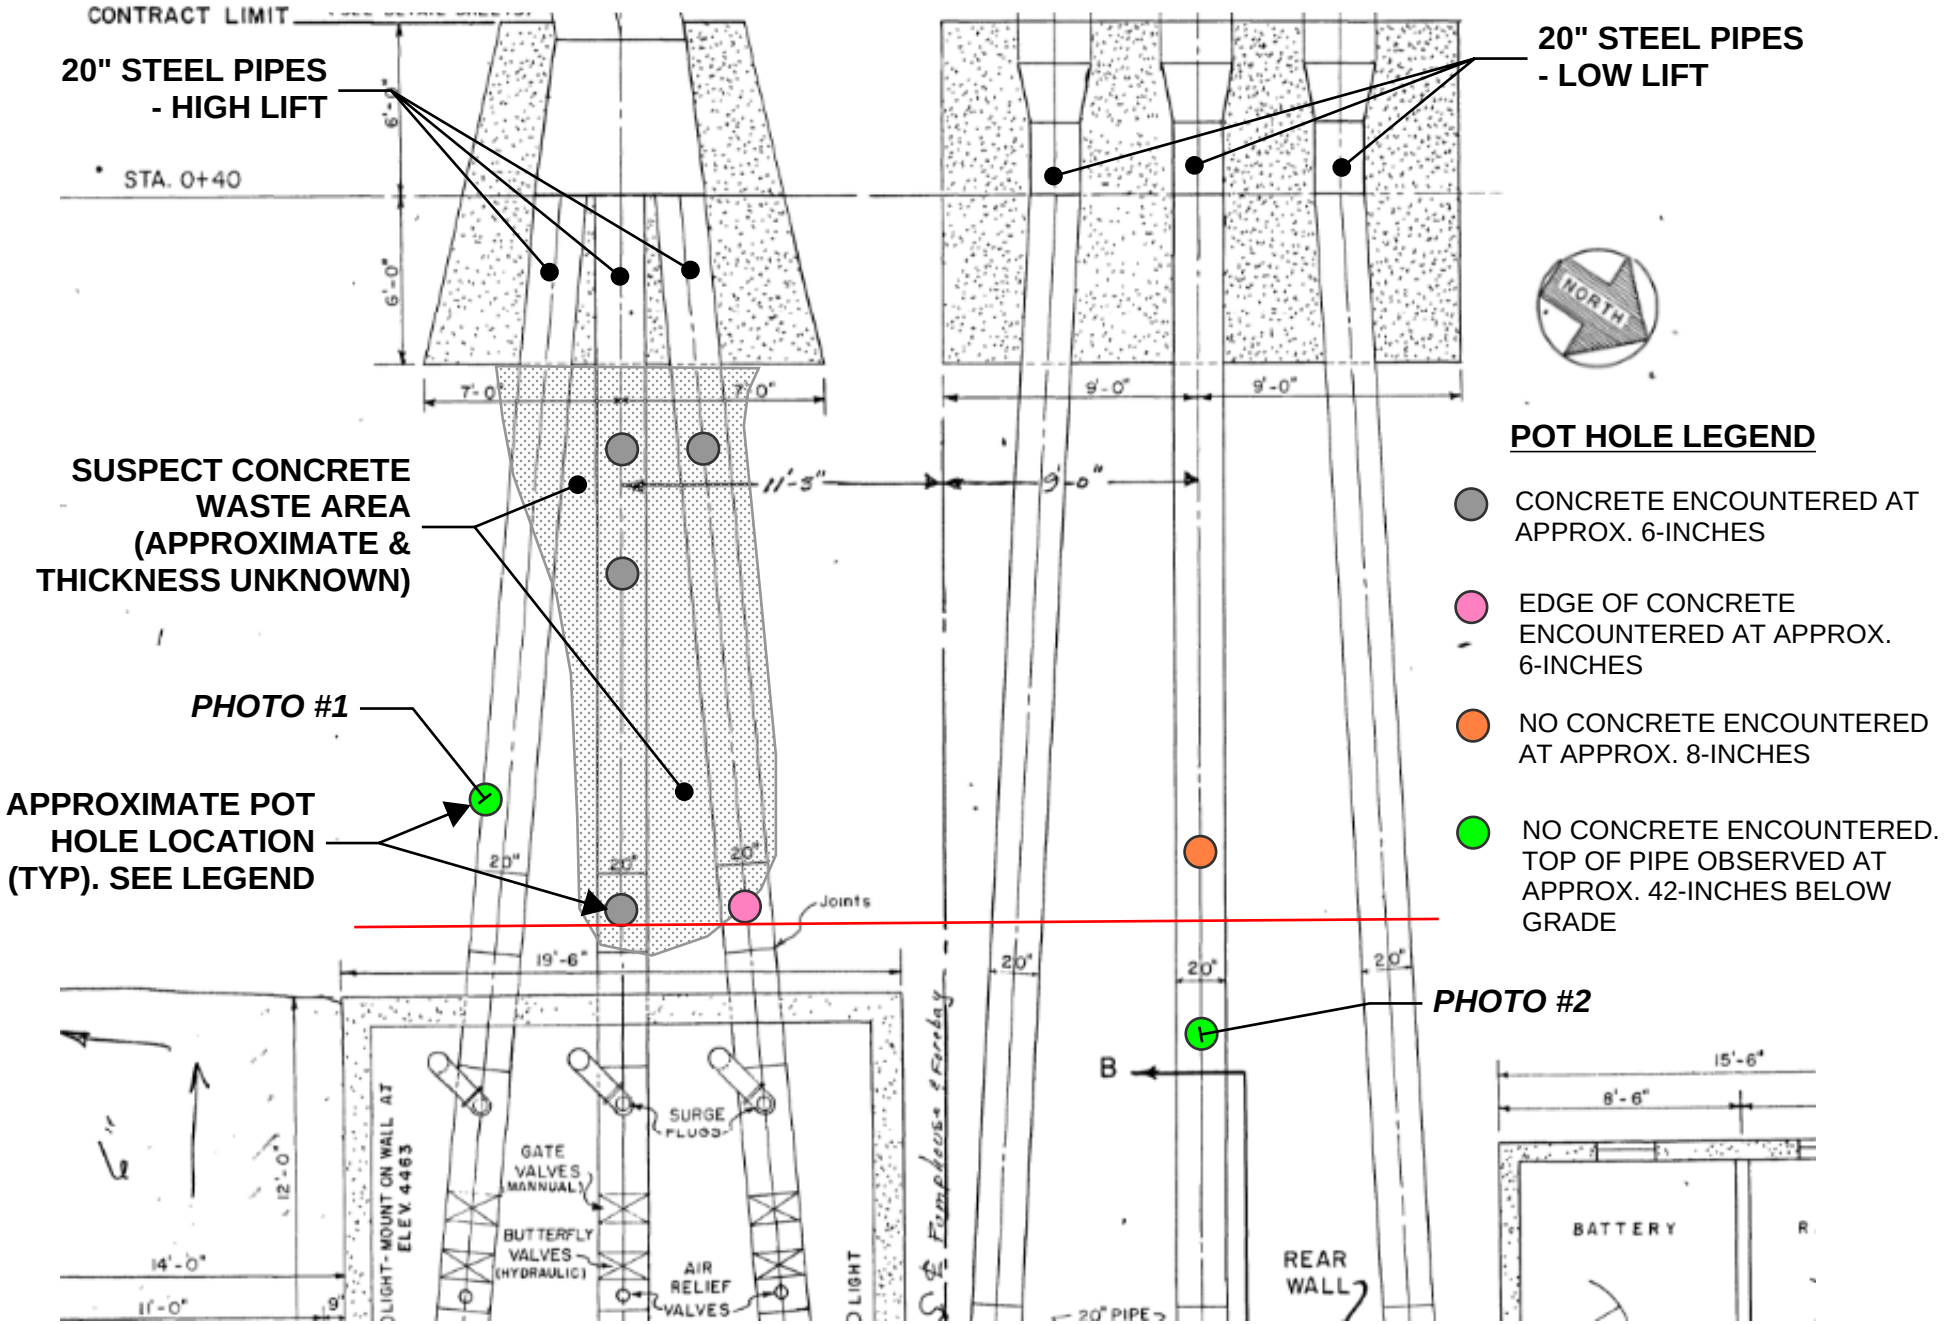
HDR observed minor visible pitting on the pipe external surface beneath what is believed to be coal tar or wax taping encompassing the pipe.

More important, the high-lift steel pipes were found to have concrete encasements as concrete was encountered at approximately six-inches below existing ground surface at the time of the observation. The encasement was not installed consistent with intended encasements, and it is believed that excess concrete may result from excess concrete being poured into the pipe trenches during the construction of the adjacent thrust blocks. Attachment 1 depicts the approximate area of the concrete encountered.

The construction contractor will be responsible for field verifying the location/depth of the suspect concrete between the pumping plant and thrust blocks and take precautions so as not to disturb the concrete during site civil work or making new pipe connections such that damage occurs to the existing buried steel pipe.
