May 4, 2026
Project 2601801

Re: Hazardous Materials Assessment – Pre-Demolition
Electrical Vault Building
Volk Field Air National Guard
100 Independence Drive
Camp Douglas, Juneau County, Wisconsin

TABLE 1
SUMMARY OF ASBESTOS ASSESSMENT RESULTS
Volk Field Air National Guard Electrical Vault Building - Pre-demolition Survey
100 Independence Drive
Camp Douglas, Juneau County, Wisconsin
GEI Project No. 2601801 Task 1.1.1

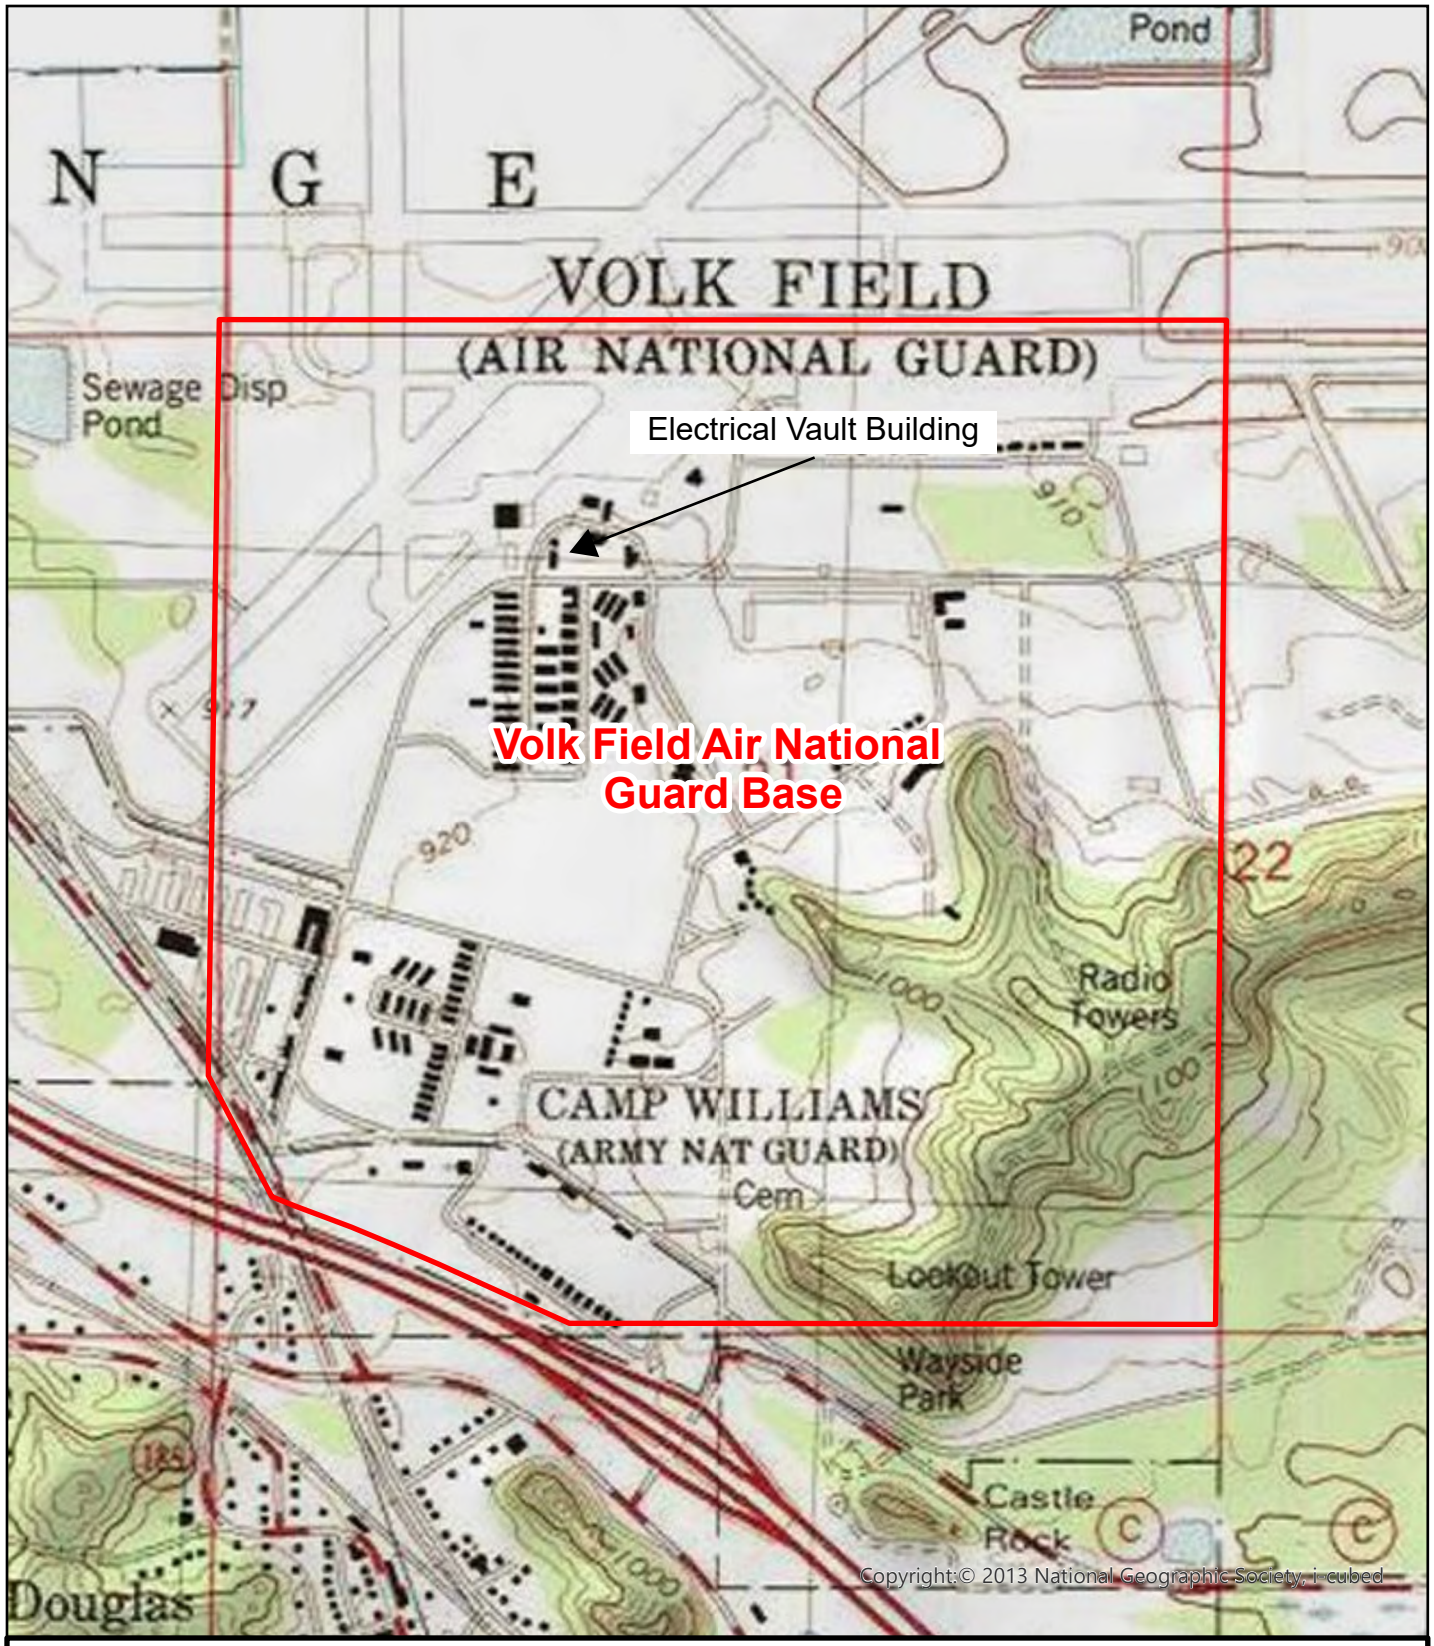
Volk Field Air National Guard Base 100 Independence Drive Camp Douglas, WI 54618	GEI Consultants	SITE LOCATION MAP
Mead & Hunt	Project 2601801	MAY 2026 FIGURE 1

The site location is indicated on Figure 1, which is a portion of a United States Geological Survey (USGS) 7.5-minute topographic map. The parcel features, including the existing electrical vault building, are indicated on Figure 2.

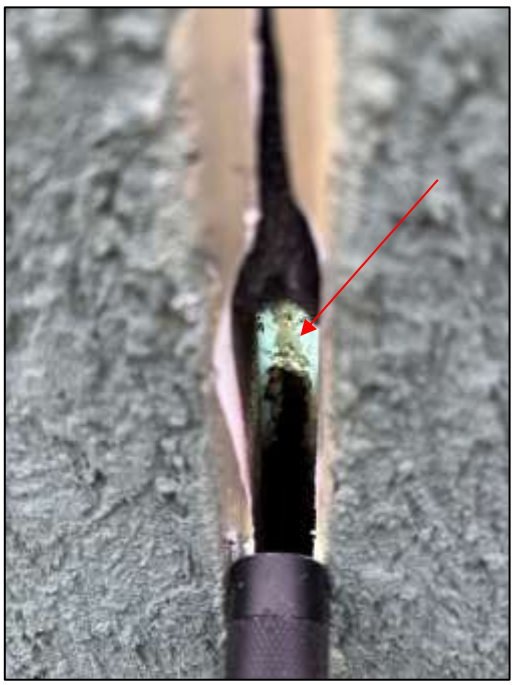
View of the white caulk on the exterior wall joint of Volk Field electrical vault building.

The white caulk was sampled for asbestos (Volk-5A-5C). The white caulk tested negative for asbestos.

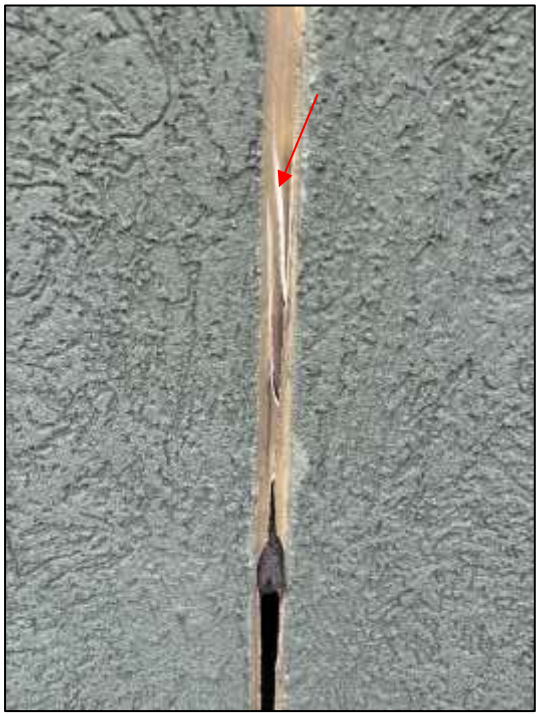
PHOTOGRAPH NO: 26	**DATE:** 4/3/2026	**LATITUDE:** 43.934187	**LONGITUDE:** -90.265239
DIRECTION: W	**SITE LOCATION:** VOLK FIELD ELECTRICAL VAULT BUILDING – 100 INDEPENDENCE DRIVE, CAMP DOUGLAS, WISCONSIN		
DESCRIPTION: View of the gray caulk on the exterior wall seam on the outside wall of the Volk Field electrical vault building. The gray caulk was sampled for asbestos (Volk-25A-25C). The gray caulk tested negative for asbestos.

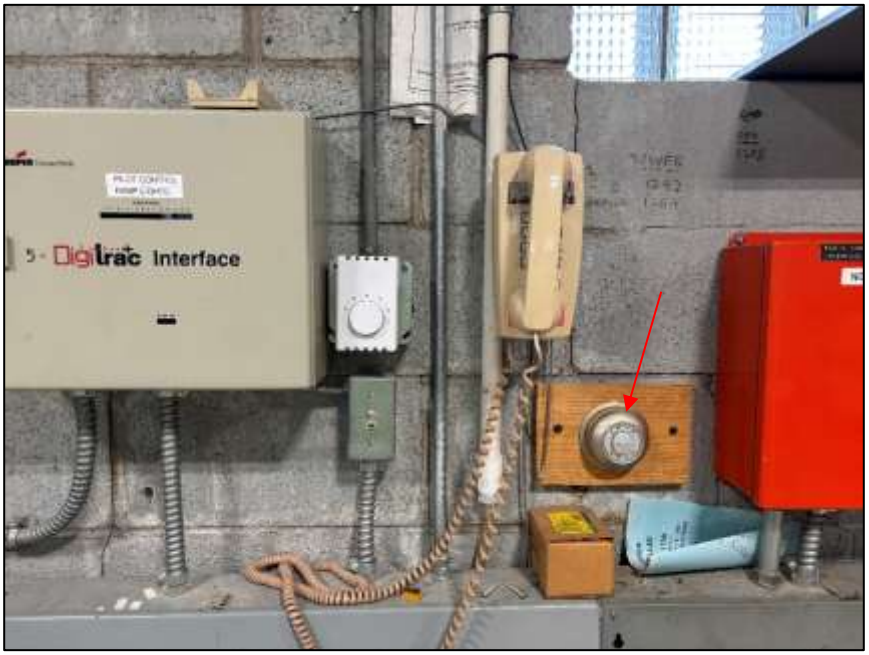
PHOTOGRAPH NO: 38	**DATE:** 4/3/2026	**LATITUDE:** 43.934187	**LONGITUDE:** -90.265239
DIRECTION: Up	**SITE LOCATION:** VOLK FIELD ELECTRICAL VAULT BUILDING – 100 INDEPENDENCE DRIVE, CAMP DOUGLAS, WISCONSIN		
DESCRIPTION: View of the one of the thermostats mounted in the Volk Field electrical vault building. The thermostat is assumed to contain mercury. Internal electrical components are assumed to contain Category II non-friable asbestos.
