EXHIBIT Z - JMMU Trench System Repairs

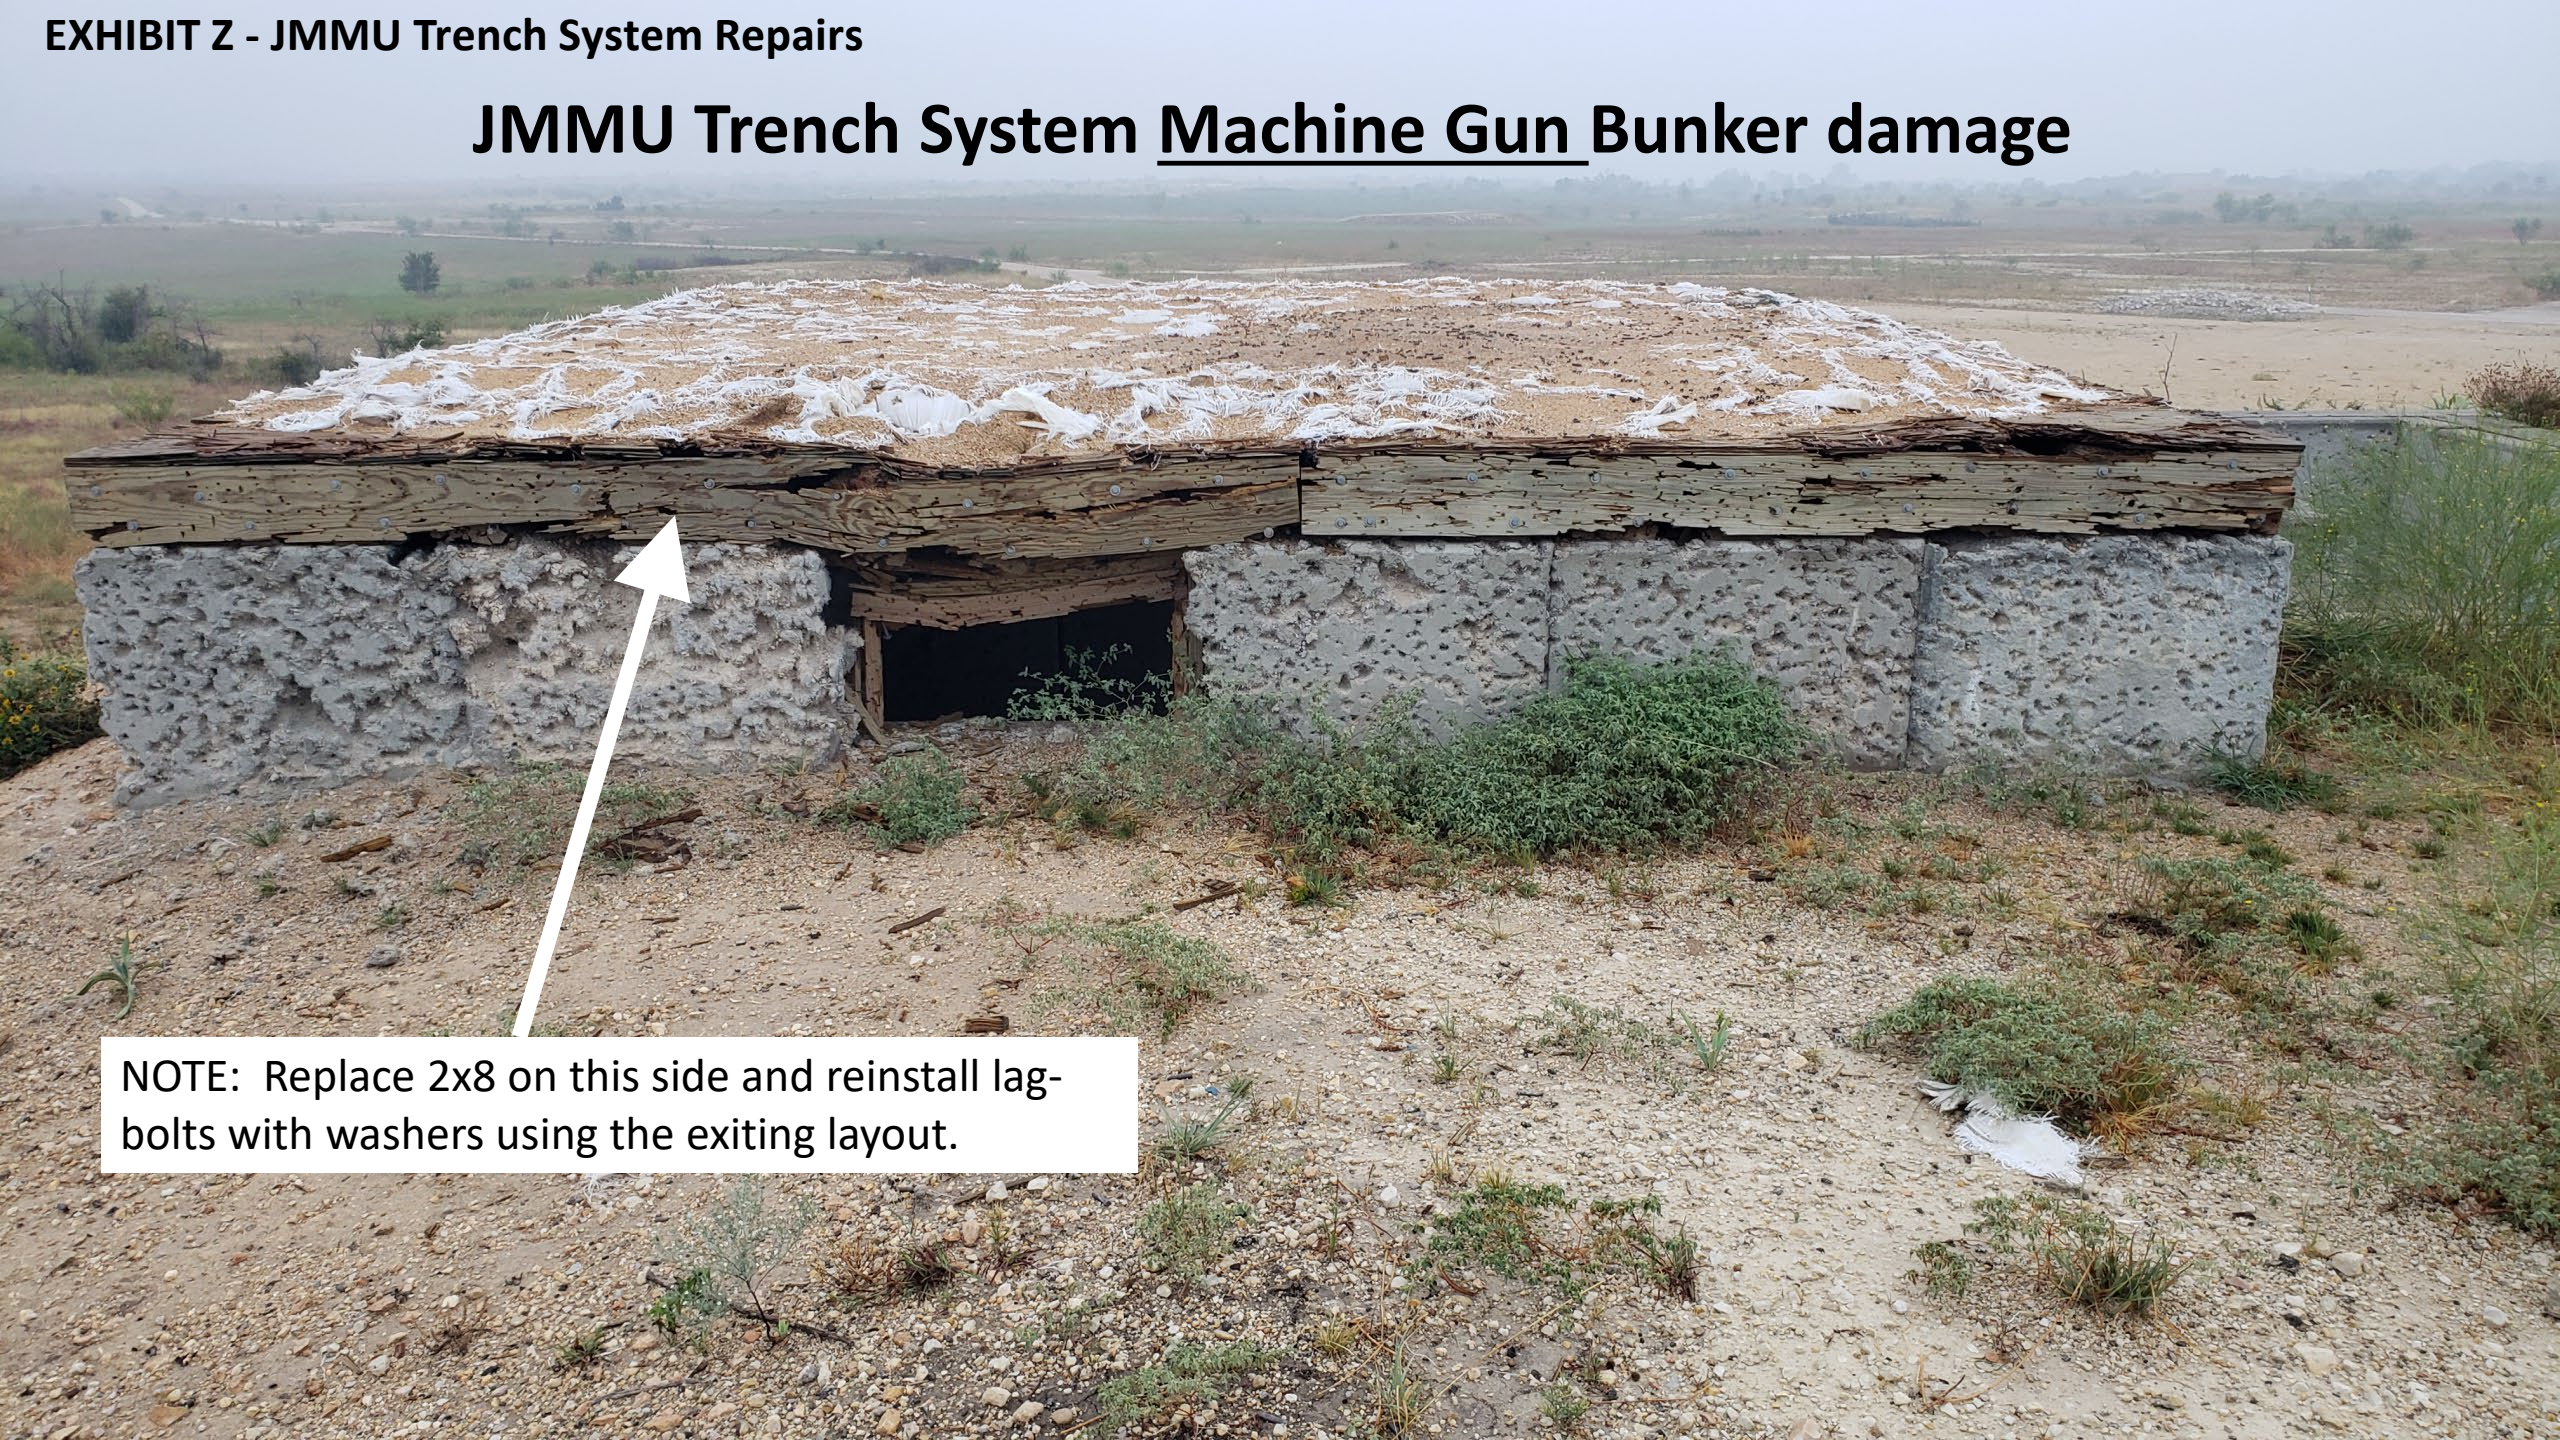
JMMU Trench System Machine Gun Bunker damage

JMMU Trench System Machine Gun Bunker damage with Superficial SACON Walls Protecting from Assault Side.

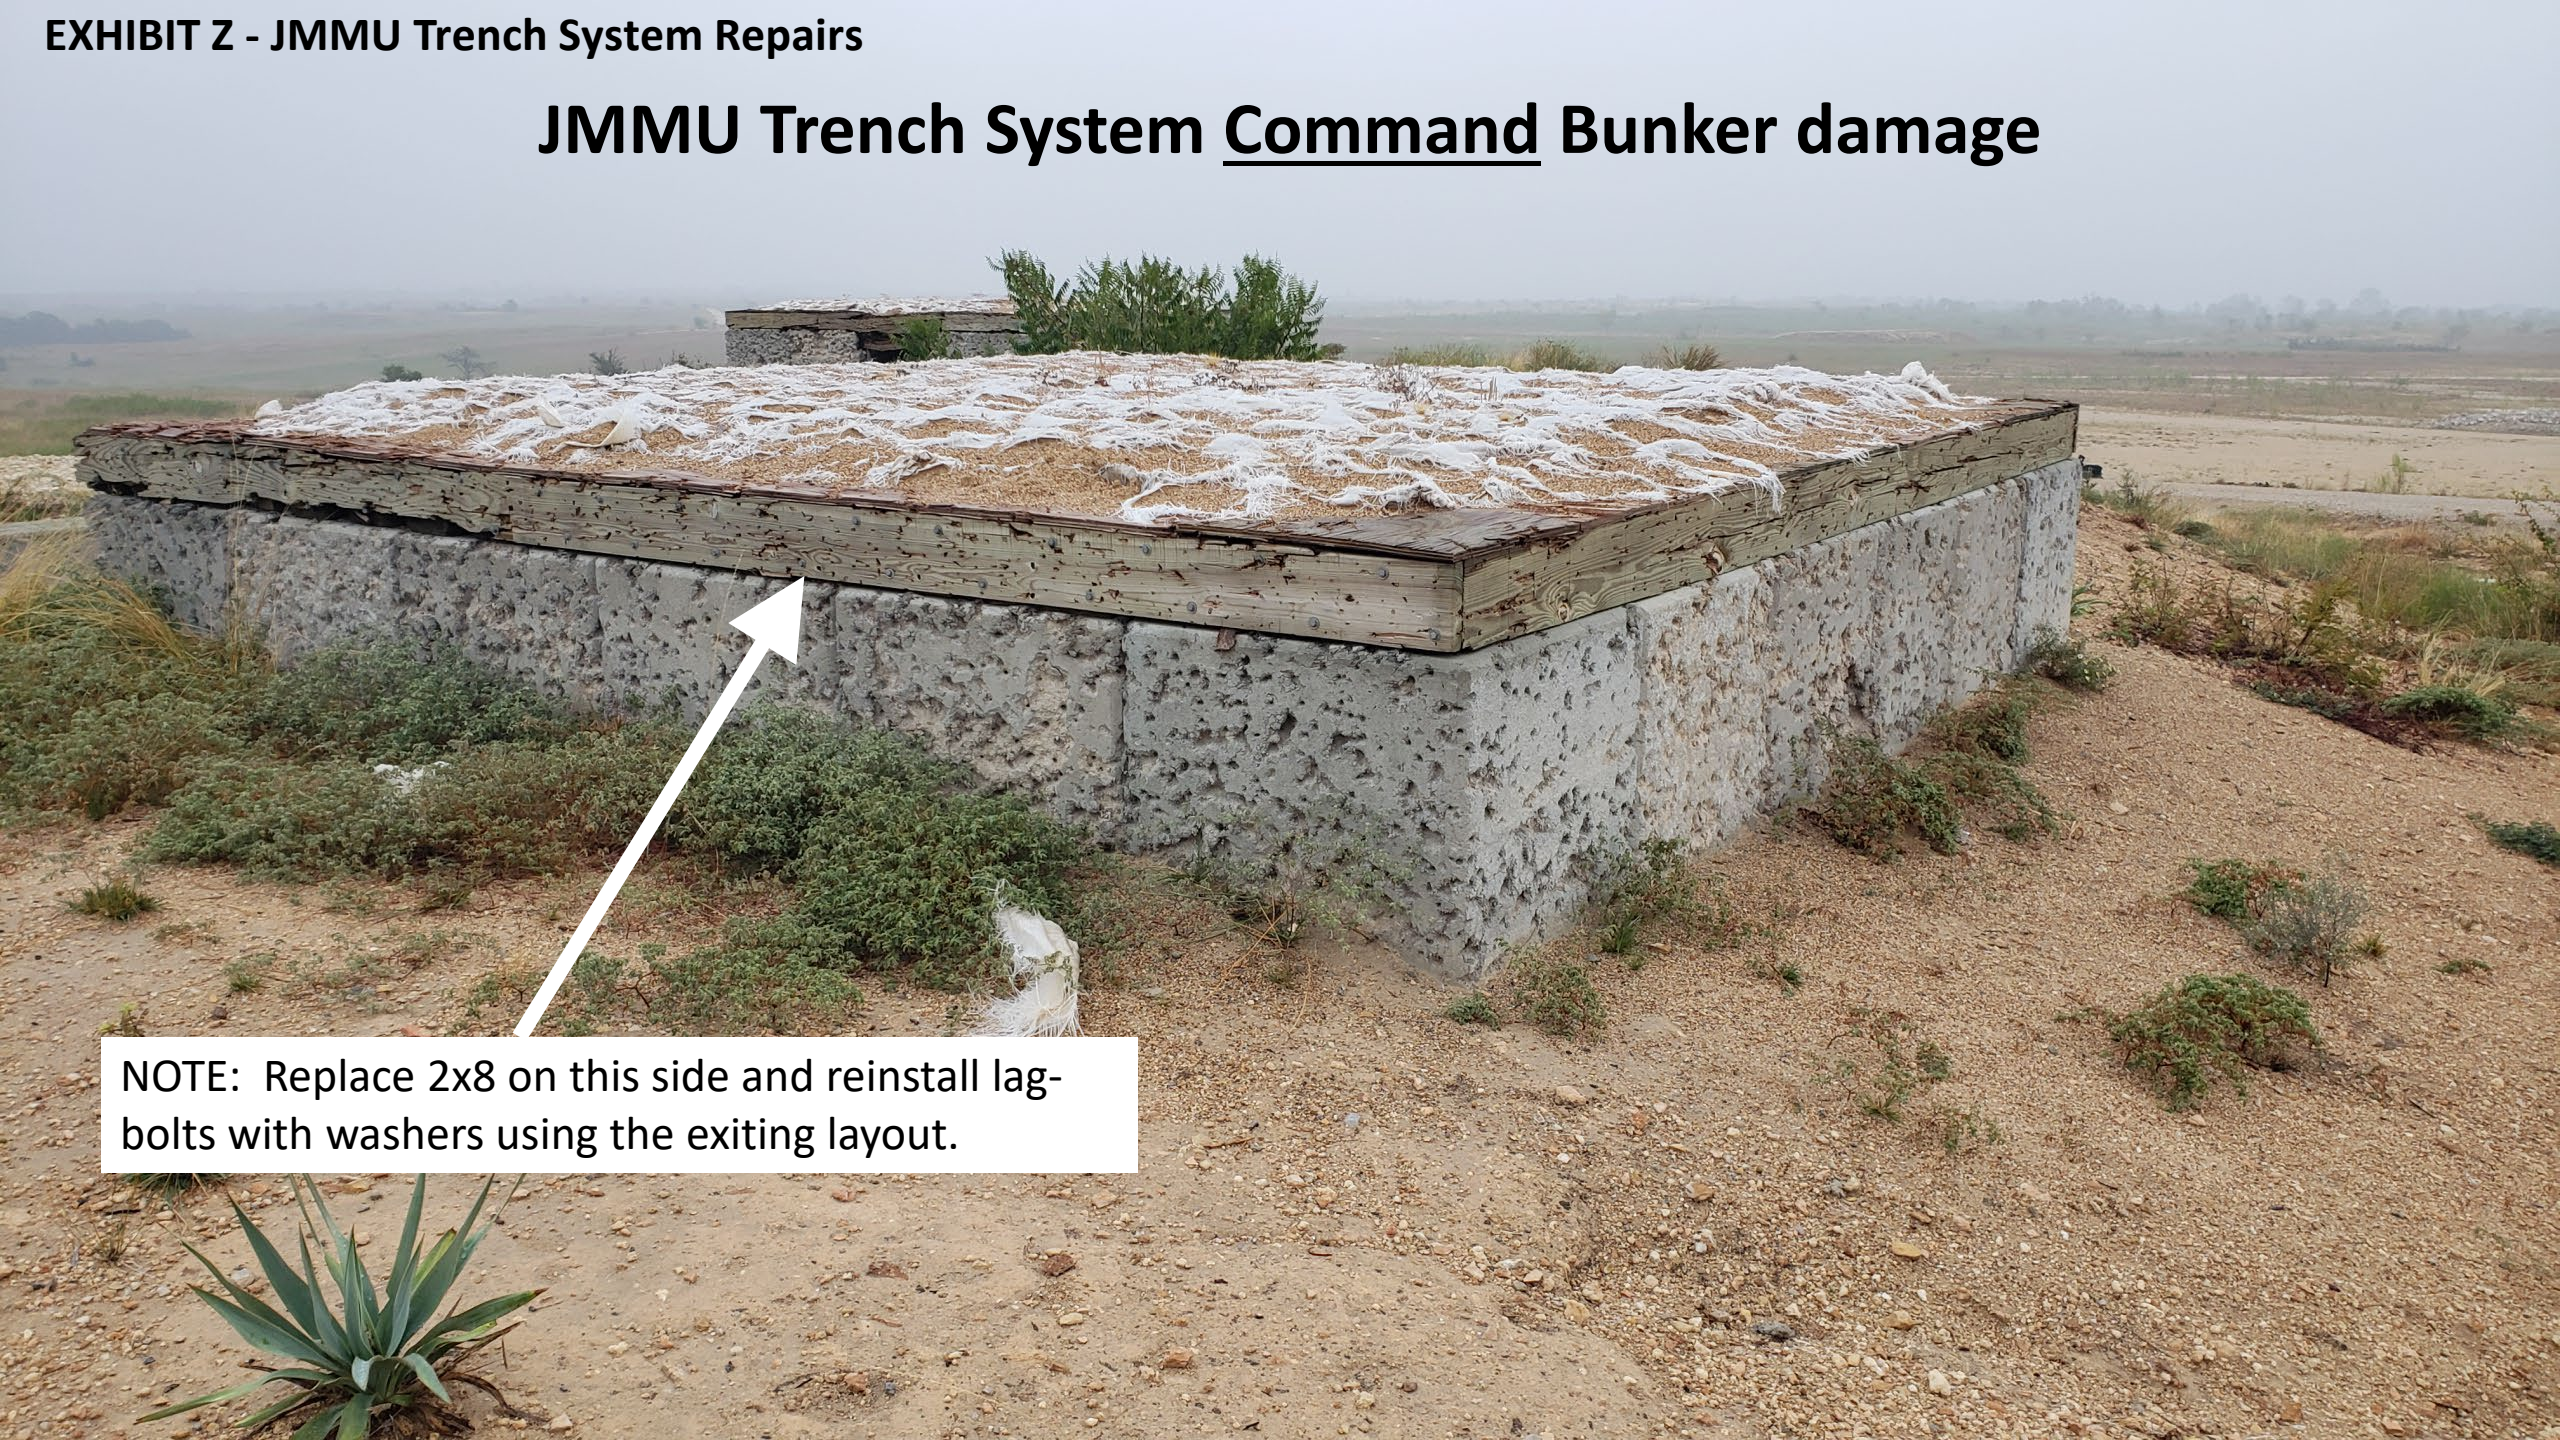
JMMU Trench System Command Bunker damage

JMMU Trench System Command Bunker with Superficial SACON Walls Protecting from Assault Side.

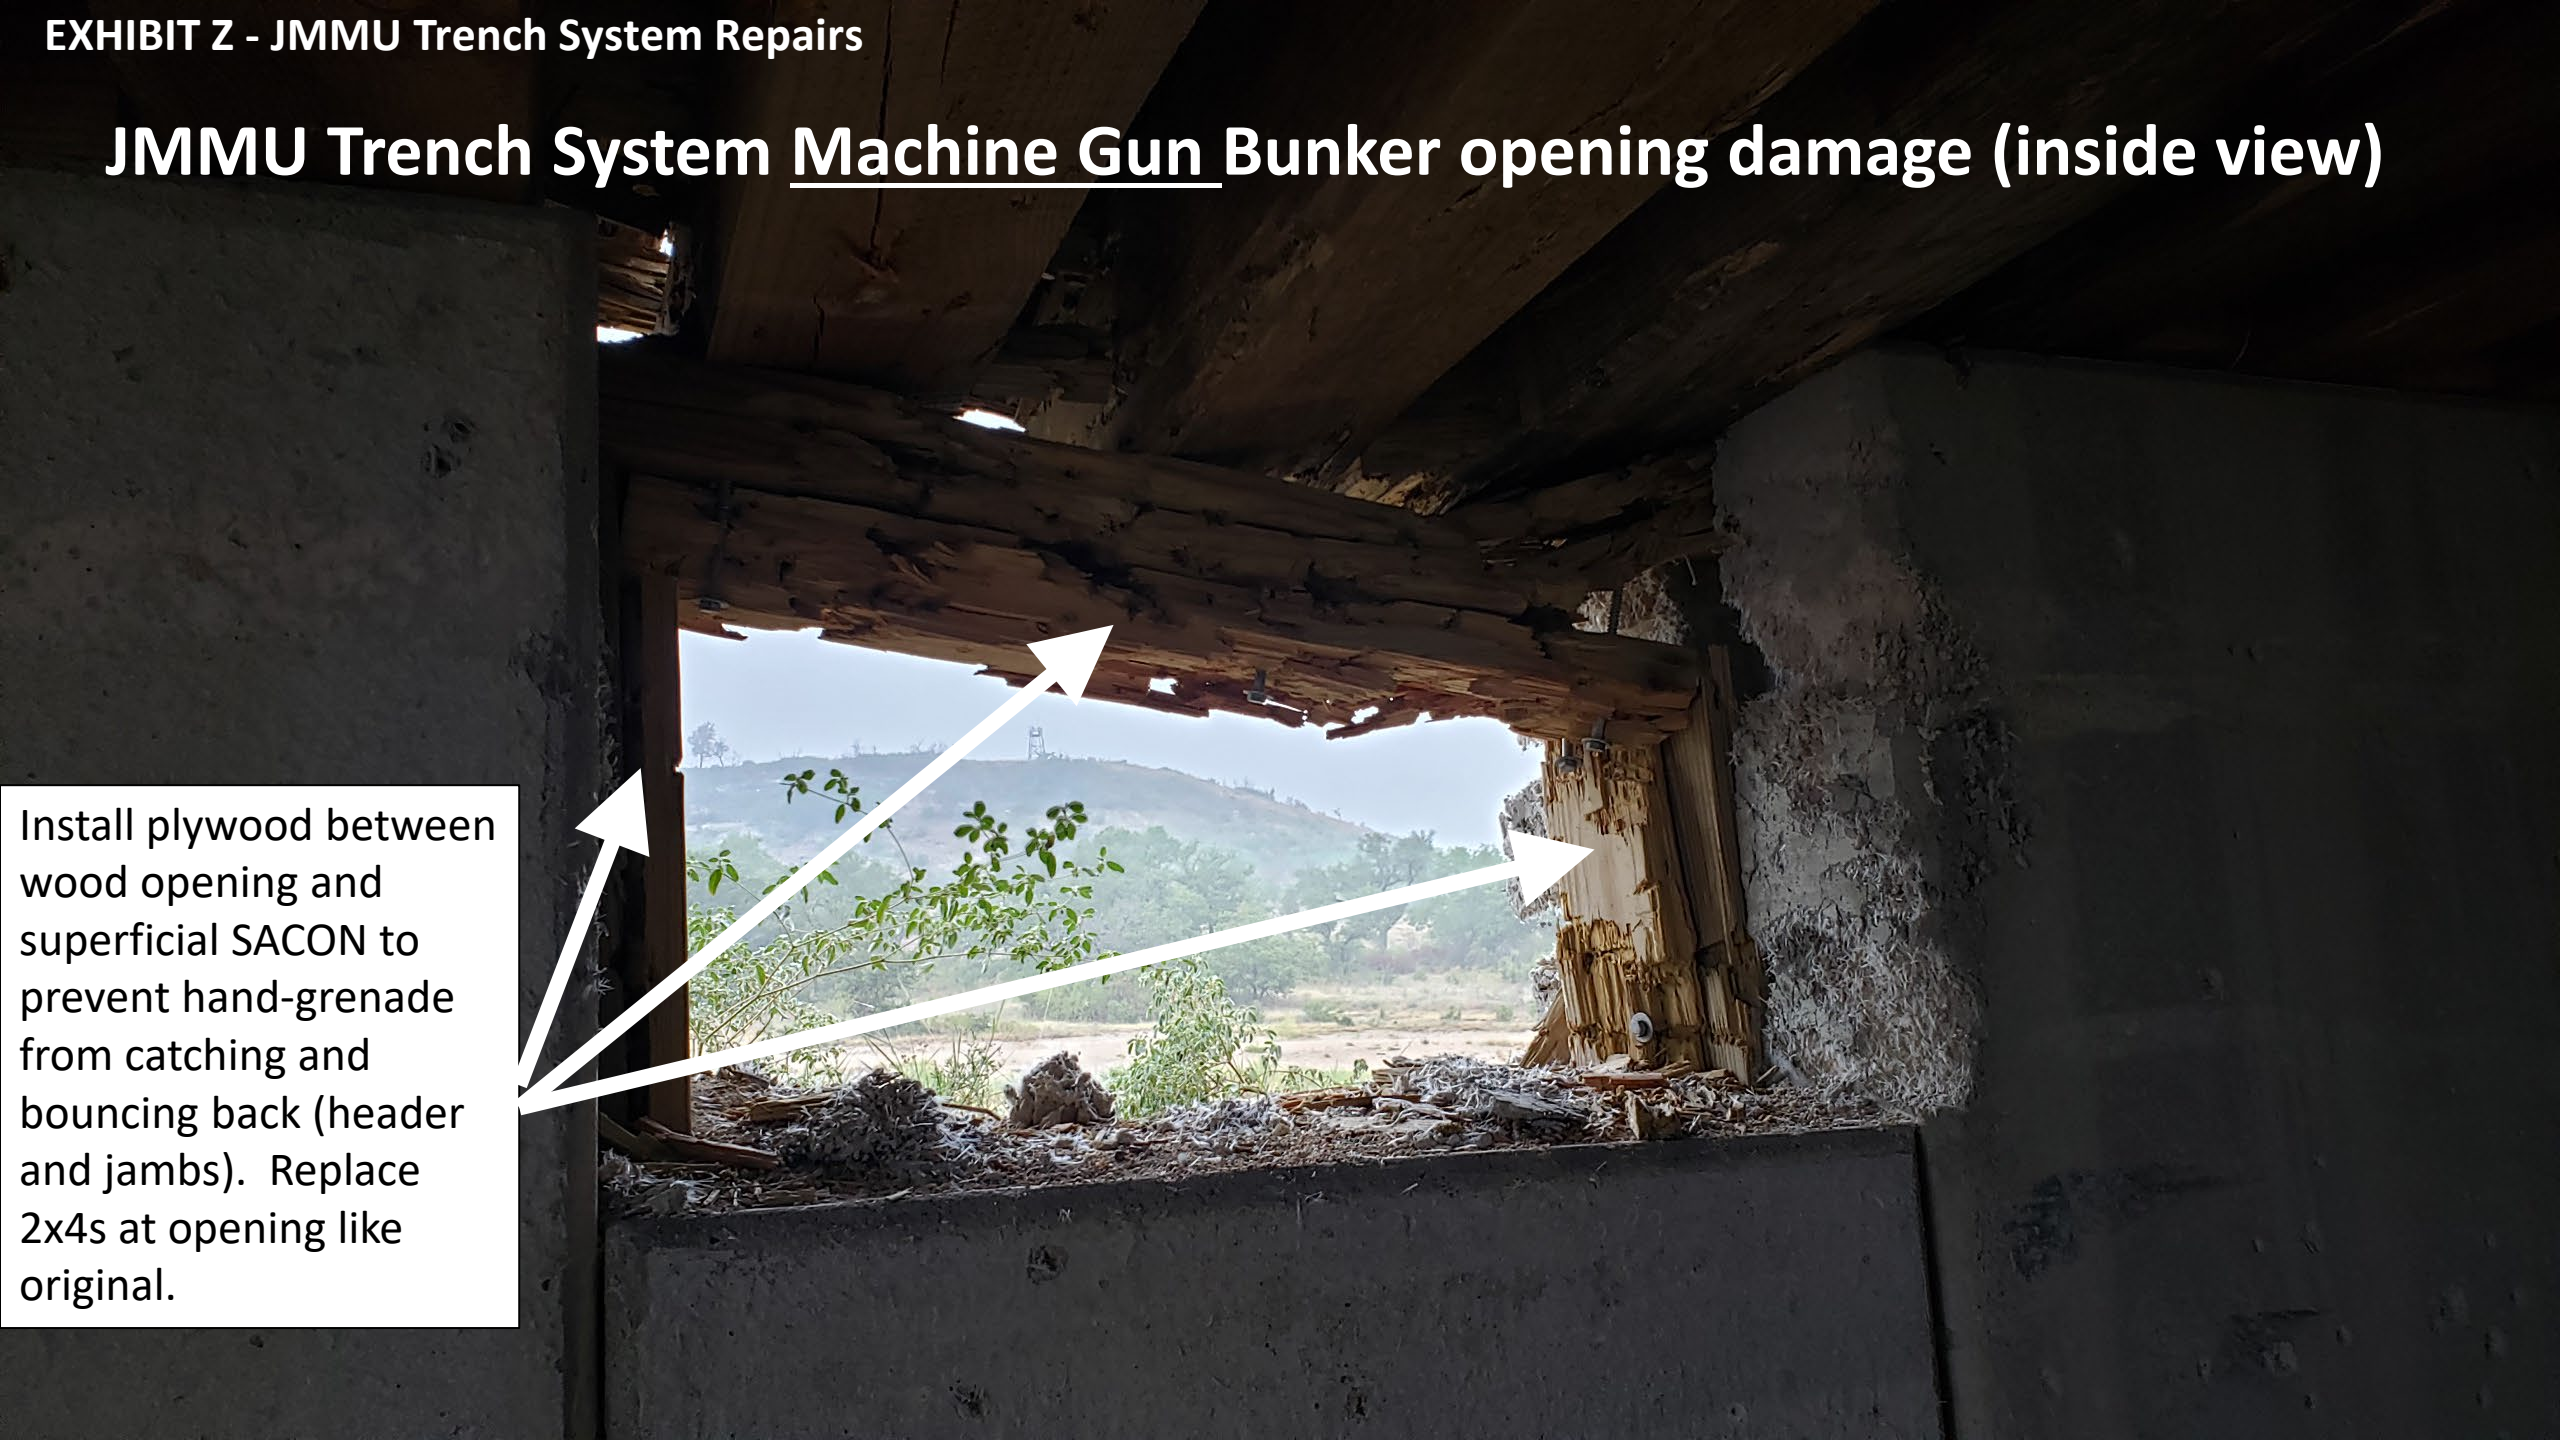
JMMU Trench System Machine Gun Bunker opening damage (outside view)

JMMU Trench System Machine Gun Bunker opening damage (inside view)

Install plywood between wood opening and superficial SACON to prevent hand-grenade from catching and bouncing back (header and jambs). Replace 2x4s at opening like original.
