TECHNICAL EXHIBIT #4

HANGAR 32 ELECTRICAL INSPECTION - MCKINSTRY CO

PROJECT: HANGAR 32 ELECTRICAL PLANS

PROJECT #: WRC-G-22-01
DATE: 12/20/23
DRAWN BY: JV
SHEET NO: E6.01

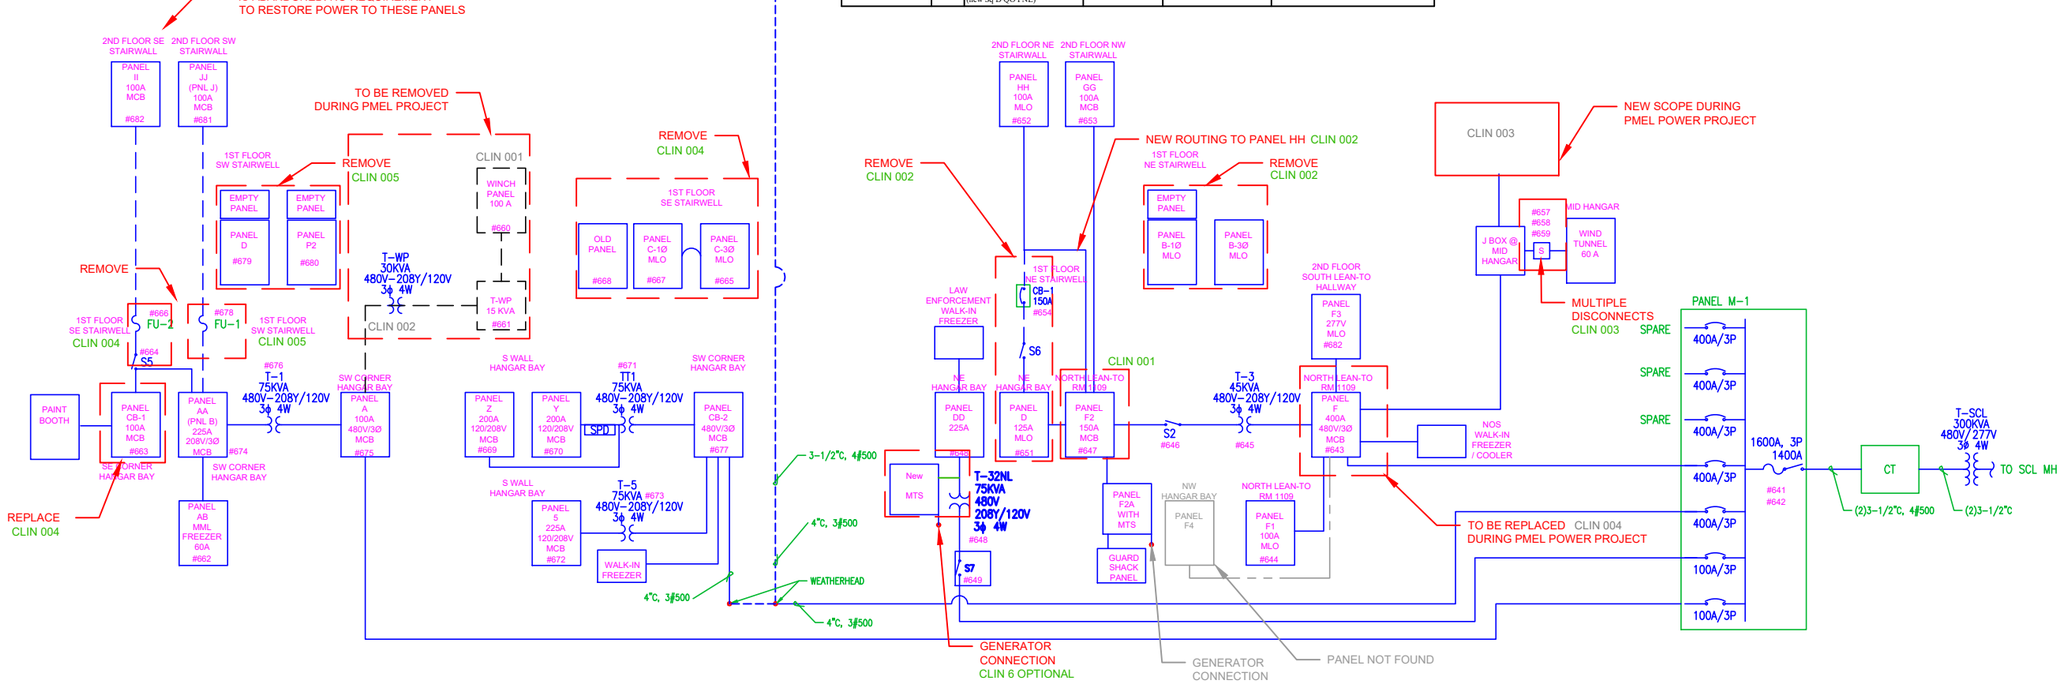
1 ED600 HANGAR 32 SINGLE-LINE DIAGRAM - POWER
SCALE: NONE

LOCATION	"ID TAG #"	EQUIPMENT DESCRIPTION	RECOMMENDED ACTION	McK REMARKS	NOAA REMARKS FOR ADDITIONAL CLIN WORK
Bldg. 32 NW Corner/Room 112	641	Switchboard 800A Fused – 480V 3PH, 4W	NONE		
Bldg. 32 NW Corner/Room 112	642	Switchboard 800A Fused – 480V, 3PH, 4W	NONE		
Bldg. 32 NW Corner/Room 109	643	PNL-F 400A Main Breaker,480V, 3PH, 4W	NONE	(5)K.O. Seals needed - Very Old, Remove/Replace	Replacing in PMEL Power Project
Bldg. 32 NW Corner/Room 109	644	PNL-F1 Main Lug 100A, 480V, 3PH, 4W	NONE		
Bldg. 32 NW Corner/Room 109	645	45 KVA Transformer 480V?208V	NONE		
Bldg. 32 NW Corner/Room 109	646	Disconnect S-2 , 150A, 208V, 3PH Feeds PNL-F2	NONE	Very Old, Remove/Replace	Remove
Bldg. 32 NW Corner/Room 109	647	PNL-F2 150A Main Breaker, 208V, 3PH, 4W	NONE	"K.O. seals needed, 3",1",3/4", ½" CKT-26,28,30 has 2wires per, wrong size wire for 100A 3-pole"	Repair
Bldg. 32 - NE Corner	648	"PNL-DD Main Lug 120/208V, 3PH, 4W Fed from 75KVA Transformer"	NONE	Panel does not have main breaker or disconnecting means. Needs ½" K.O. seal	Repair as part of new MTS for generator connection

Bldg. 32 - NE Corner	649	Disconnect T-32NL 100A 480V, 3PH, 3W	NONE	"Disconnect is not fused, missing bushing on line side, missing mounting screws to hold to wall. Fed from?"	Repair as part of new MTS for generator connection
Bldg. 32 - NE Corner	650	75 KVA Transformer	NONE		
Bldg. 32 - NE Corner	651	PNL-D 125A 120/208V, 3PH, 4W	NONE	Main lugs used to splice #2 and #6 STR copper conductors. Fed from?	Remove
Bldg. 32 - NE Stair – 2nd Floor	652	PNL-HH 100A 120/208V 3W	Low Grade Fault	"CKT-18 To be monitored – Plan new inspection within 90 days Dan Krigsvold removed hot breaker(#18), Re-terminated wire to ckt-20"	Review for repair
Bldg. 32 - NE Stair – 2nd Floor	653	PNL-GG 100A 120/208V 3W	NONE		
Bldg. 32 - NE Stair – 2nd Floor	654	150A Breaker Feeds Security Fed from Panel D (splice box)	NONE	Very old – Plexiglass cover Remove/Replace - Wrong size wire	Remove
Bldg. 32 – Center - West	655	PNL-K 225A 3PH, 4W	NONE	Old – Remove/Replace Many code violations	Removed in BiB Demo

Bldg. 32 – Center - West	656	75 KVA Transformer T-2 480V?208V	NONE		Removed in BiB Demo
Bldg. 32 – South of Center	657	60A Disconnect 480V, 3PH (Rope Strength Tester)	NONE	"Code Violations – wire size too small (2)#10 wires on each lug of load side"	Repair
Bldg. 32 – South of Center	658	Disconnect 60A 480V, 3PH	NONE	"Code Violations-#12AWG Doubled up w/#6AWG on Line side lugs. Remove/Replace"	Repair
Bldg. 32 – South of Center	659	Disconnect 30A 480V, 3PH	NONE	Code Violations- 250V fuses, Remove/Replace – Very old	Repair
Bldg. 32 – South of Center – West wall	660	"100A PNL, 120/208V, 3PH, 4W (new Sq D PNL fed from 30KVA XFMR)"	NONE		
Bldg. 32 – South of Center – West wall	661	30 KVA Transformer 480V?120/208V	NONE		
Bldg. 32 - SE (Brown Structure)	662	"PNL- AB 125A 120/208V 3PH, 4W, Main Lug (new Sq D QO PNL)"	NONE	Code Violation- needs correct lug (#4-#14AWG) for ground.	Repair

LOCATION	"ID TAG #"	EQUIPMENT DESCRIPTION	RECOMMENDED ACTION	McK REMARKS	NOAA REMARKS FOR ADDITIONAL CLIN WORK
Bldg. 32 - SE	663	PNL-CB1 100A, 208V, 4W, Main Breaker	NONE		Relocate for proper access
Bldg. 32 - SE	664	Disconnect S-5 125A Fused, 208V, 3PH,	NONE	"Code Violation-Line side lugs not rated for (2)#2AWG, Load side not rated for #6 and #2AWG- Very old – Remove/Replace"	Remove / Replace if needed
Bldg. 32 – SE Stair Room 132C	665	PNL-C 3PH, Sub to P2	NONE	Very old, Remove/Replace	Remove - unclear if this has lighting circuits
Bldg. 32 – SE Stair Room 132C	666	FU-2 (2)100A Fuses 208V	NONE	Very old, Remove/Replace	Remove
Bldg.32	667	Light Panel C Single Phase Bottom Right	NONE	Very old, Remove/De-Energized	Remove - unclear if this has lighting circuits
Bldg.32	668	Panel Top Right (8)Glass Fuses 120/208V	NONE	Very old, Remove/Replace	Remove
Bldg.32	669	PNL-Z 200A, 120/208V, 3PH, 4W, Main Breaker	NONE

Bldg.32	670	PNL-Y 200A, 120/208V, 3PH, 4W, Main Breaker	NONE		
Bldg.	671	75 KVA Transformer TT1	NONE		
Bldg.32	672	PNL#5 225A, 120/208V	NONE		
Bldg.32	673	75 KVA Transformer #5 480?208V	NONE		
Bldg.32 - South Wall - West	674	"PNL-AA 225A, 120/208V, 3PH, 4W, Main Breaker"	NONE		
Bldg.32 - South Wall - West	675	PNL-A 100A 277/480V, 3PH, 4W, Main Breaker	NONE	"Code Violation- Line side main breaker (2)#4AWG on each lug"	Repair
Bldg.32 - South Wall - West	676	75 KVA Transformer T-1 480?208V	NONE	Top of transformer damaged	
Bldg.32 - South Wall - West	677	"PNL-CB2 400A, 277/480V, 3PH, 4W, Main Breaker"	NONE		
Bldg.32 SW Room 149D	678	PNL-FU-1 (2)150A Fuses 120/208V	NONE	Very old, Remove/Replace	Remove
Bldg.32 SW Room 149D	679	PNL-D	NONE	Very old - Remove – De-Energized	Remove
Bldg.32 SW Room 149D	680	PNL-P2	NONE	Very old - Remove – De-Energized	Remove
Bldg.32 - SW - Stair – 2nd floor	681	PNL-JJ 100A 1PH, 3W, 120/208V, Main Breaker	NONE	Splices in panel	Investigate for repair

Bldg.32-South-2nd floor-Hall/Center	682	PNL-F3 100A 277/480V, 3PH, 4W, Main Lugs	NONE	"Code Violation- 480V PNL w/ 120/208V colors(Blk,Rd,Blu)"	Change marking on panel to conform with code.
