Hazardous Materials Investigation Report
Grand Canyon South Rim Wastewater Treatment Plant

Task Order #148045100

CJSeto Project #2910

November 2023

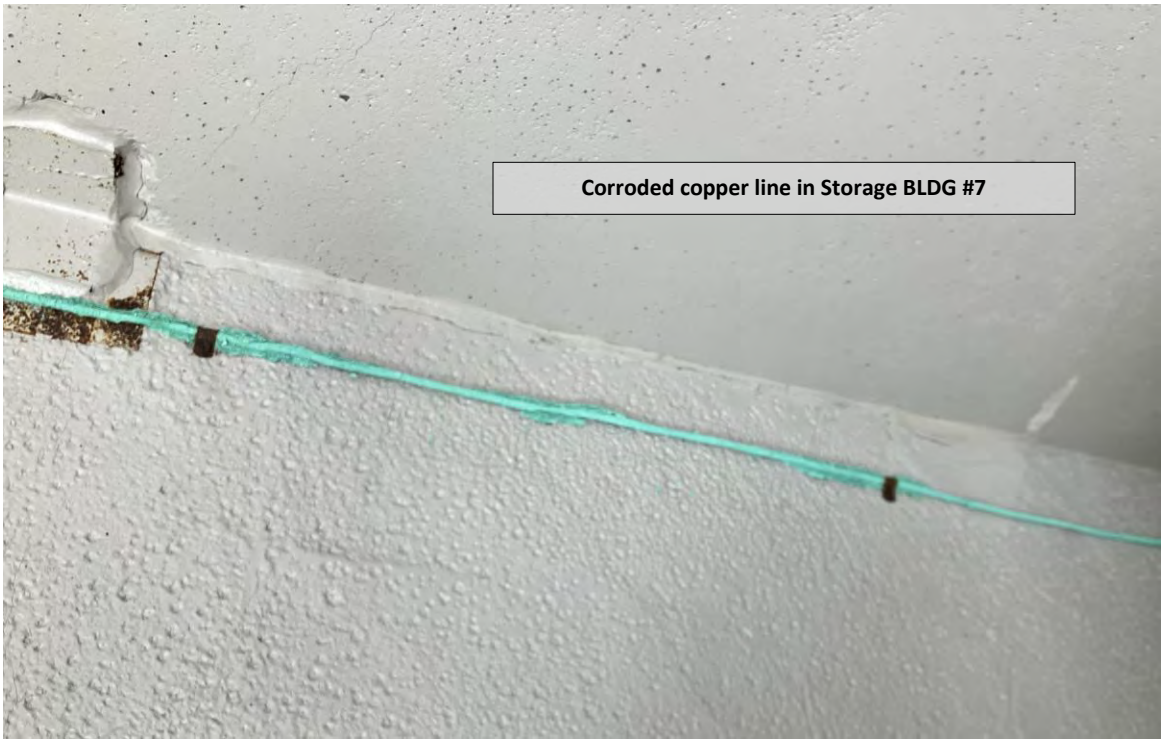
4) Corroded copper in Storage BLDG #7 (Sodium bisulfate storage)

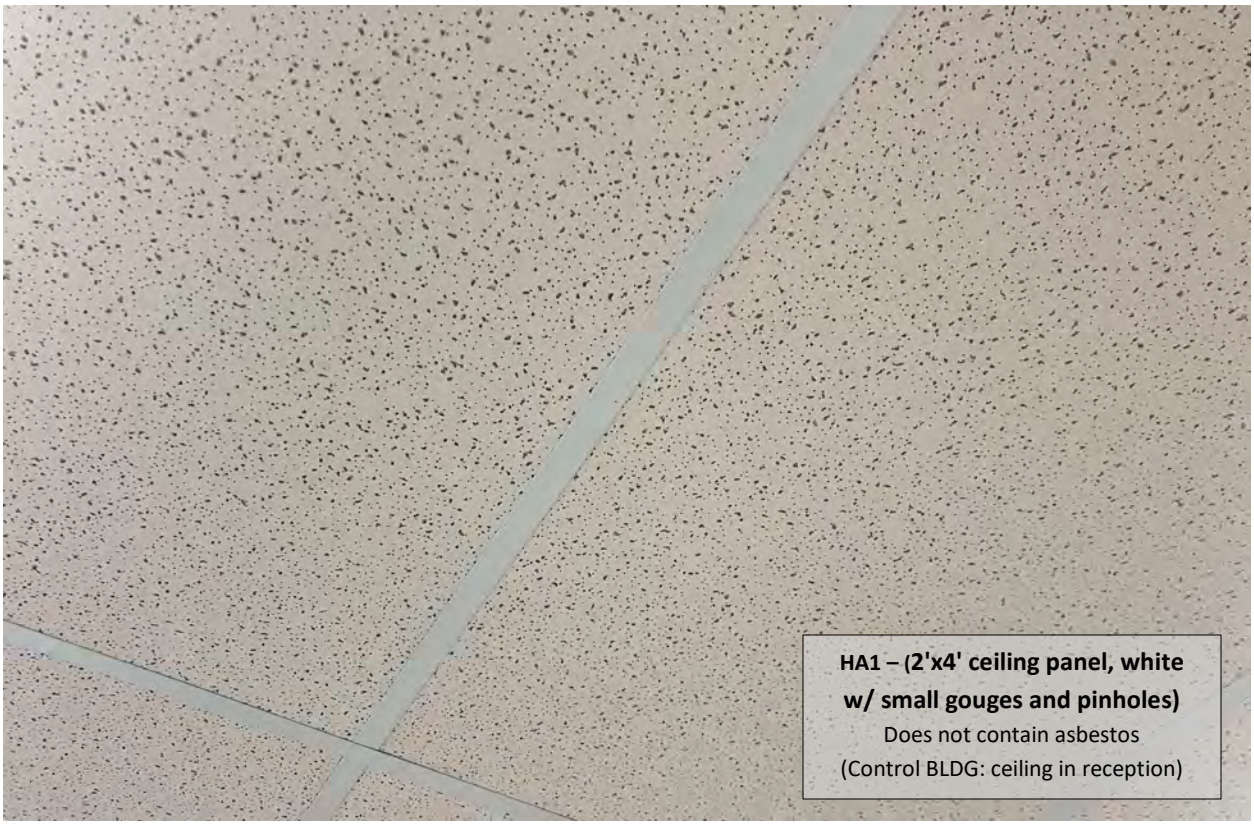
HA1 – (2'x4' ceiling panel, white w/ small gouges and pinholes)
Does not contain asbestos
(Control BLDG: ceiling in reception)

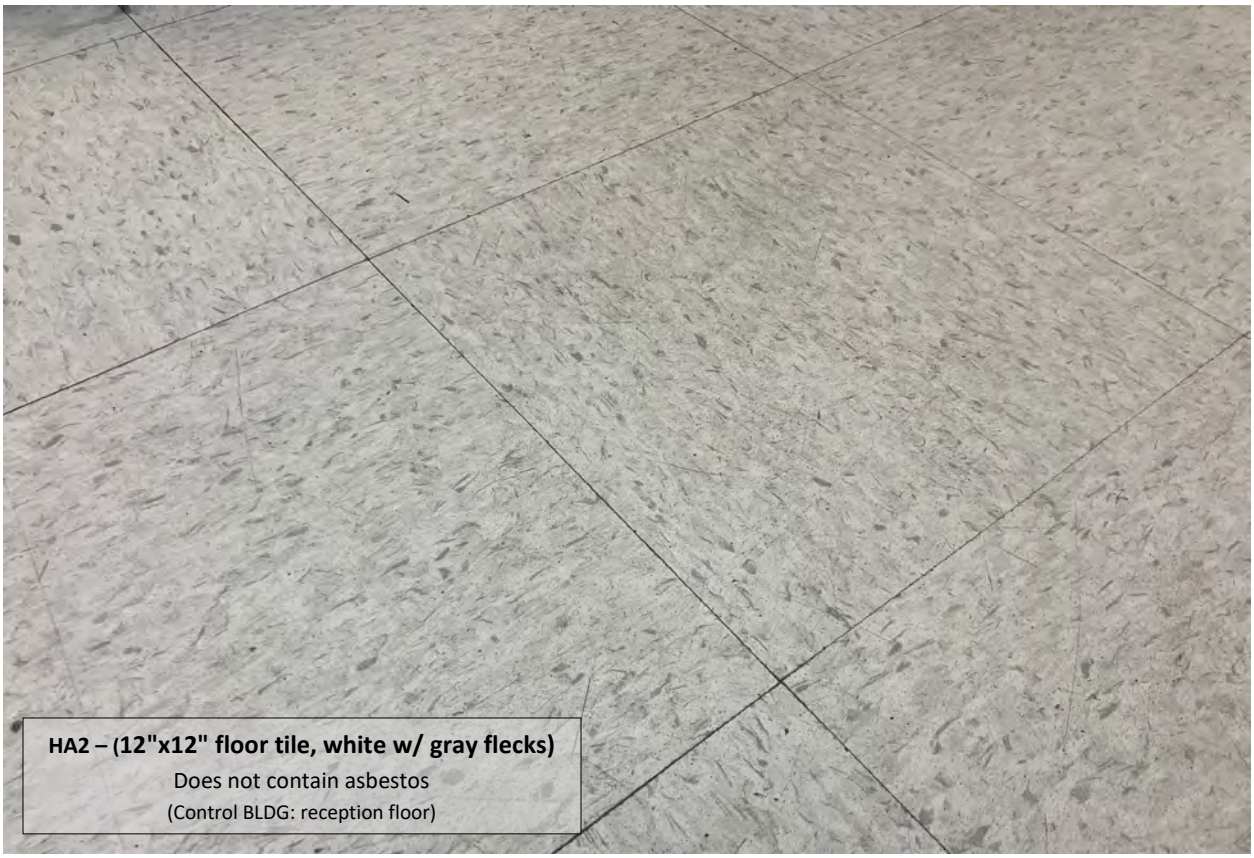
HA2 – (12"x12" floor tile, white w/ gray flecks)
Does not contain asbestos
(Control BLDG: reception floor)

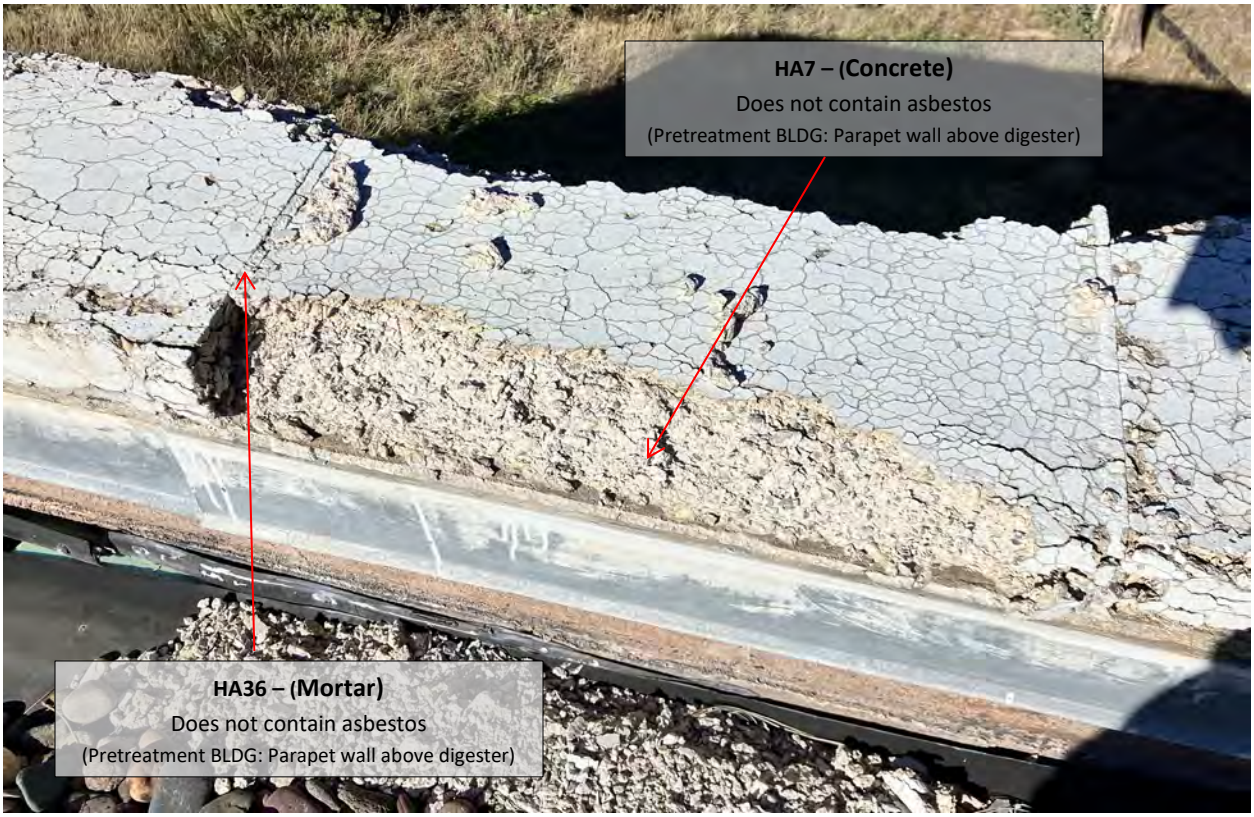
HA7 – (Concrete)
Does not contain asbestos
(Pretreatment BLDG: Parapet wall above digester)
HA36 – (Mortar)
Does not contain asbestos
(Pretreatment BLDG: Parapet wall above digester)

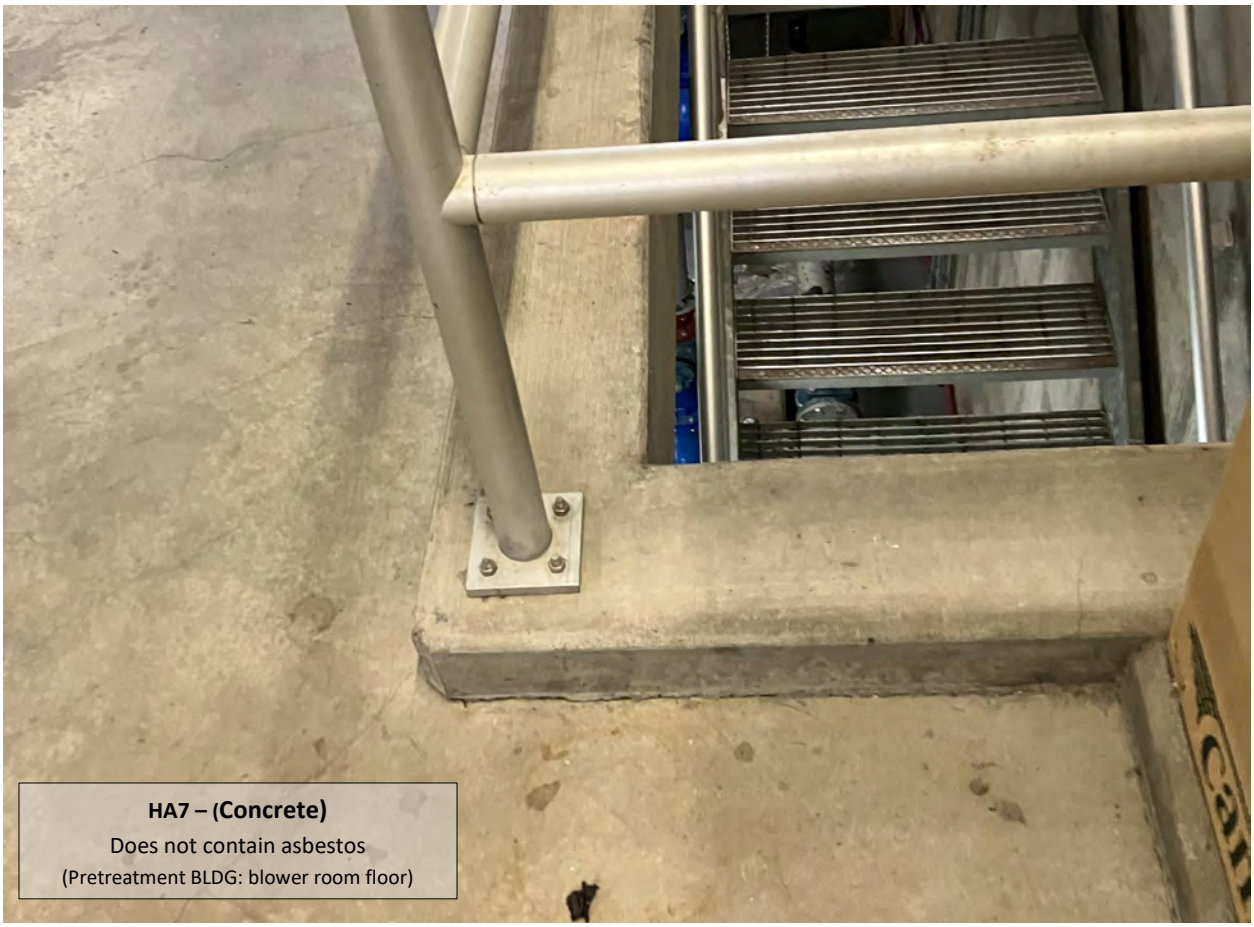
HA7 – (Concrete)
Does not contain asbestos
(Pretreatment BLDG: blower room floor)

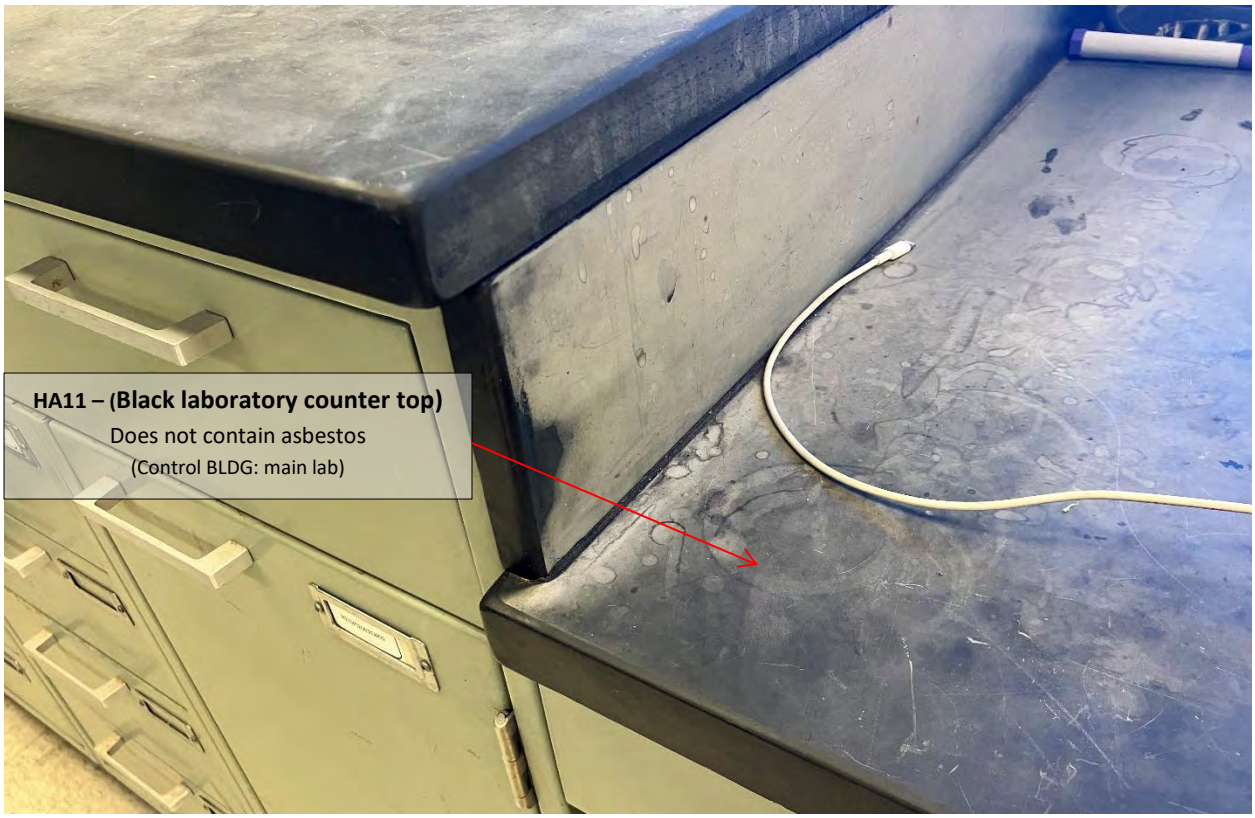
HA11 – (Black laboratory counter top)
Does not contain asbestos
(Control BLDG: main lab)

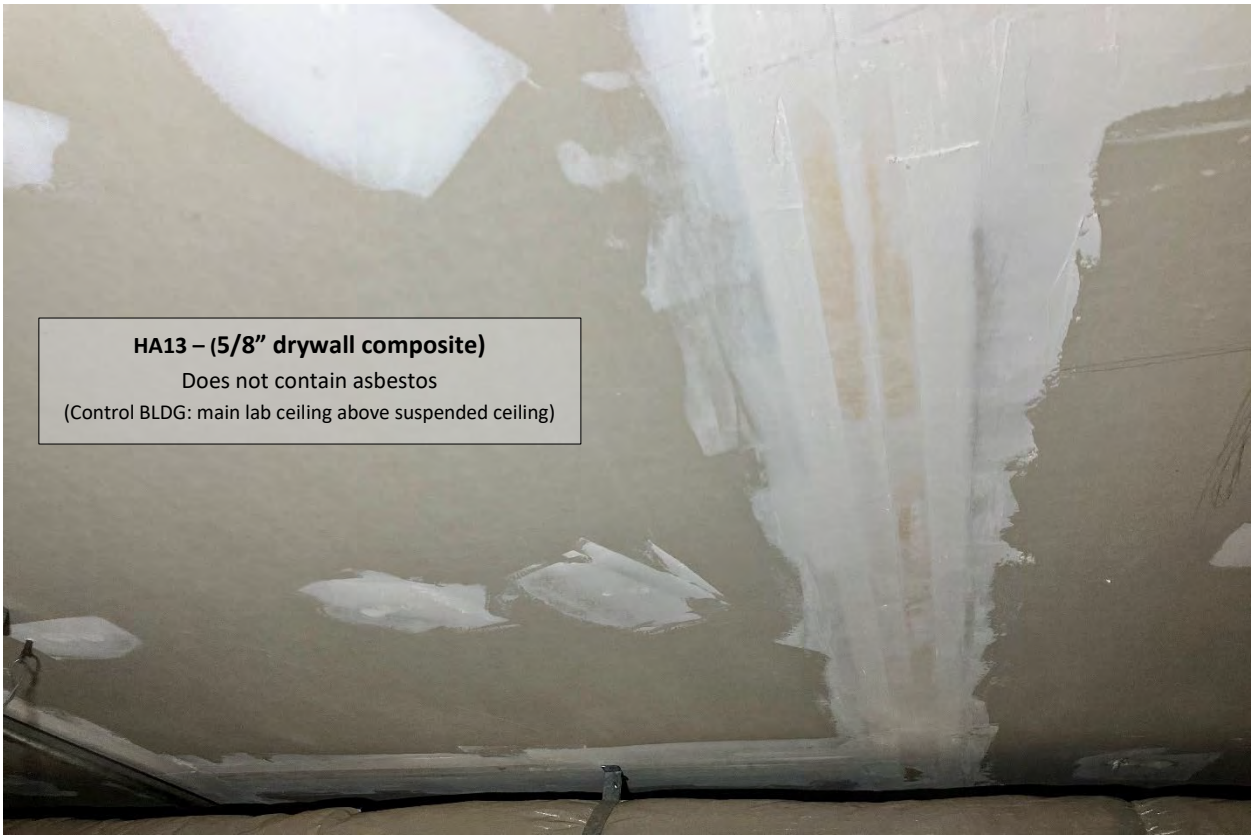
HA13 – (5/8" drywall composite)
Does not contain asbestos
(Control BLDG: main lab ceiling above suspended ceiling)

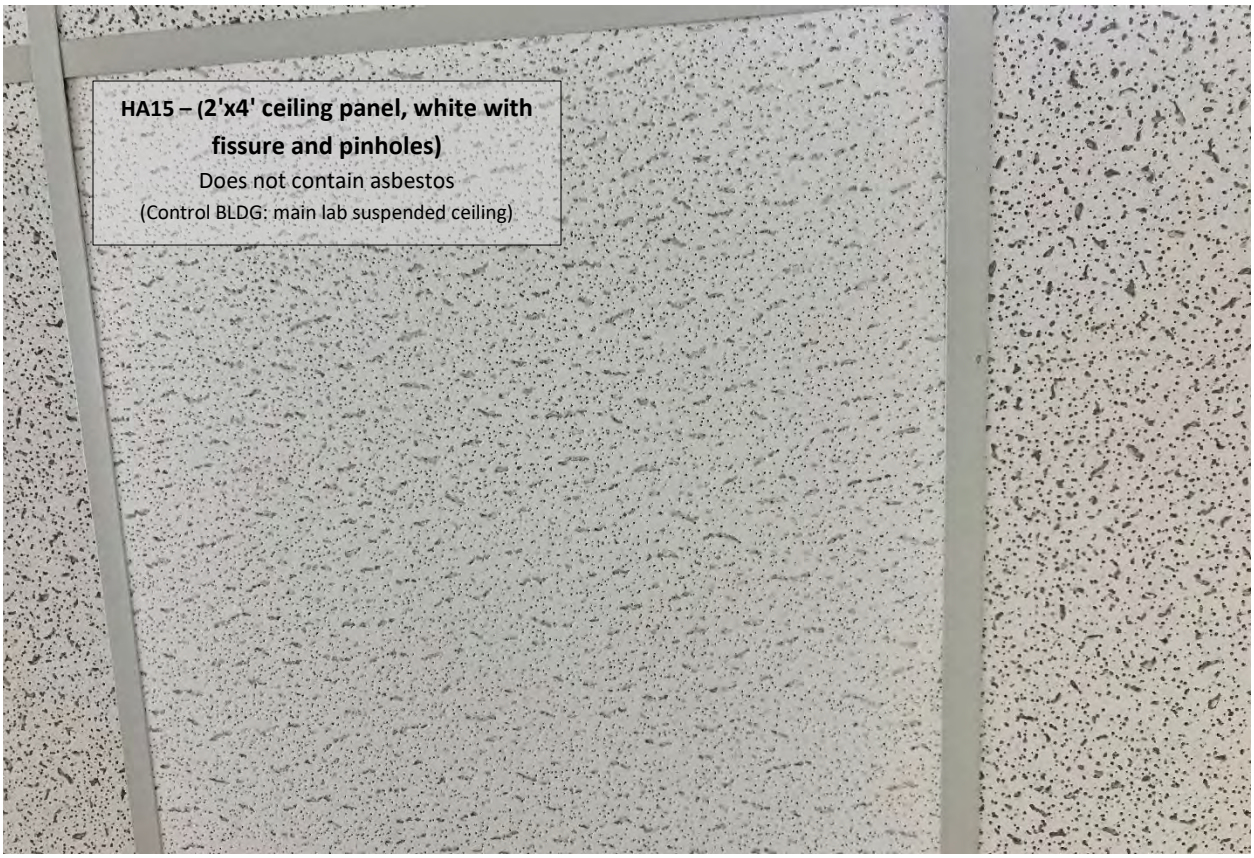
HA15 – (2'x4' ceiling panel, white with fissure and pinholes)
Does not contain asbestos
(Control BLDG: main lab suspended ceiling)

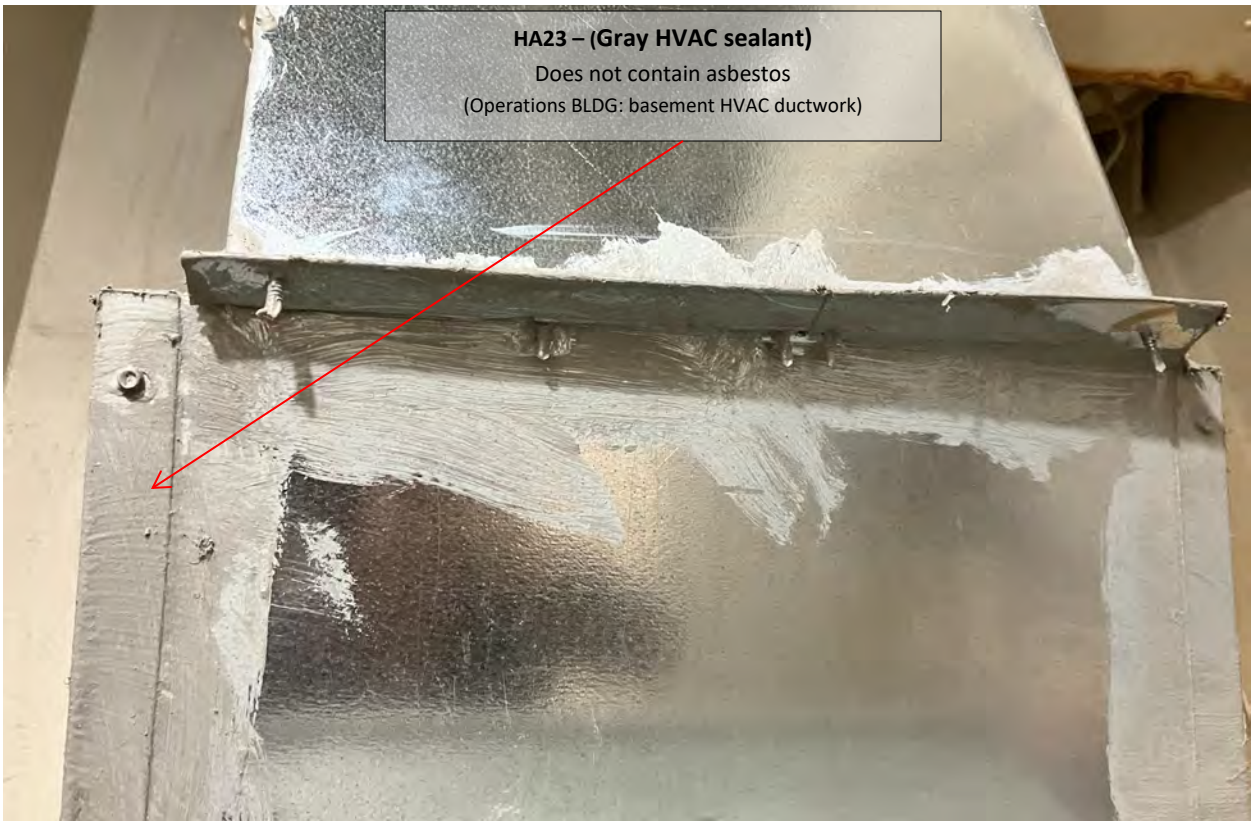
HA23 – (Gray HVAC sealant)
Does not contain asbestos
(Operations BLDG: basement HVAC ductwork)

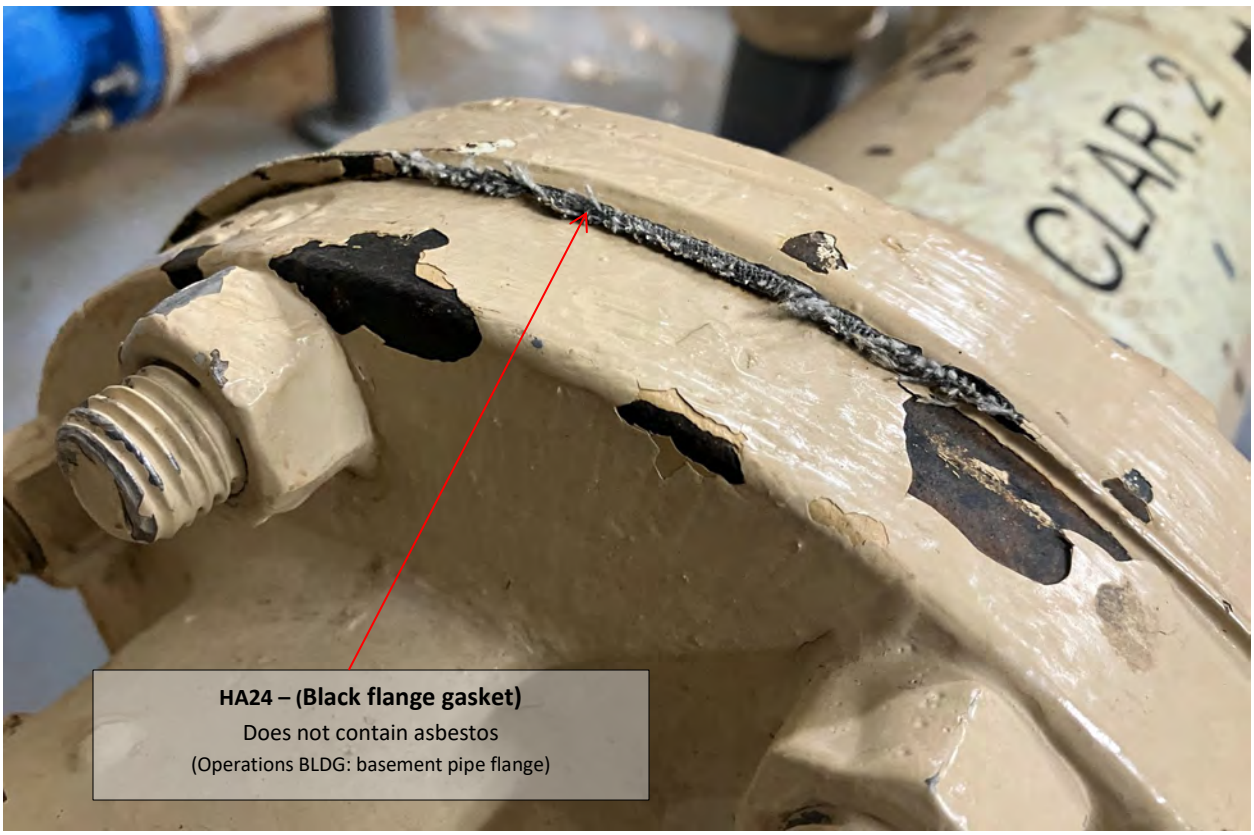
CLAR 2
HA24 – (Black flange gasket)
Does not contain asbestos
(Operations BLDG: basement pipe flange)

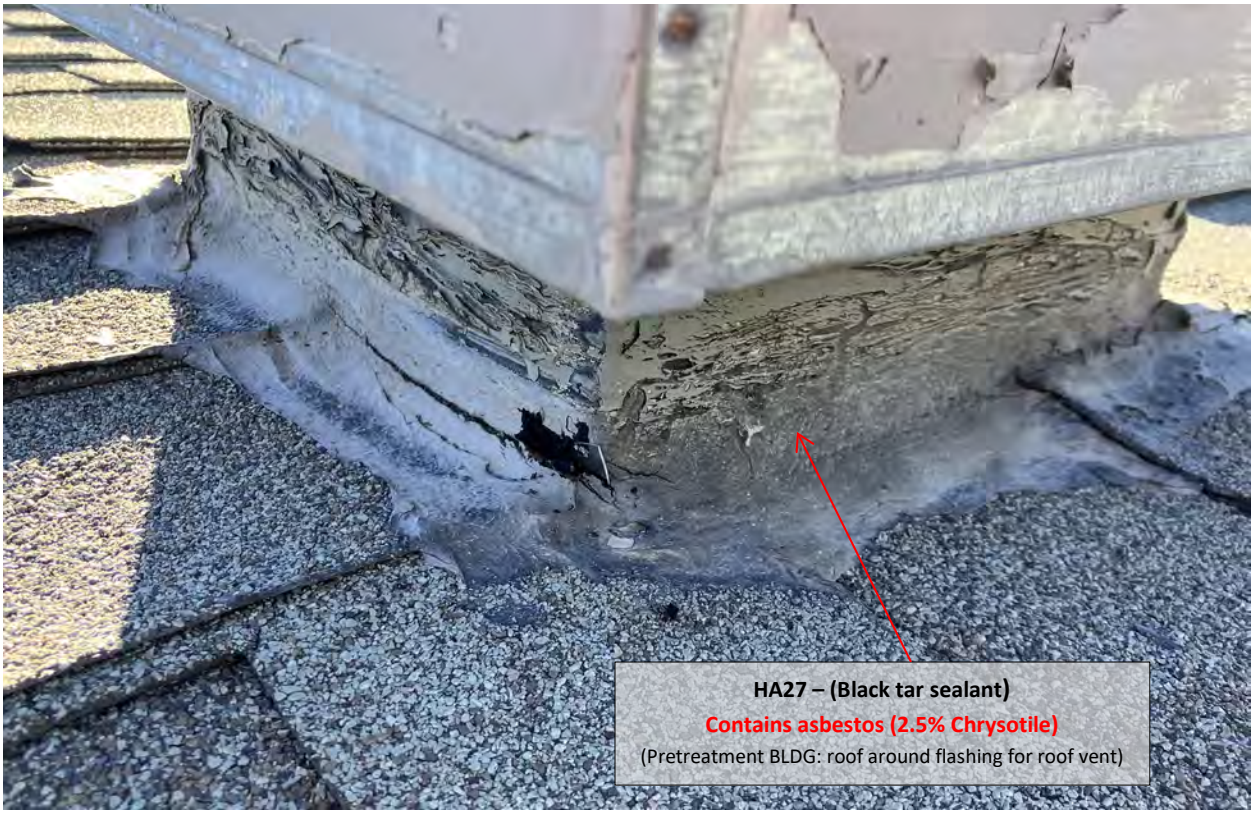
- *Black tar sealant over flashing around roof penetrations on Control BLDG, Pretreatment BLDG, and Storage BLDG #6 – contains 2.5% Chrysotile asbestos.*

HA27 – (Black tar sealant)
Contains asbestos (2.5% Chrysotile)
(Pretreatment BLDG: roof around flashing for roof vent)

The following ACM may remain in/on the building during demolition/renovation as long as the following apply: the materials to which ACMs are adhered (concrete/wood/metal) are not recycled/reclaimed; the ACMs are removed intact and are declared and disposed of at a construction and demolition (C&D) or asbestos landfill; and the materials are not subjected to cutting, grinding, scraping, abrading, sanding, burning (torch cutting), drilling or any other action that may render the materials friable or create resultant dust that may become airborne: Local and state regulations may require stricter protocols.

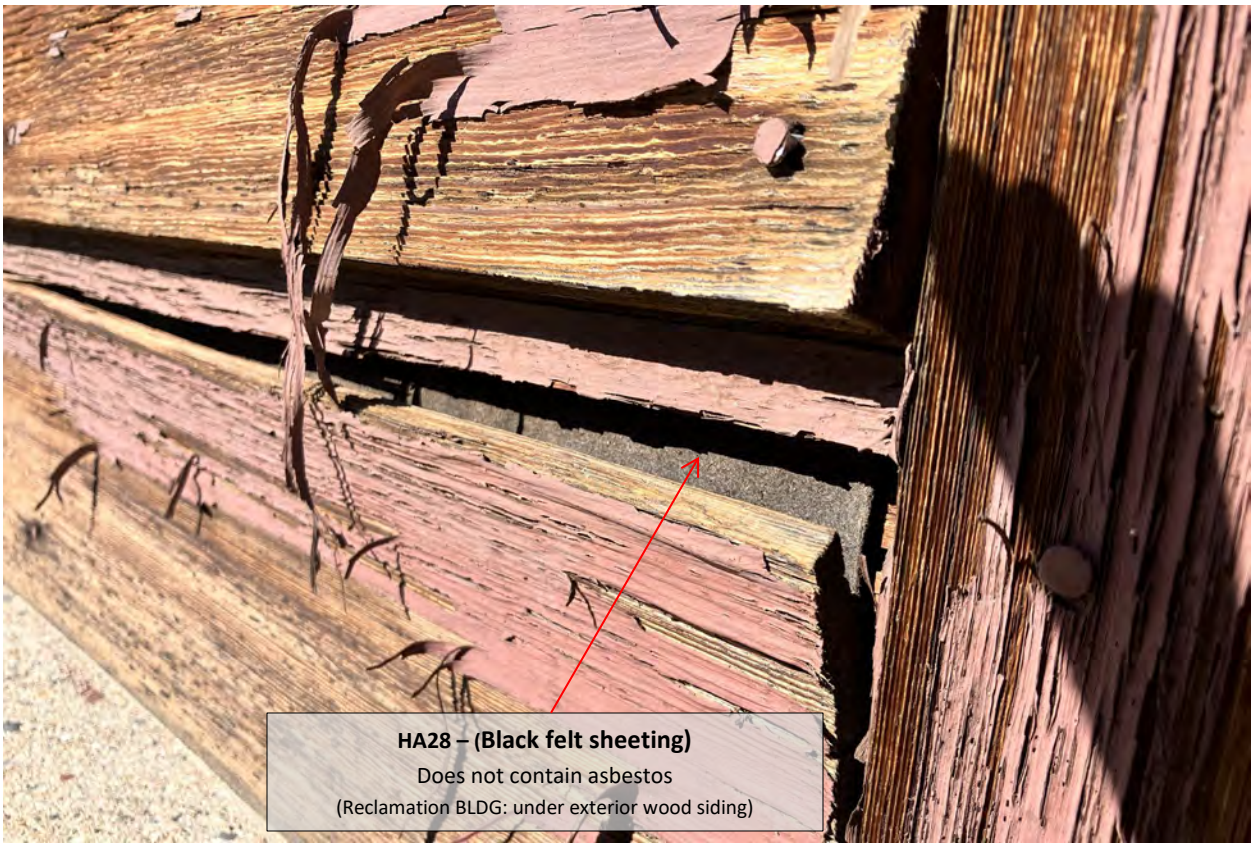
HA28 – (Black felt sheeting)
Does not contain asbestos
(Reclamation BLDG: under exterior wood siding)

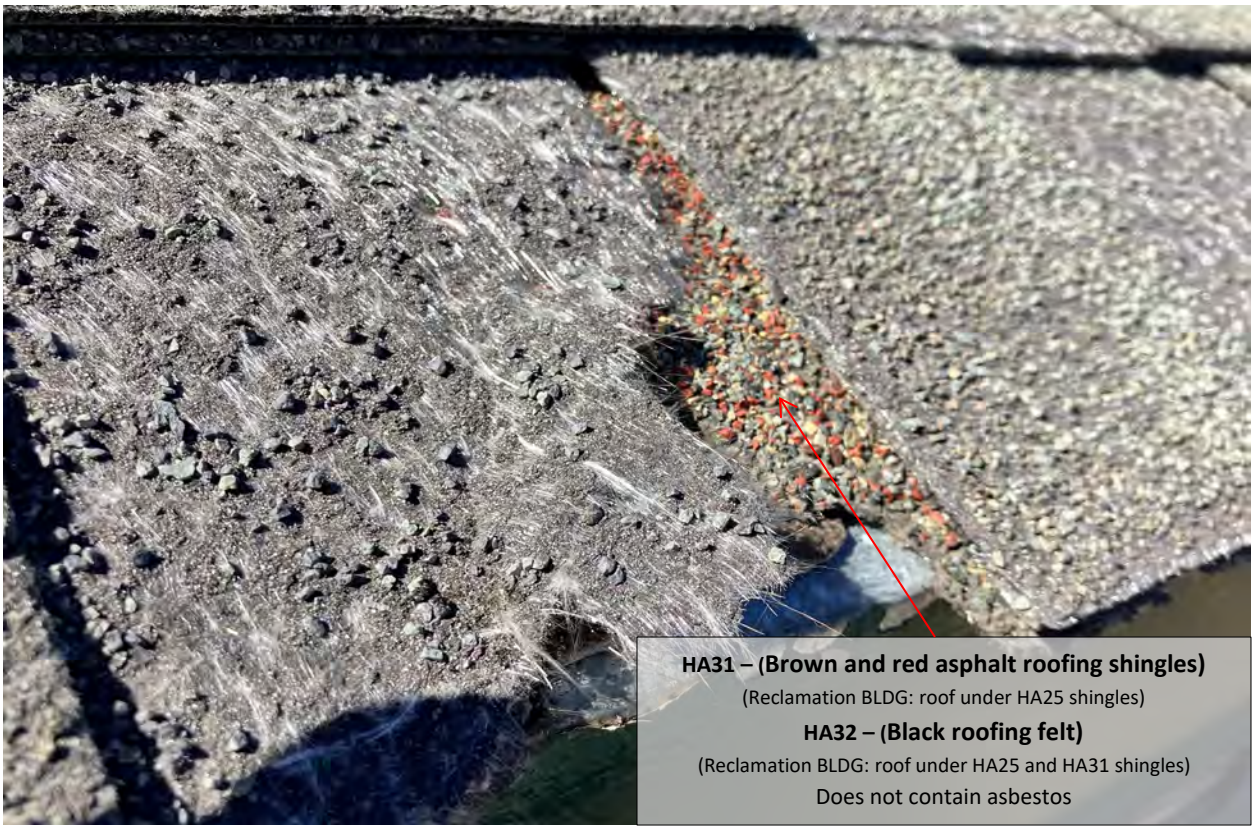
HA31 – (Brown and red asphalt roofing shingles)
(Reclamation BLDG: roof under HA25 shingles)
HA32 – (Black roofing felt)
(Reclamation BLDG: roof under HA25 and HA31 shingles)
Does not contain asbestos

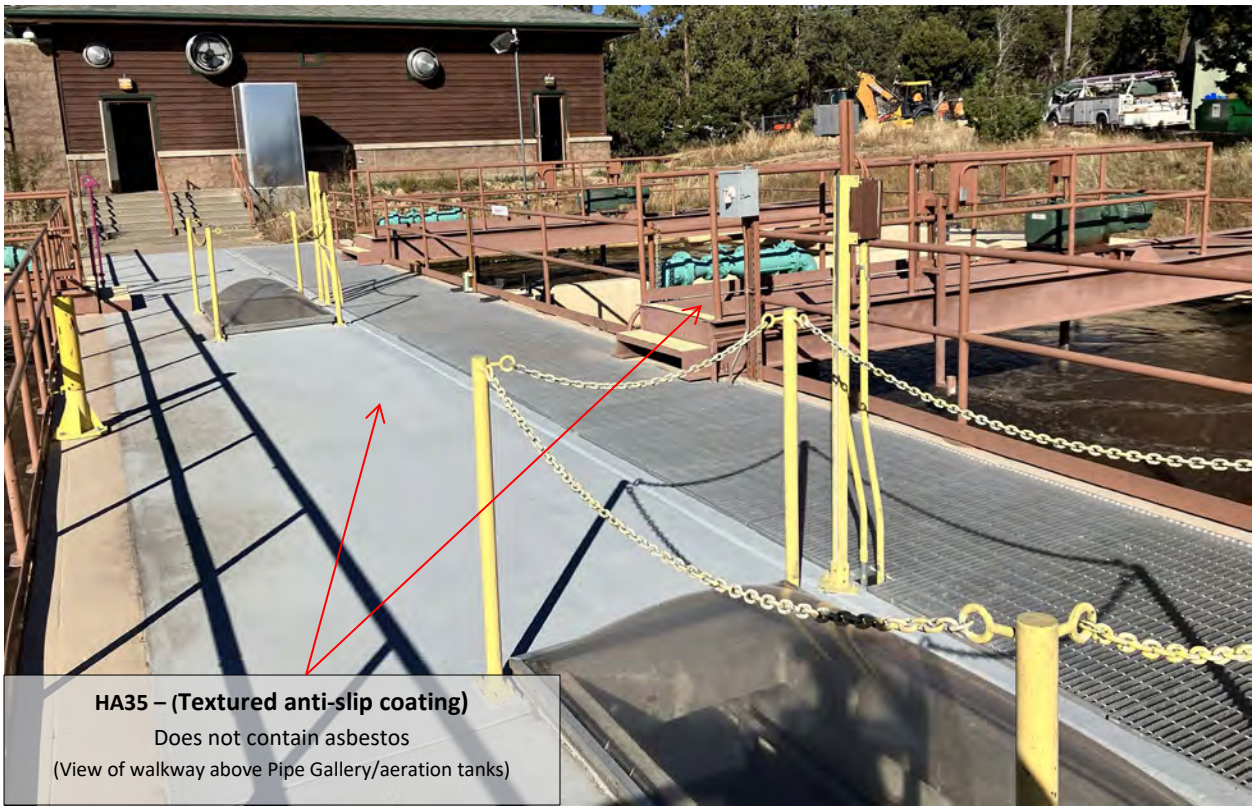
HA35 – (Textured anti-slip coating)
Does not contain asbestos
(View of walkway above Pipe Gallery/aeration tanks)

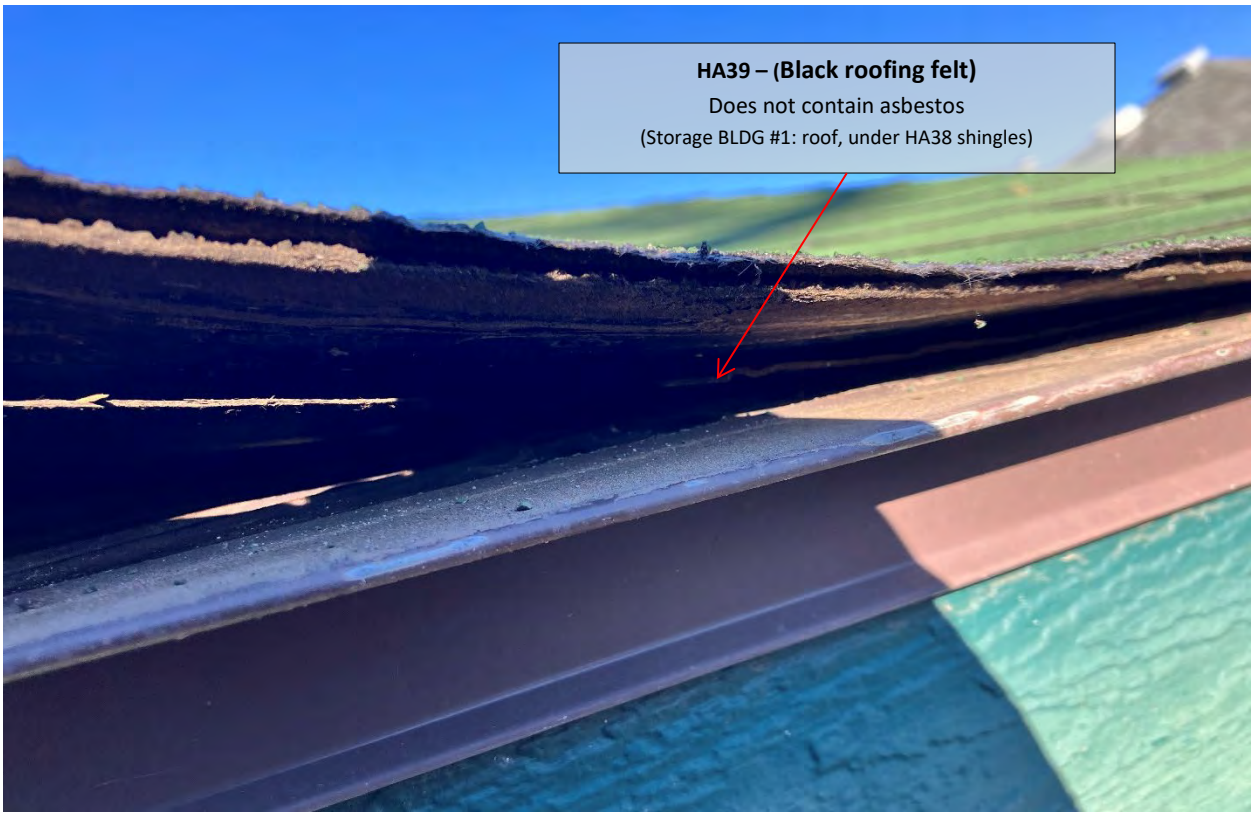
HA39 – (Black roofing felt)
Does not contain asbestos
(Storage BLDG #1: roof, under HA38 shingles)

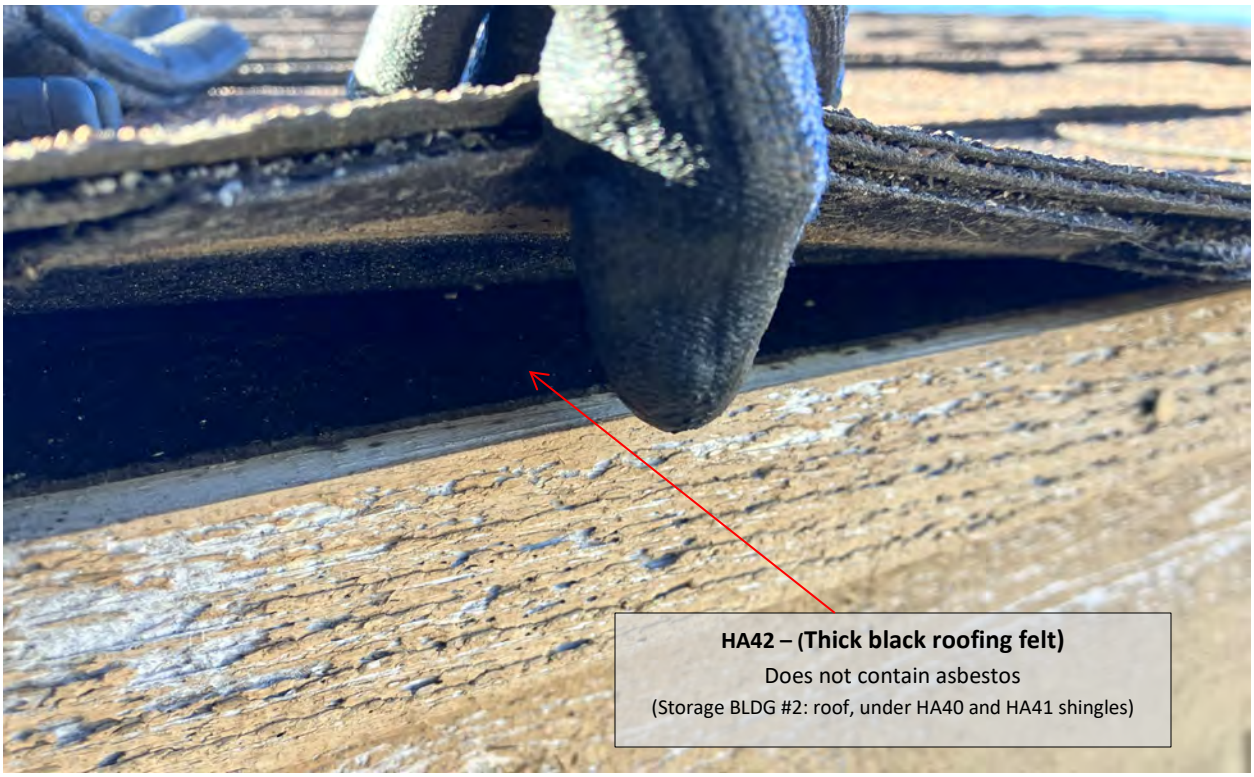
HA42 – (Thick black roofing felt)
Does not contain asbestos
(Storage BLDG #2: roof, under HA40 and HA41 shingles)

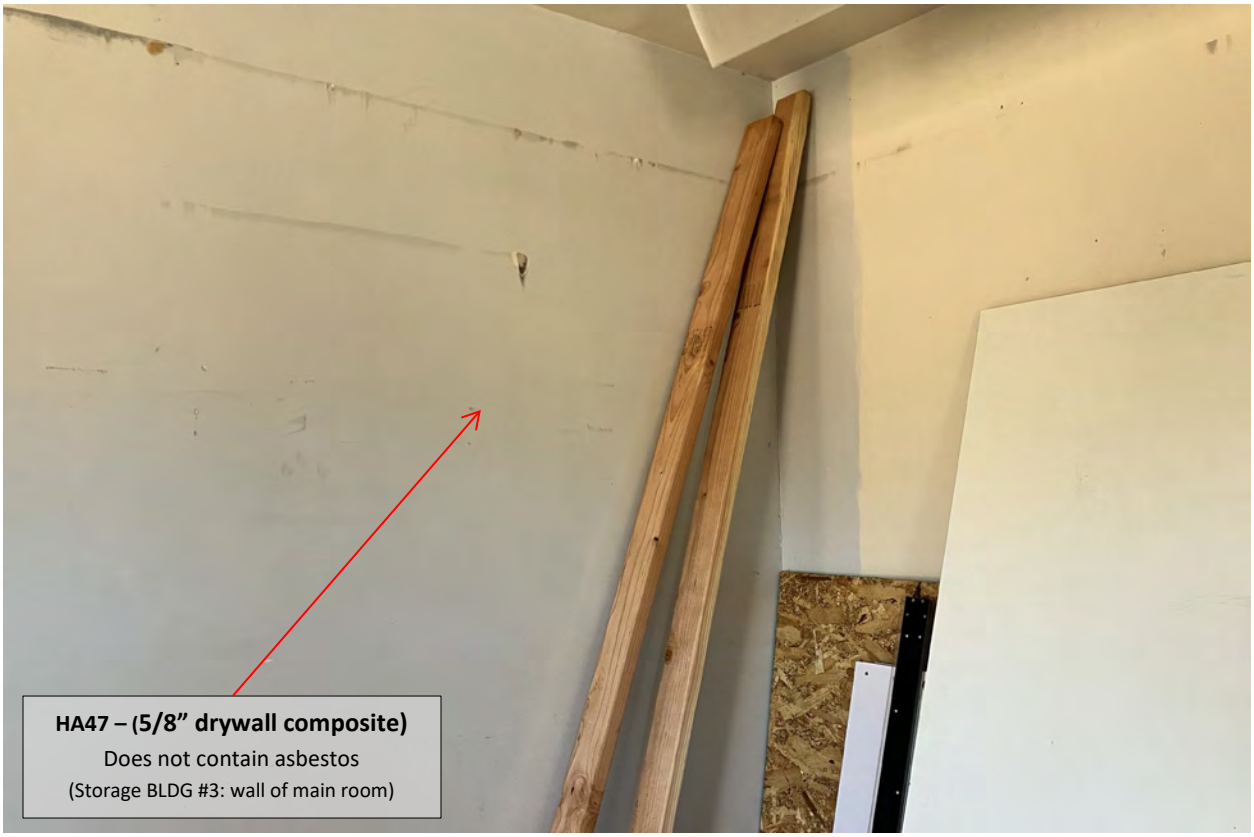
HA47 – (5/8" drywall composite)
Does not contain asbestos
(Storage BLDG #3: wall of main room)

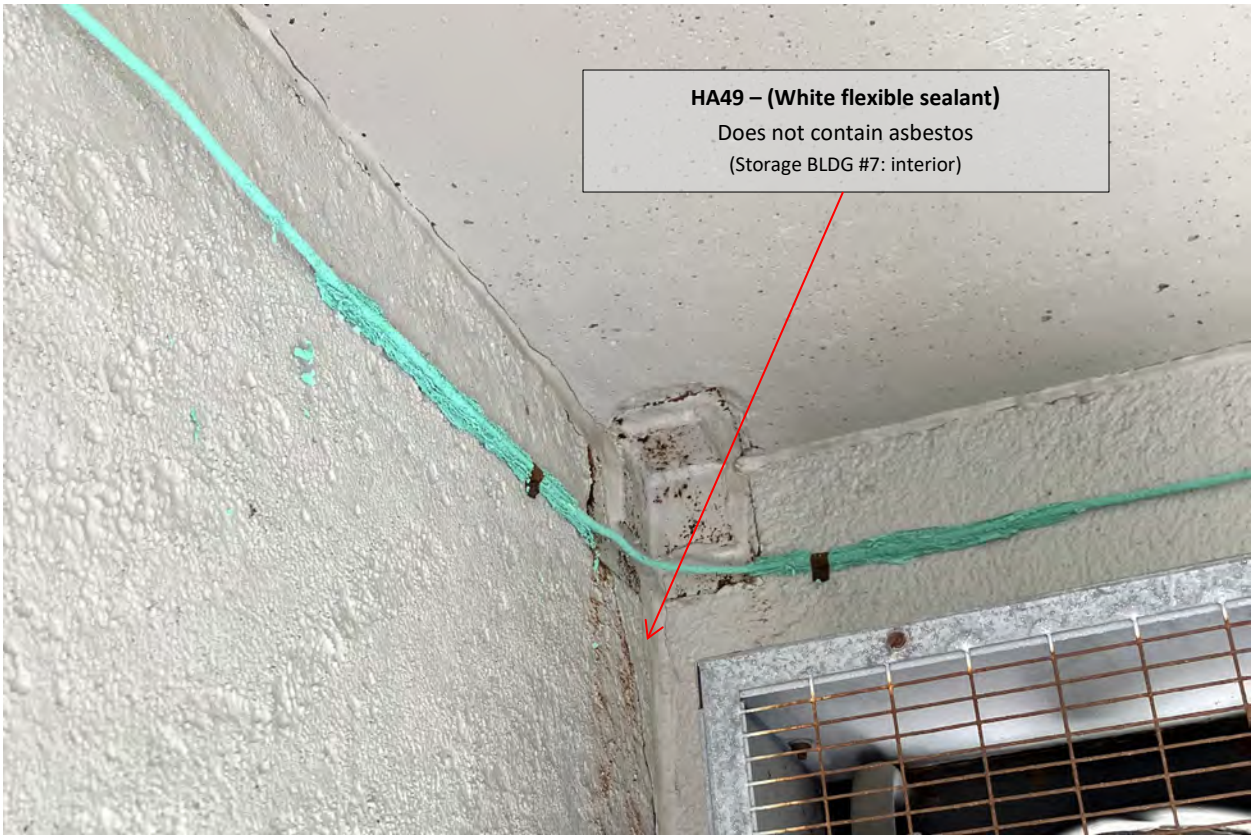
HA49 – (White flexible sealant)
Does not contain asbestos
(Storage BLDG #7: interior)

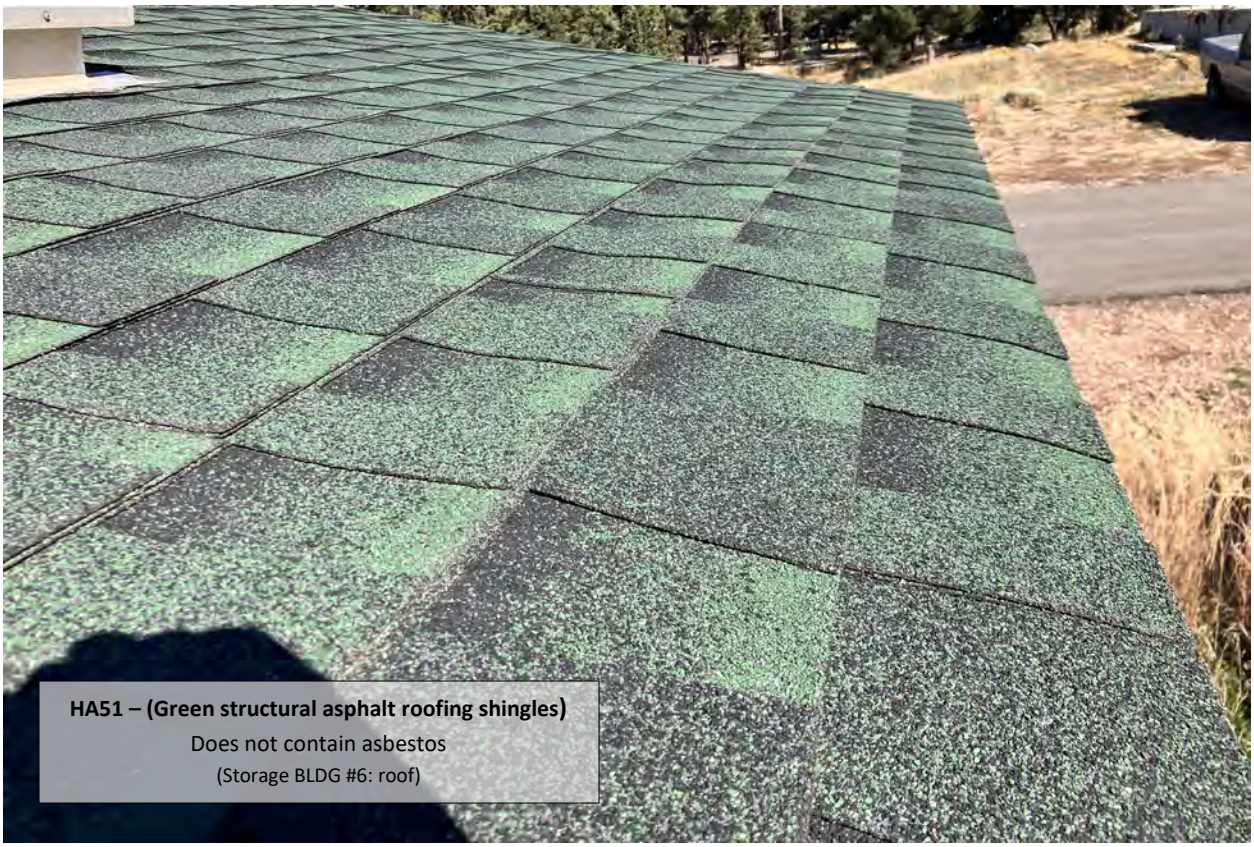
HA51 – (Green structural asphalt roofing shingles)
Does not contain asbestos
(Storage BLDG #6: roof)

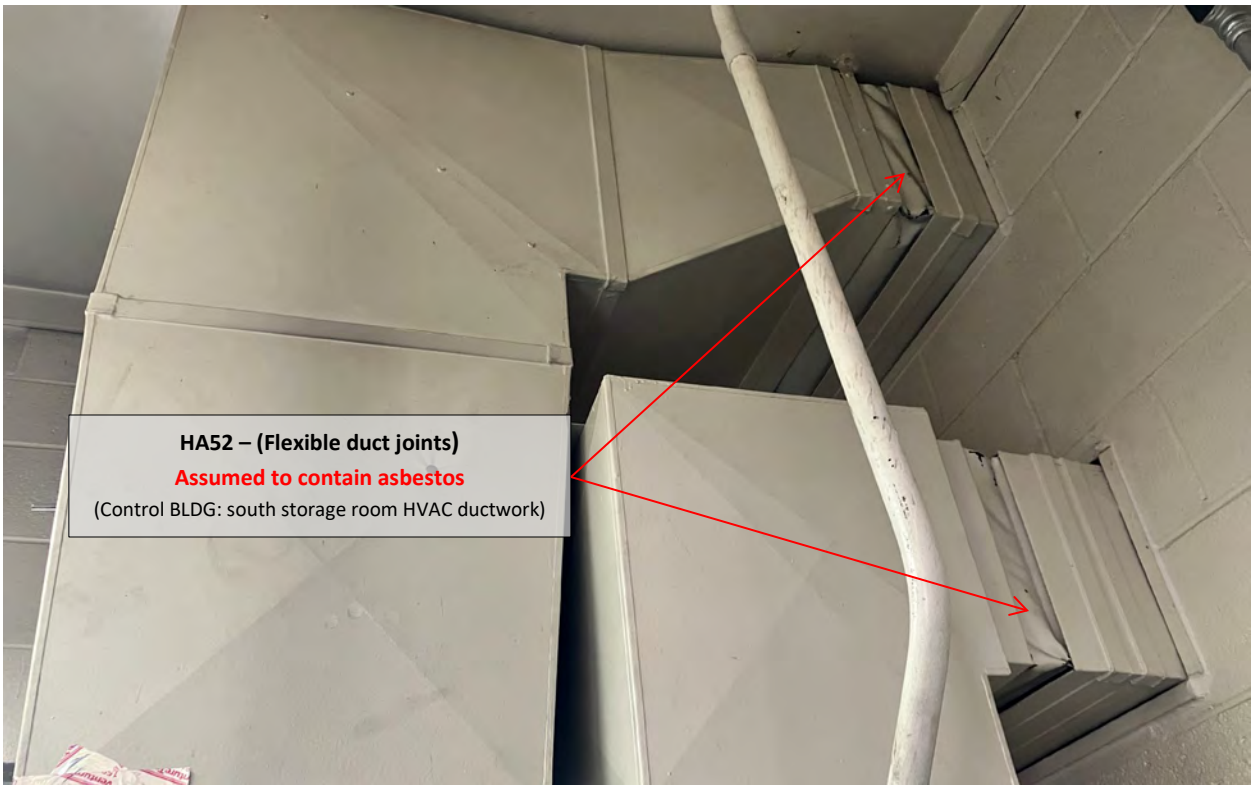
HA52 – (Flexible duct joints)
Assumed to contain asbestos
(Control BLDG: south storage room HVAC ductwork)

The follow material is assumed ACM and should either be sampled by destructive methods to rebut the assumption, or removed prior to demolition or renovation activities if they could become disturbed during such activities:

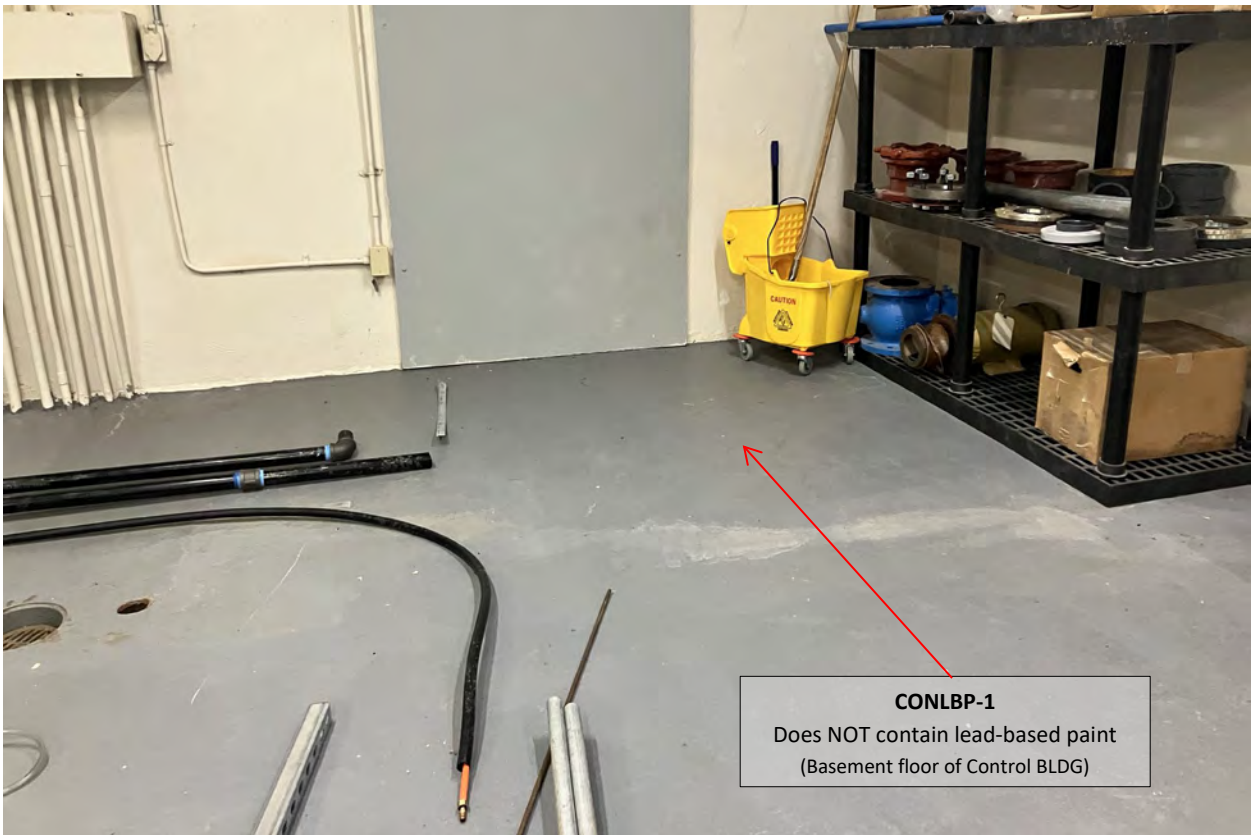
CONLBP-1
Does NOT contain lead-based paint
(Basement floor of Control BLDG)
