Hazardous Materials Investigation Report
Grand Canyon South Rim Wastewater Treatment Plant

Task Order #148045100

CJSeto Project #2910

November 2023

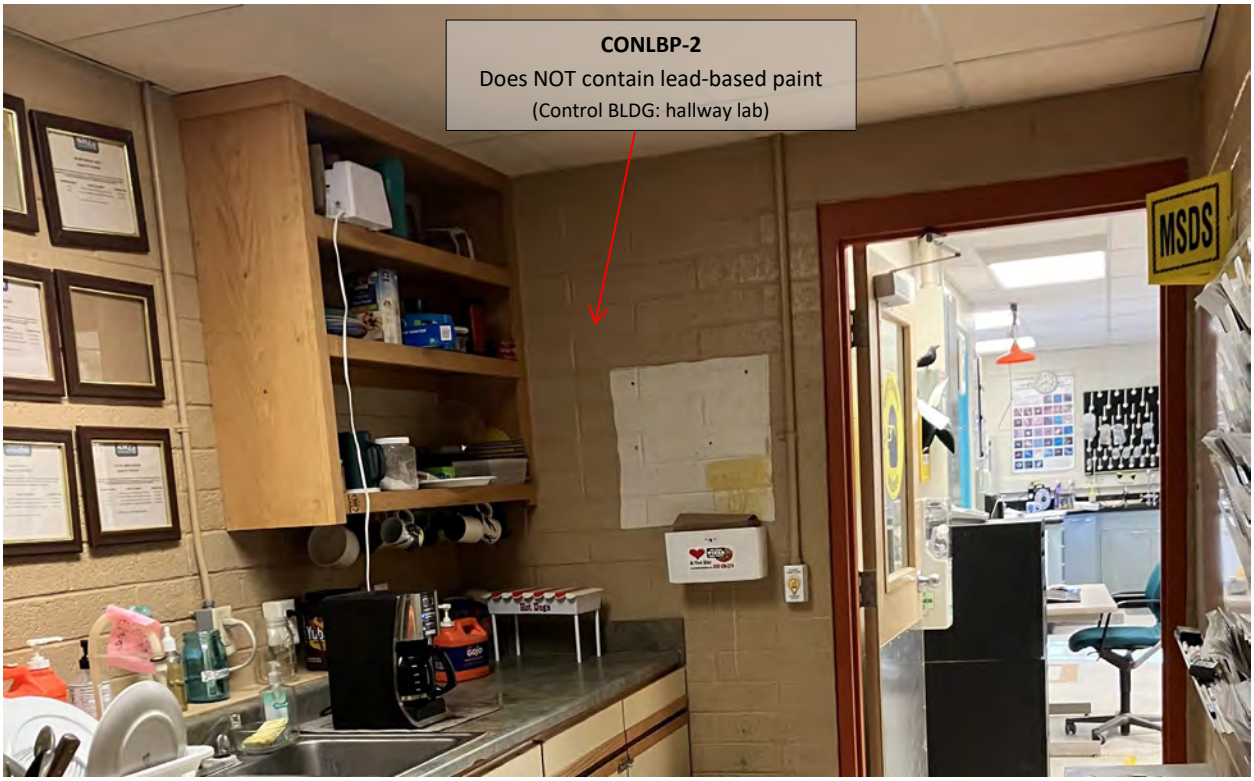
CONLBP-2
Does NOT contain lead-based paint
(Control BLDG: hallway lab)
MSDS

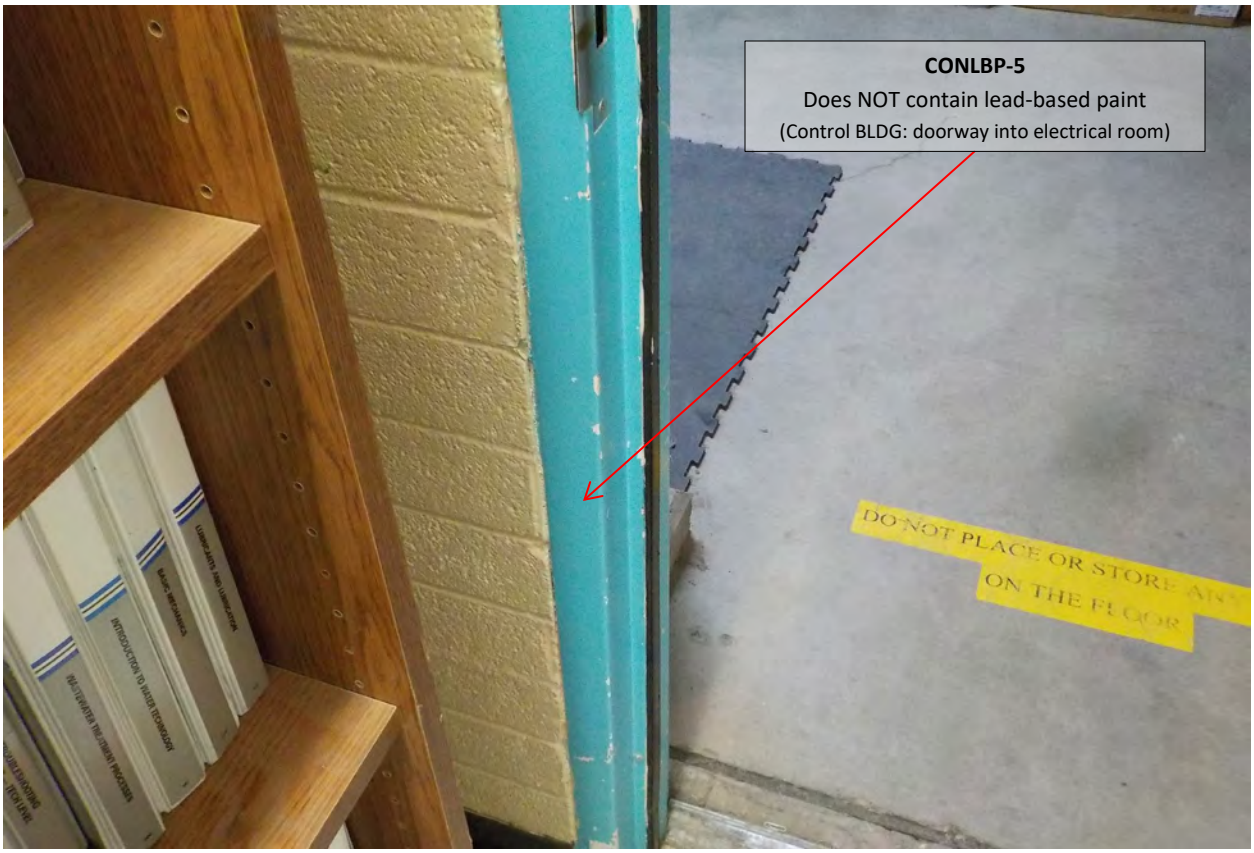
CONLBP-5
Does NOT contain lead-based paint
(Control BLDG: doorway into electrical room)
DO NOT PLACE OR STORE ANY
ON THE FLOOR

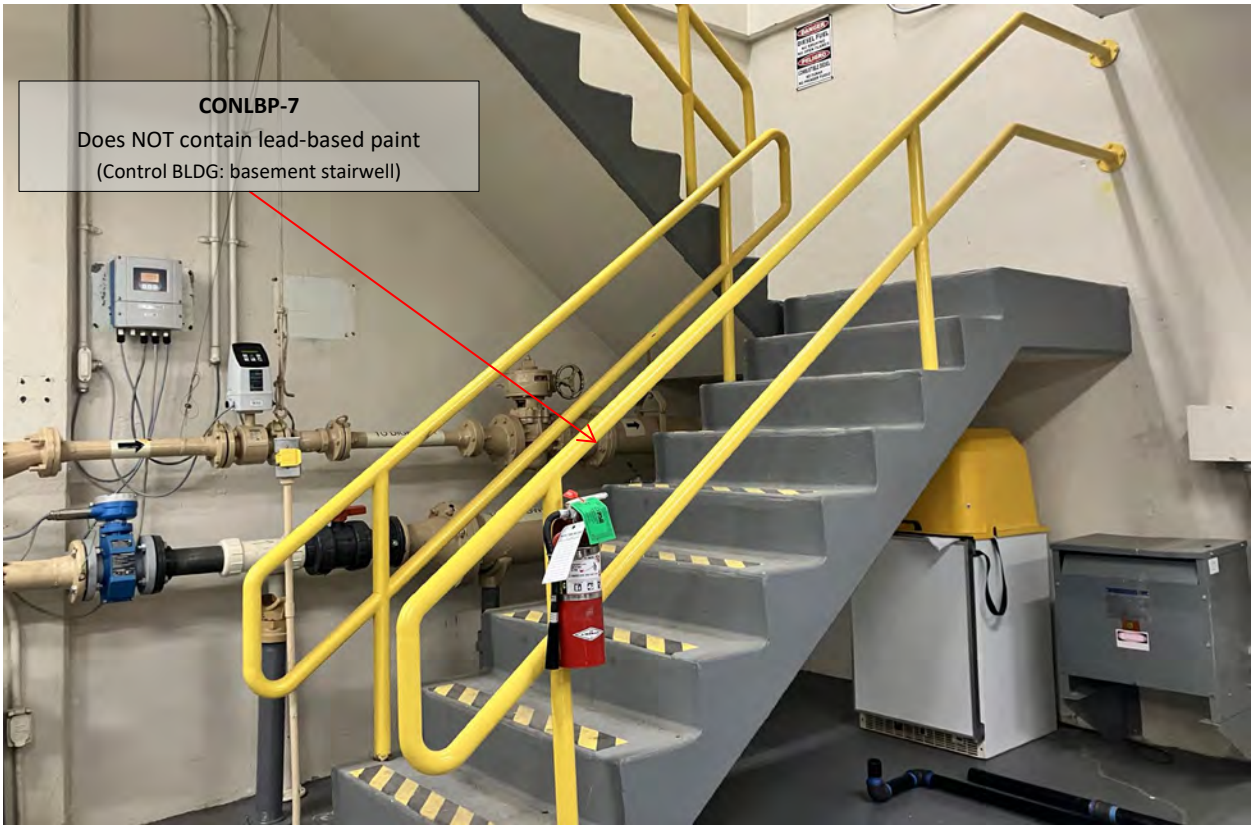
CONLBP-7
Does NOT contain lead-based paint
(Control BLDG: basement stairwell)

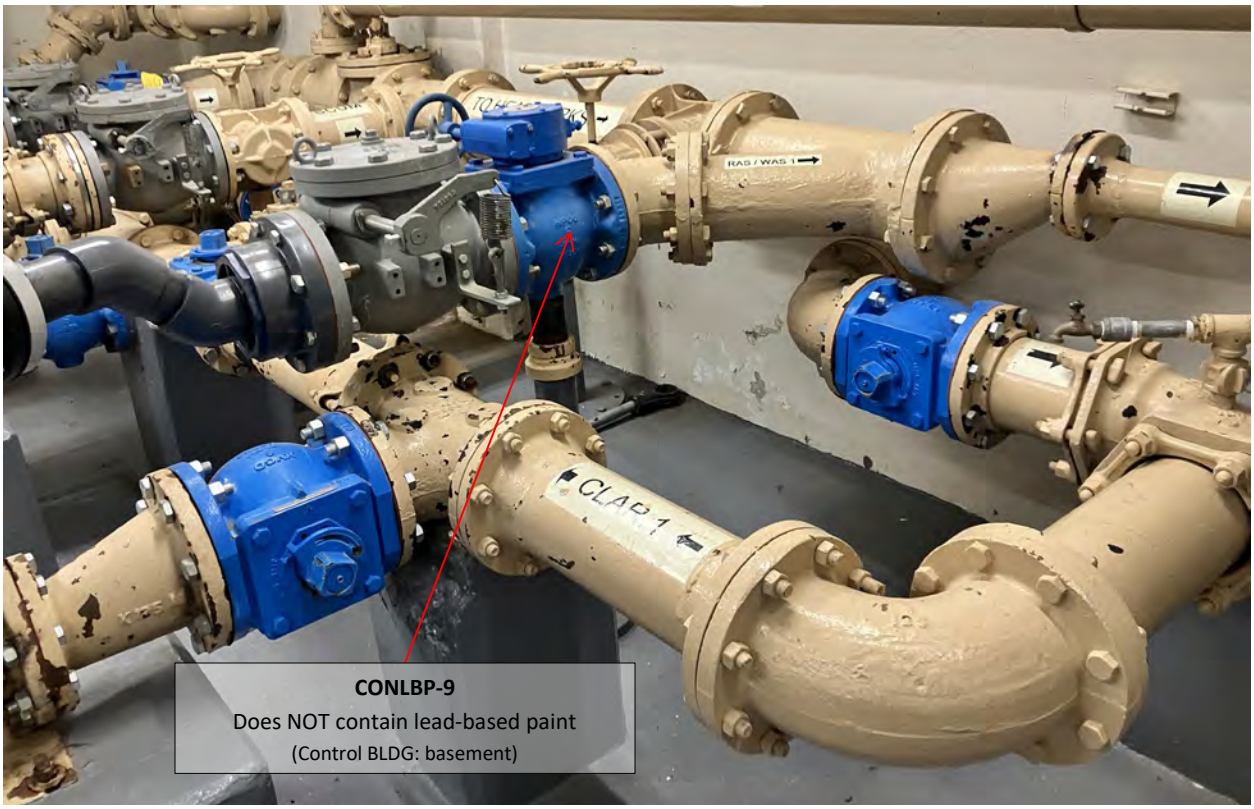
CONLBP-9
Does NOT contain lead-based paint
(Control BLDG: basement)

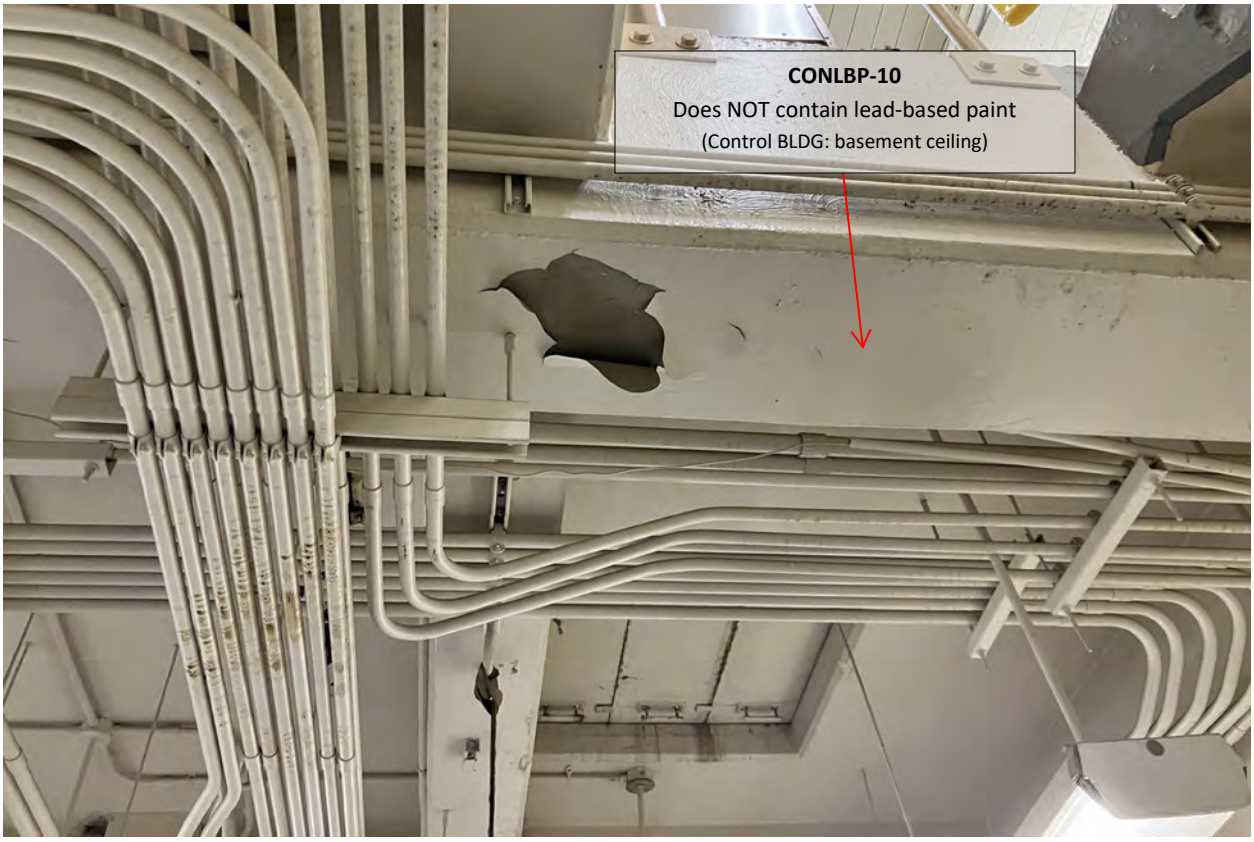
CONLBP-10
Does NOT contain lead-based paint
(Control BLDG: basement ceiling)

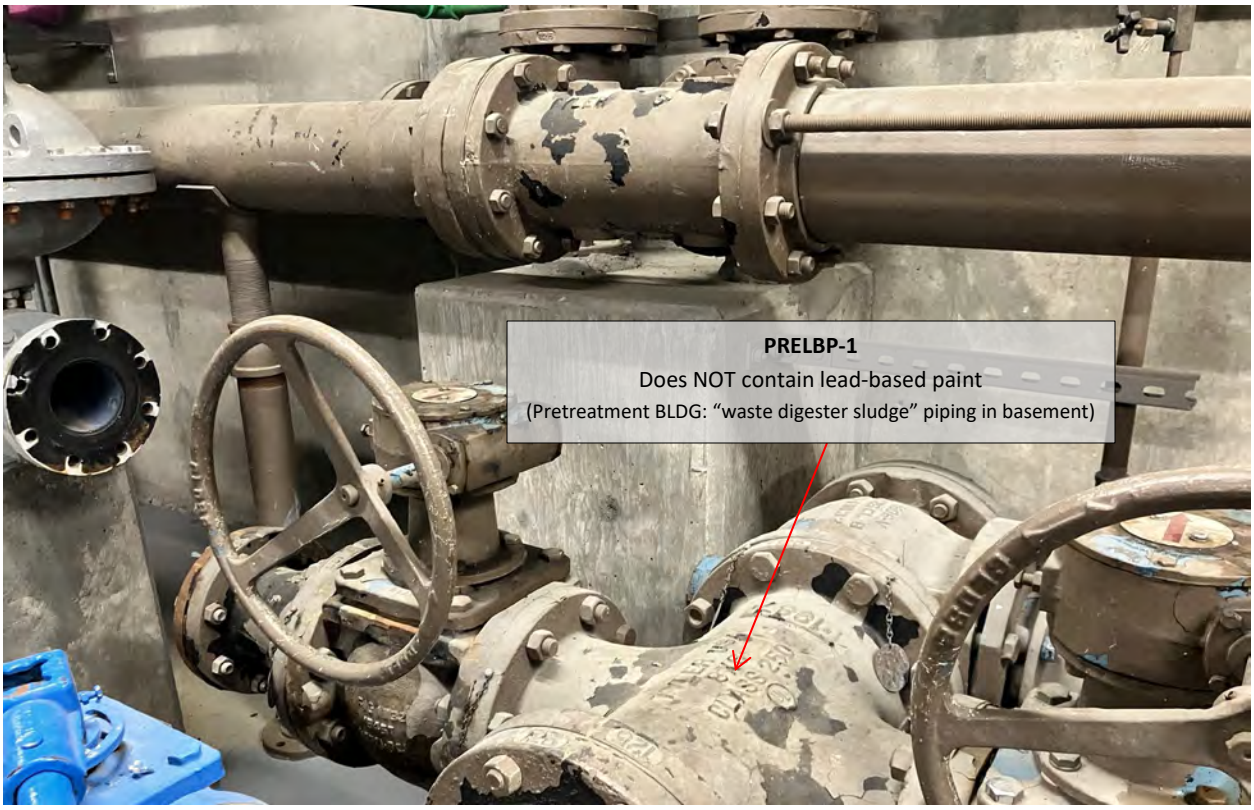
PRELBP-1
Does NOT contain lead-based paint
(Pretreatment BLDG: "waste digester sludge" piping in basement)

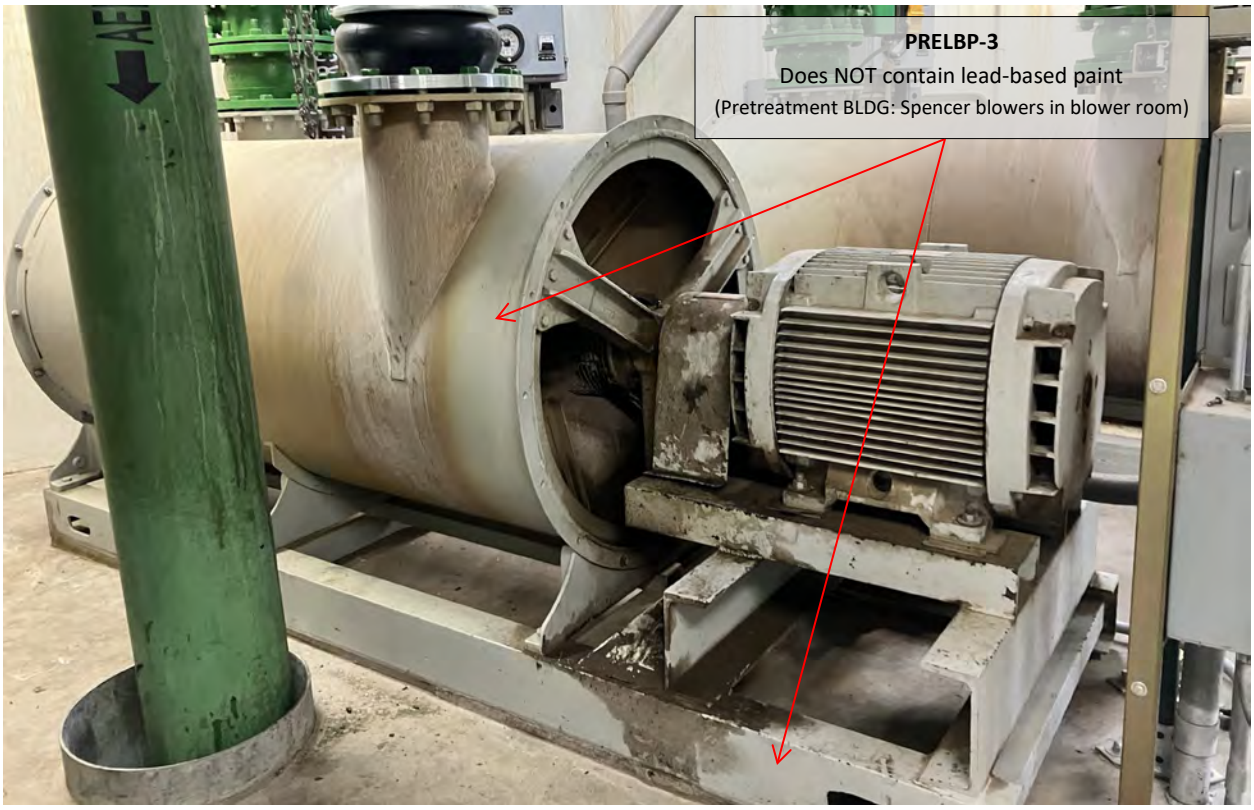
PRELBP-3
Does NOT contain lead-based paint
(Pretreatment BLDG: Spencer blowers in blower room)

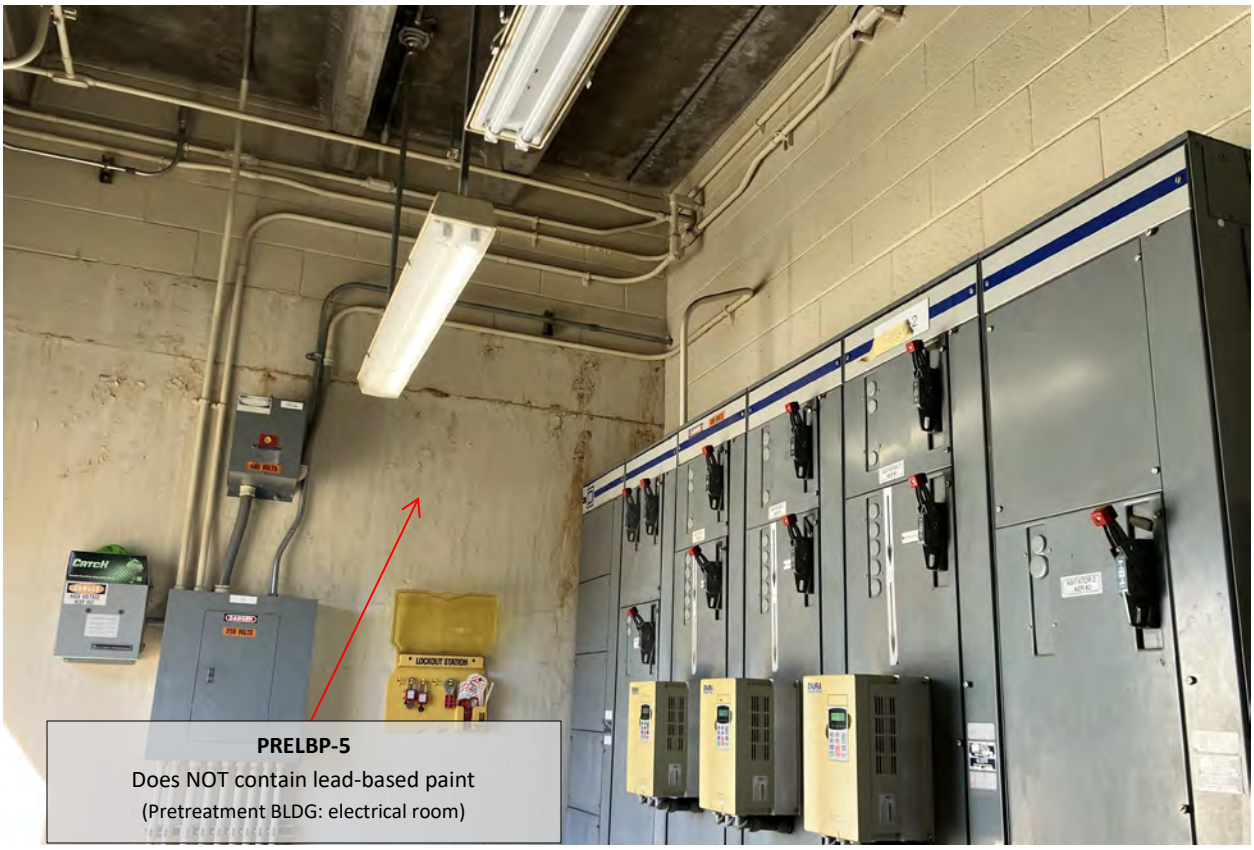
PRELBP-5
Does NOT contain lead-based paint
(Pretreatment BLDG: electrical room)

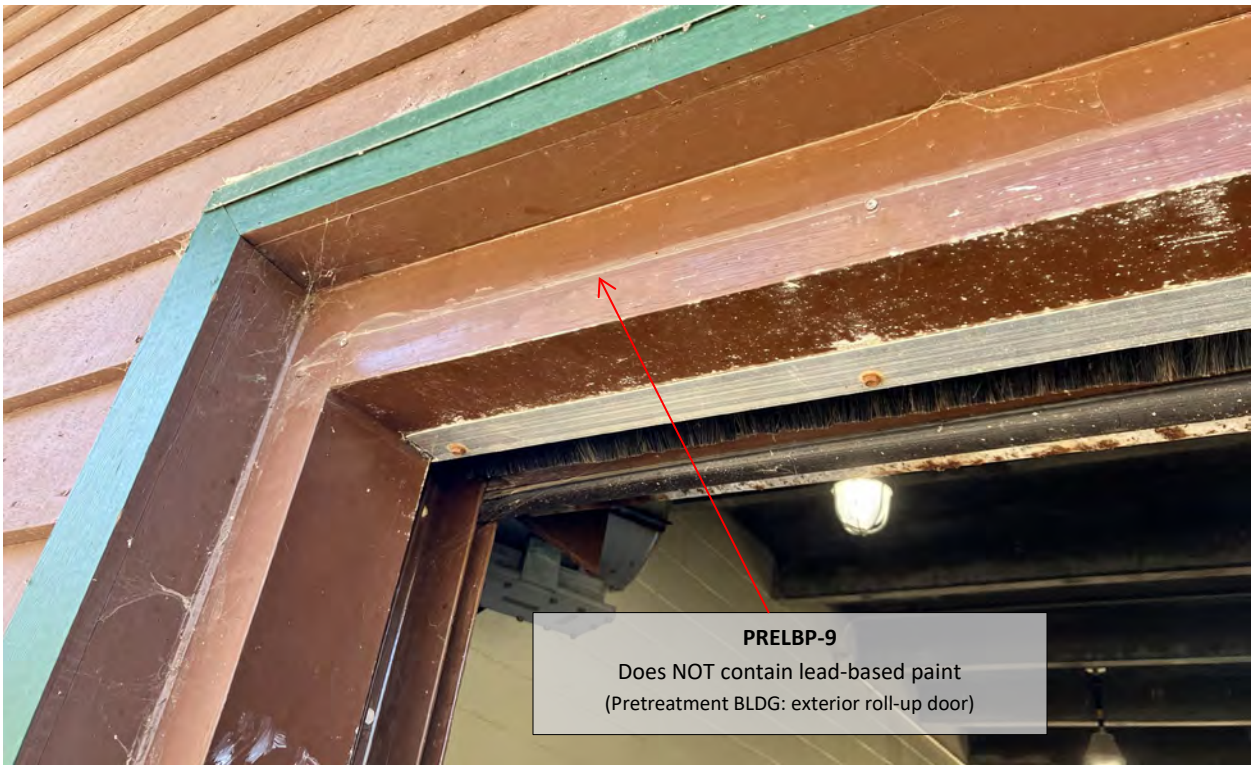
PRELBP-9
Does NOT contain lead-based paint
(Pretreatment BLDG: exterior roll-up door)

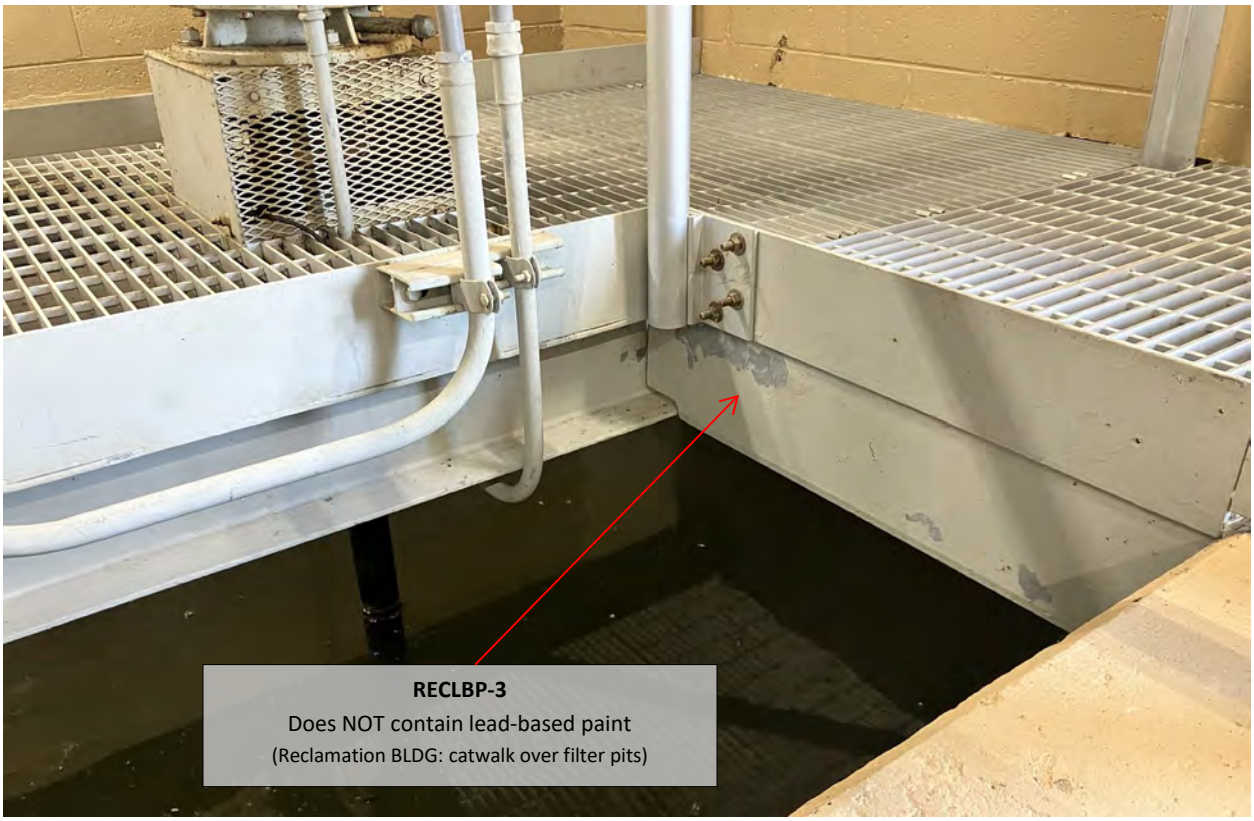
RECLBP-3
Does NOT contain lead-based paint
(Reclamation BLDG: catwalk over filter pits)

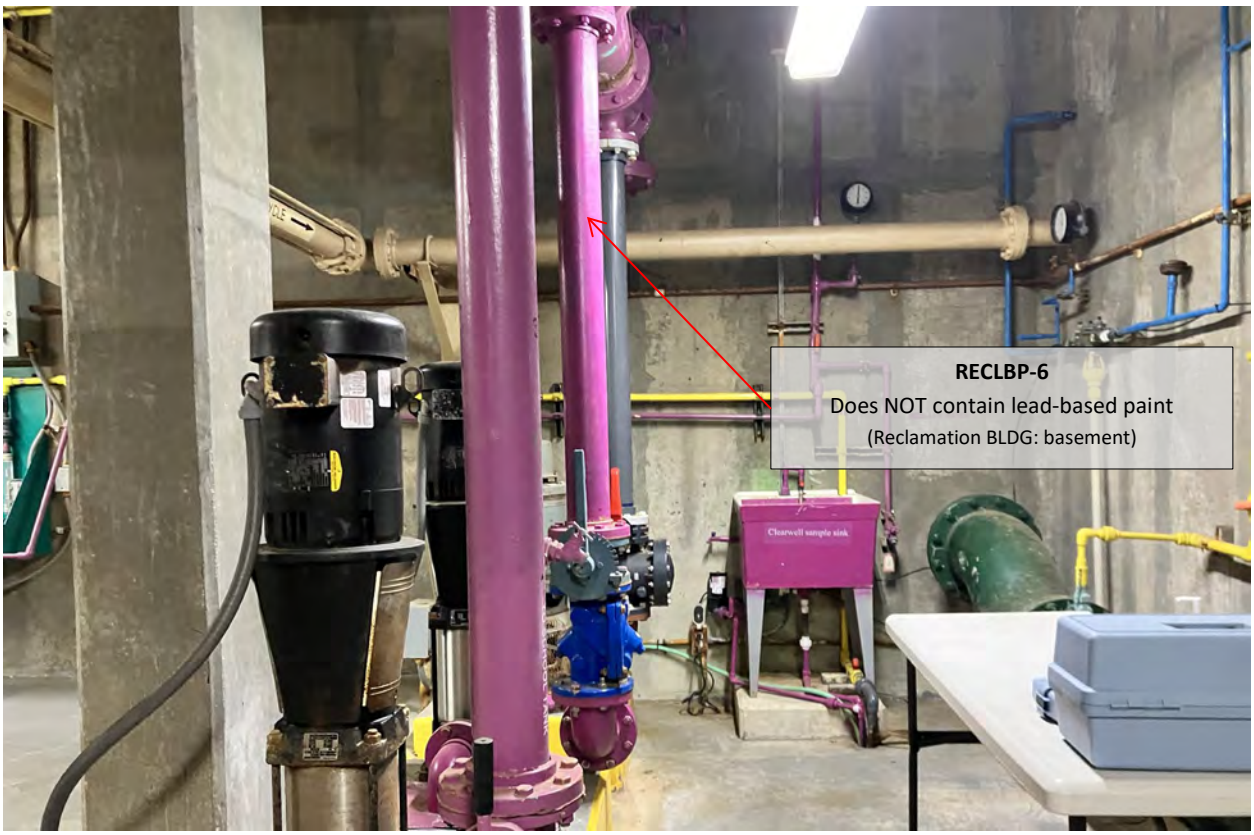
RECLBP-6
Does NOT contain lead-based paint
(Reclamation BLDG: basement)

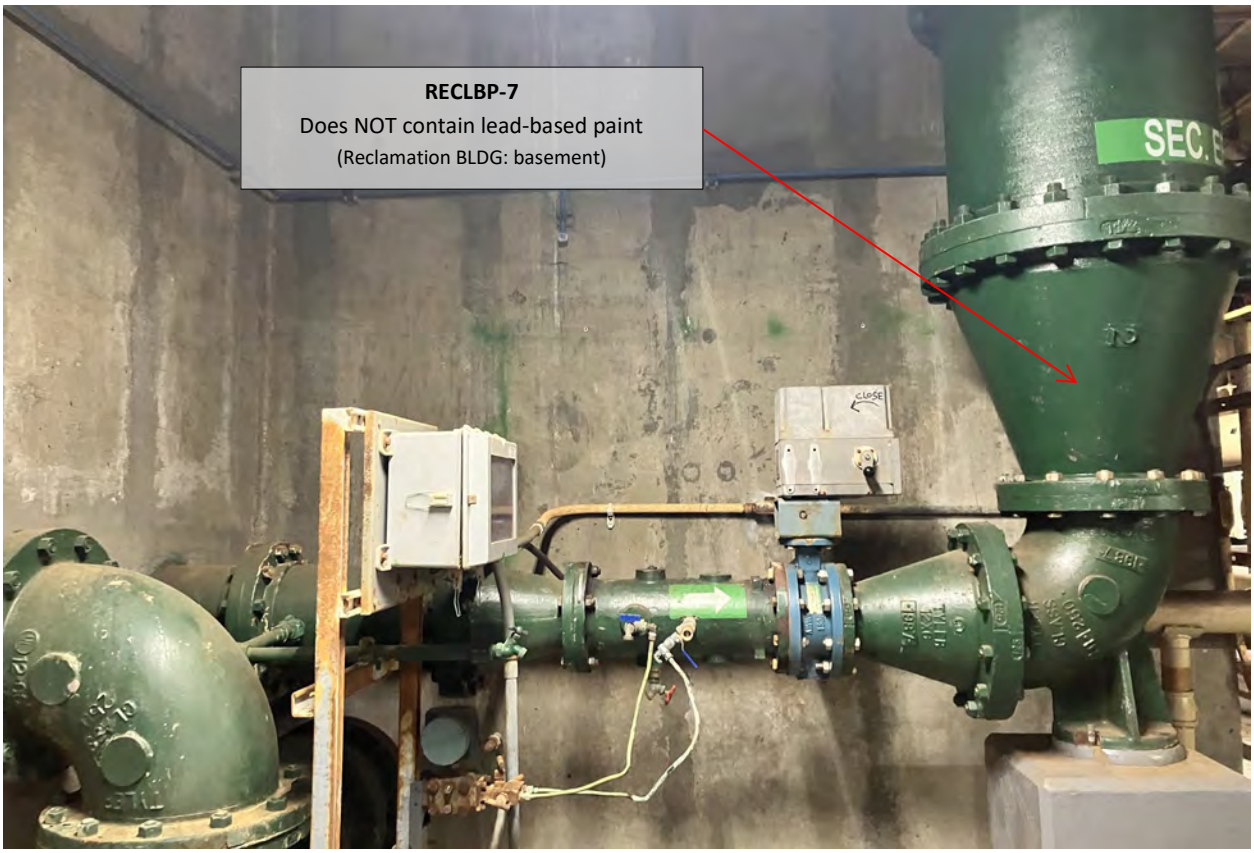
RECLBP-7
Does NOT contain lead-based paint
(Reclamation BLDG: basement)
SEC.
CLOSE

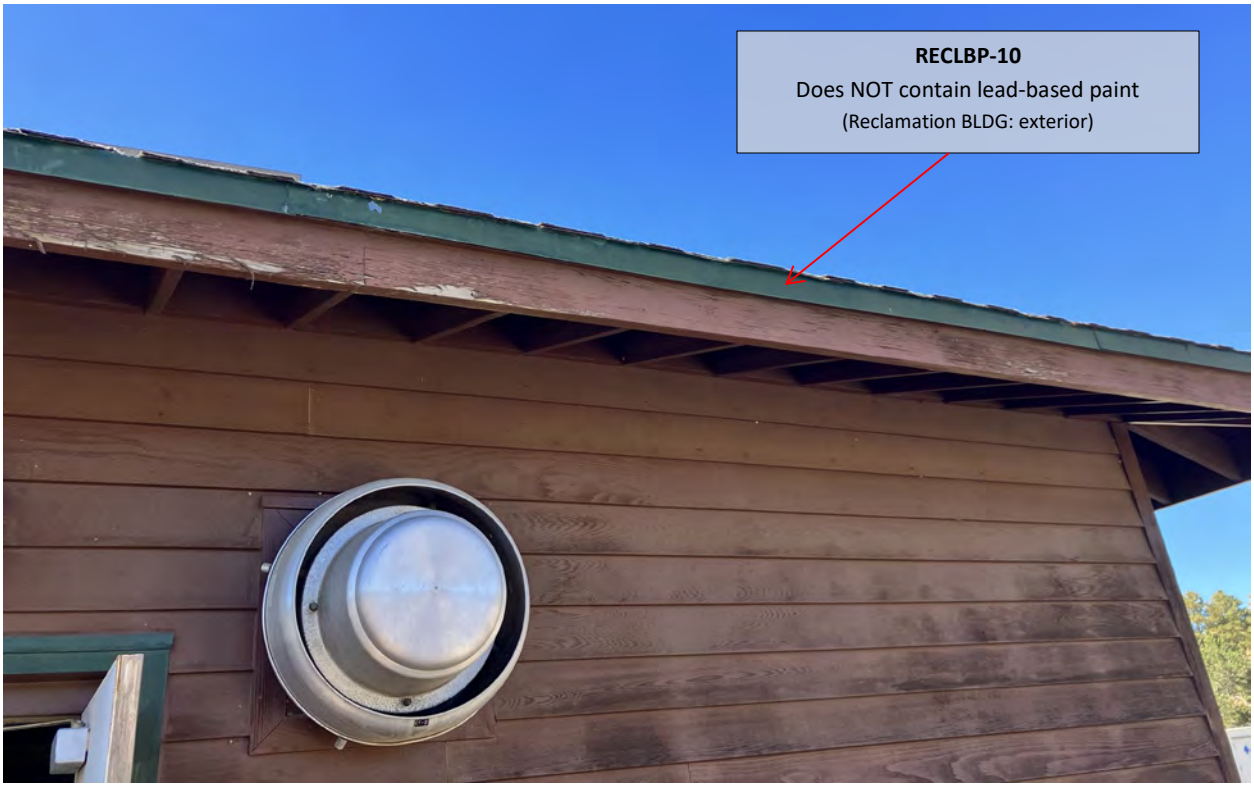
RECLBP-10
Does NOT contain lead-based paint
(Reclamation BLDG: exterior)

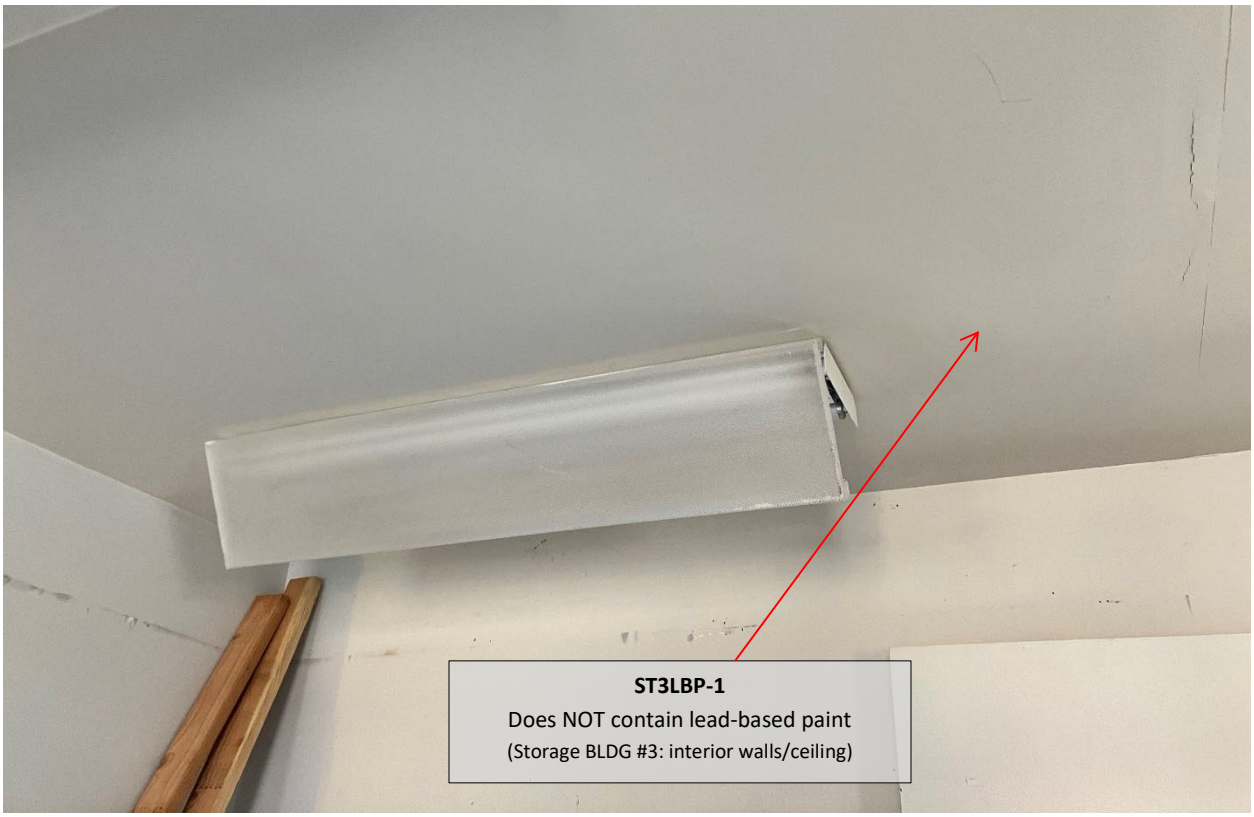
ST3LBP-1
Does NOT contain lead-based paint
(Storage BLDG #3: interior walls/ceiling)

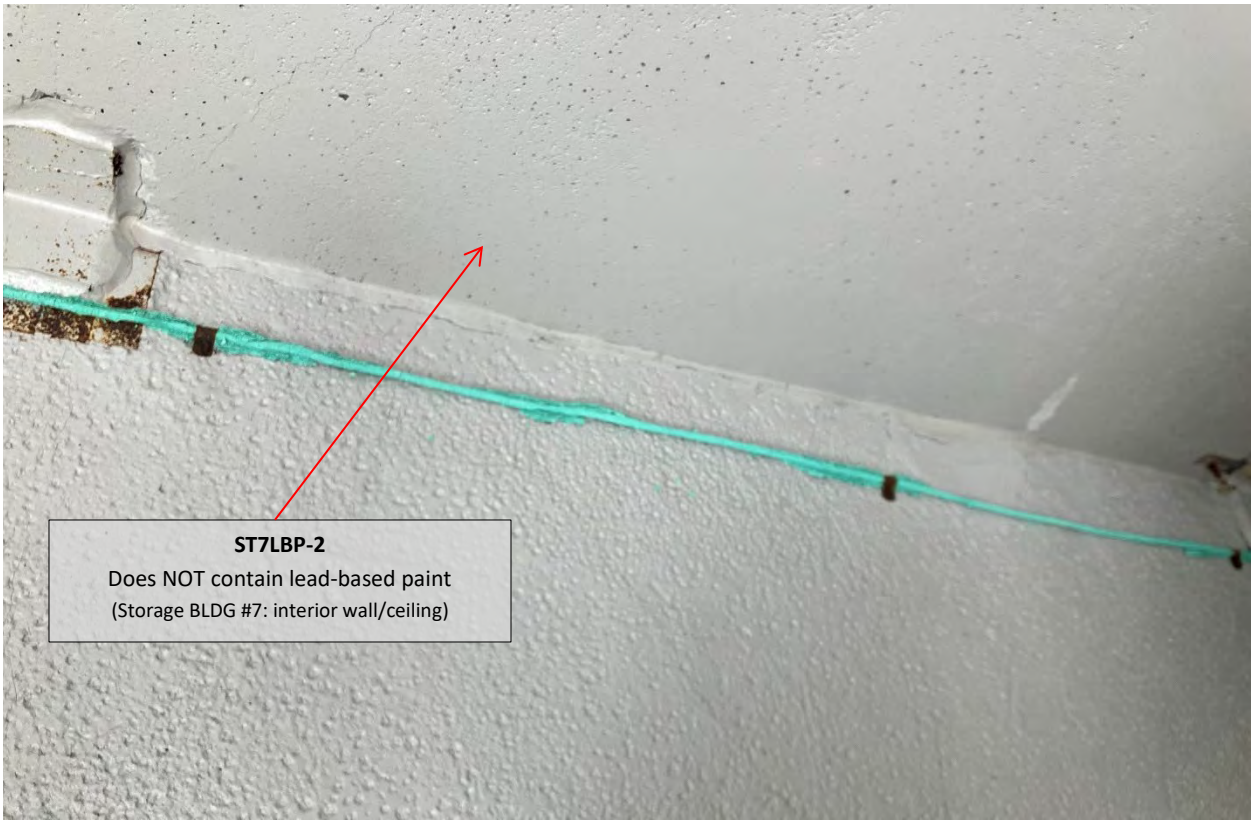
ST7LBP-2
Does NOT contain lead-based paint
(Storage BLDG #7: interior wall/ceiling)

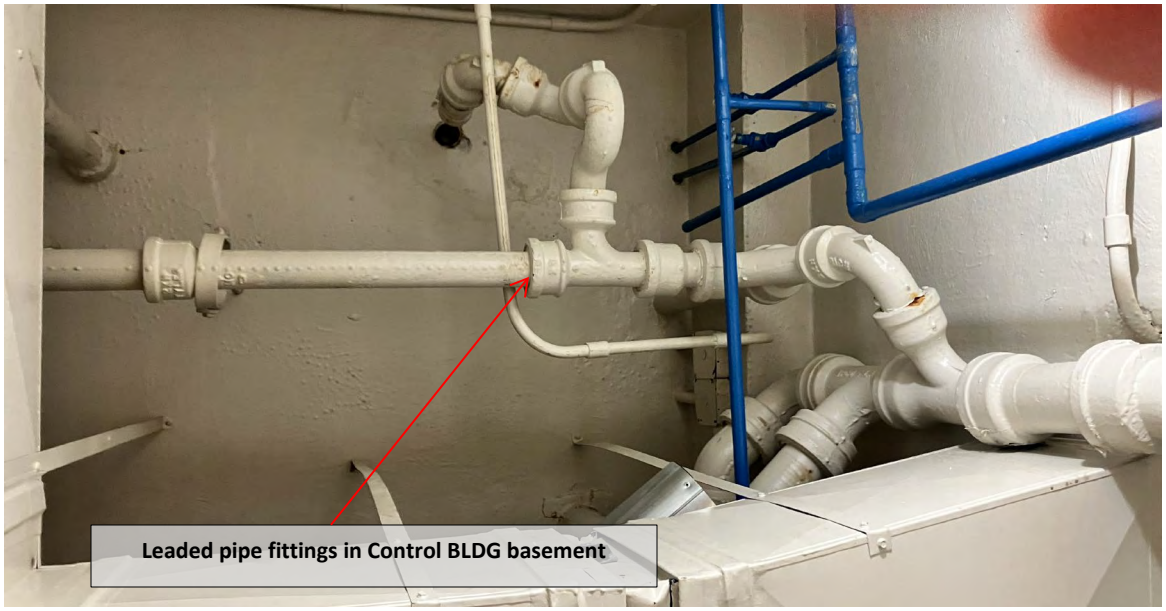
Though not paint, leaded pipe fittings in older cast iron drain piping were observed in the Control Building basement below the restroom.

Leaded pipe fittings in Control BLDG basement
