Deficiency found - Panel ‘C’ in Generator Building

ANAKTUVUK POWER PLANT

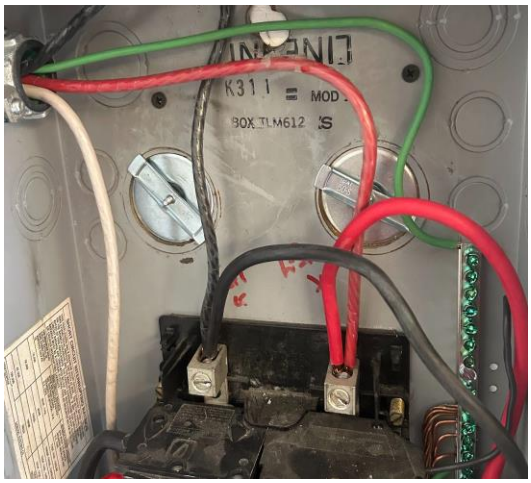
Currently the feeder for C1 (the wire that we added polaris connectors to) is landed on the main lugs with the incoming power from the inverter. It should have its own breaker.

We recommend replacing Panel ‘C’ as part of any further work here. It is old and has many plugged holes. Possibly the feeders for C1 and C2 could be downsized between ‘C’ and the exterior splice cabinet (gutter), currently they are oversized for the 60A breakers being used.
