RE: SUBMITTAL OF ASBESTOS & LEAD SURVEY REPORT
Ft. Bliss Bldg. #2414
ENCON Project #103-08-150

ASBESTOS SURVEY REPORT
BUILDING 2414
FORT BLISS, TEXAS 79916

ASBESTOS SURVEY REPORT
Ft. Bliss, Bldg. 2414

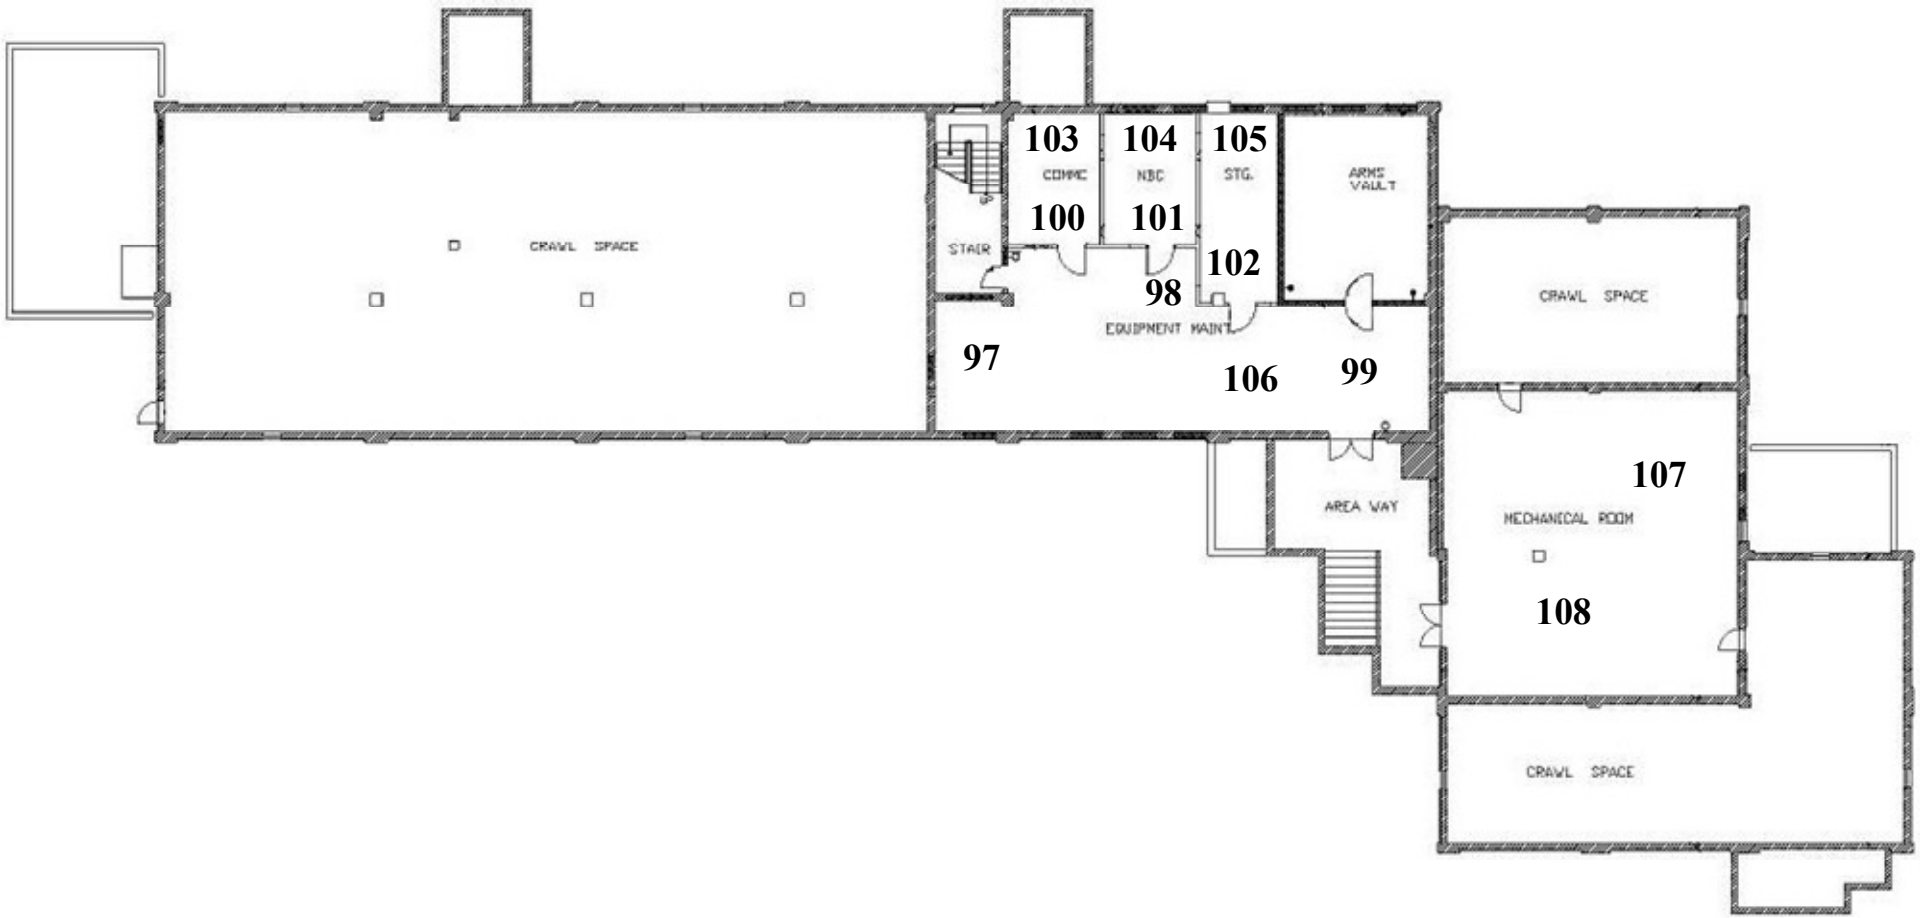
Asbestos Sample Locations **ENCON #: 103-08-150** **Date: 12/11/2008**	**Legend** **# Asbestos Sample Location** **# Positive Asbestos Sample**	**Bldg. 2414** **Asbestos Sample Location Drawing** **Basement**	**N.T.S**

No Asbestos-containing materials were identified as part of this Asbestos Survey. No further assessment is recommended at this time. If, during the course of any remodeling or demolition activities suspect materials are found, additional sampling and analysis may be required.

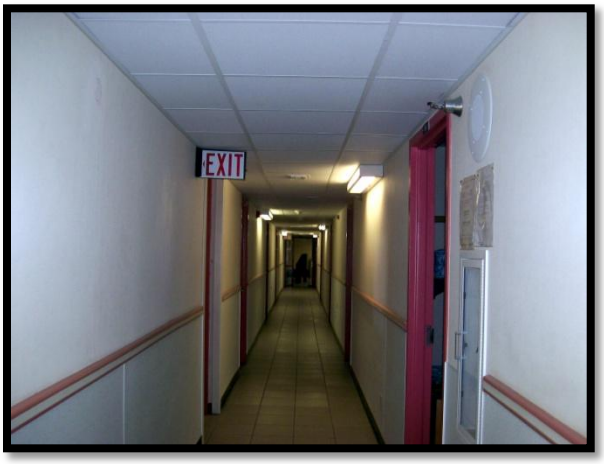
View of hallway inside building.

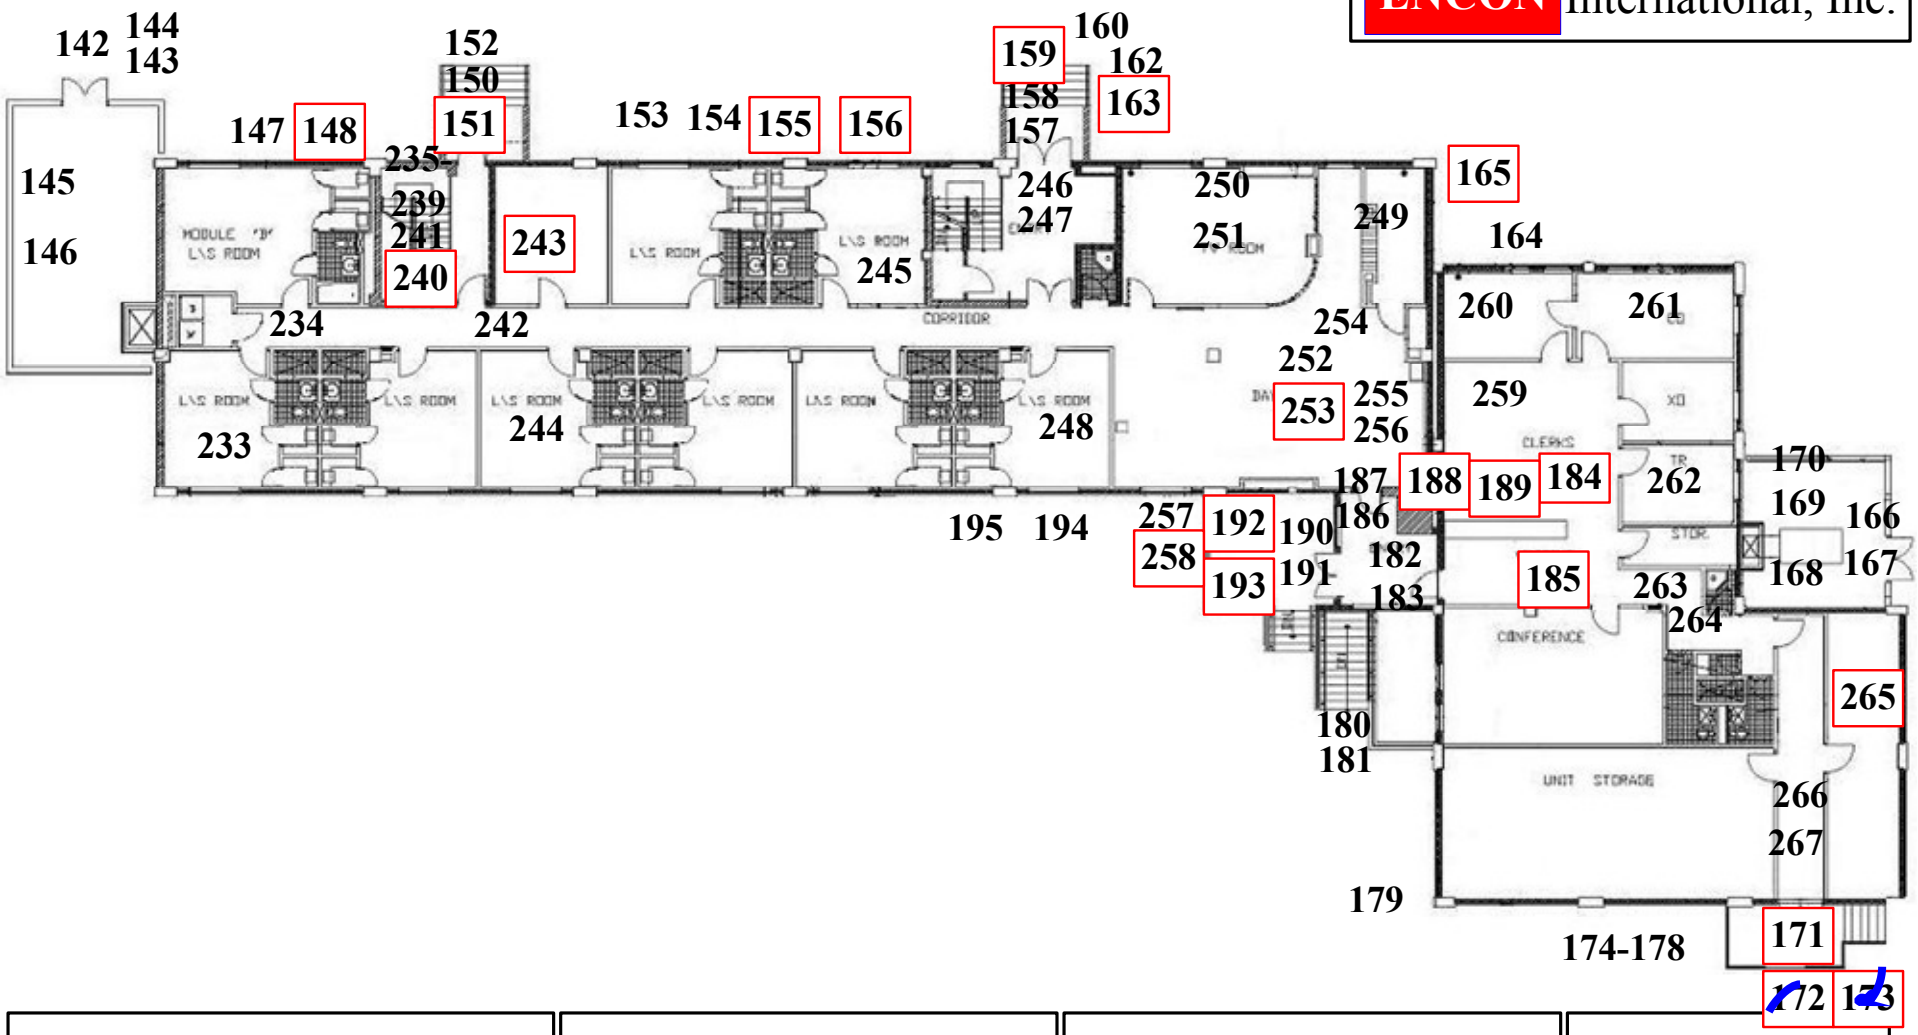
Lead Sample Locations **ENCON #: 103-08-150** **Date: 12/08/2008**	**Legend** **# Lead Sample Location** **[#] Positive Lead Sample**	**Bldg. 2414** **Lead Sample Location Drawing** **First Floor**	**N.T.S**

LEAD - Results indicate that thirty-two (32) of the one hundred thirty-nine (139) XRF readings tested at or above the limit of 0.3 mg/cm^2.

Care shall also be taken for surfaces that contain levels of lead below the Action Level stated above for the instrument (0.3 mg/cm^2), which could create lead dust or lead-contaminated soil hazards if the paint is turned into dust by abrasion, scraping, or sanding.
