ASBESTOS-CONTAINING MATERIAL (ACM) SURVEY AND ABATEMENT COST ESTIMATE

BLM Task Order 164, BPA L14PB00728 (NAB060001 Legacy Number)

L1440784 – Vale District Office
43.98692 / -117.23875
Vale District Office, Oregon

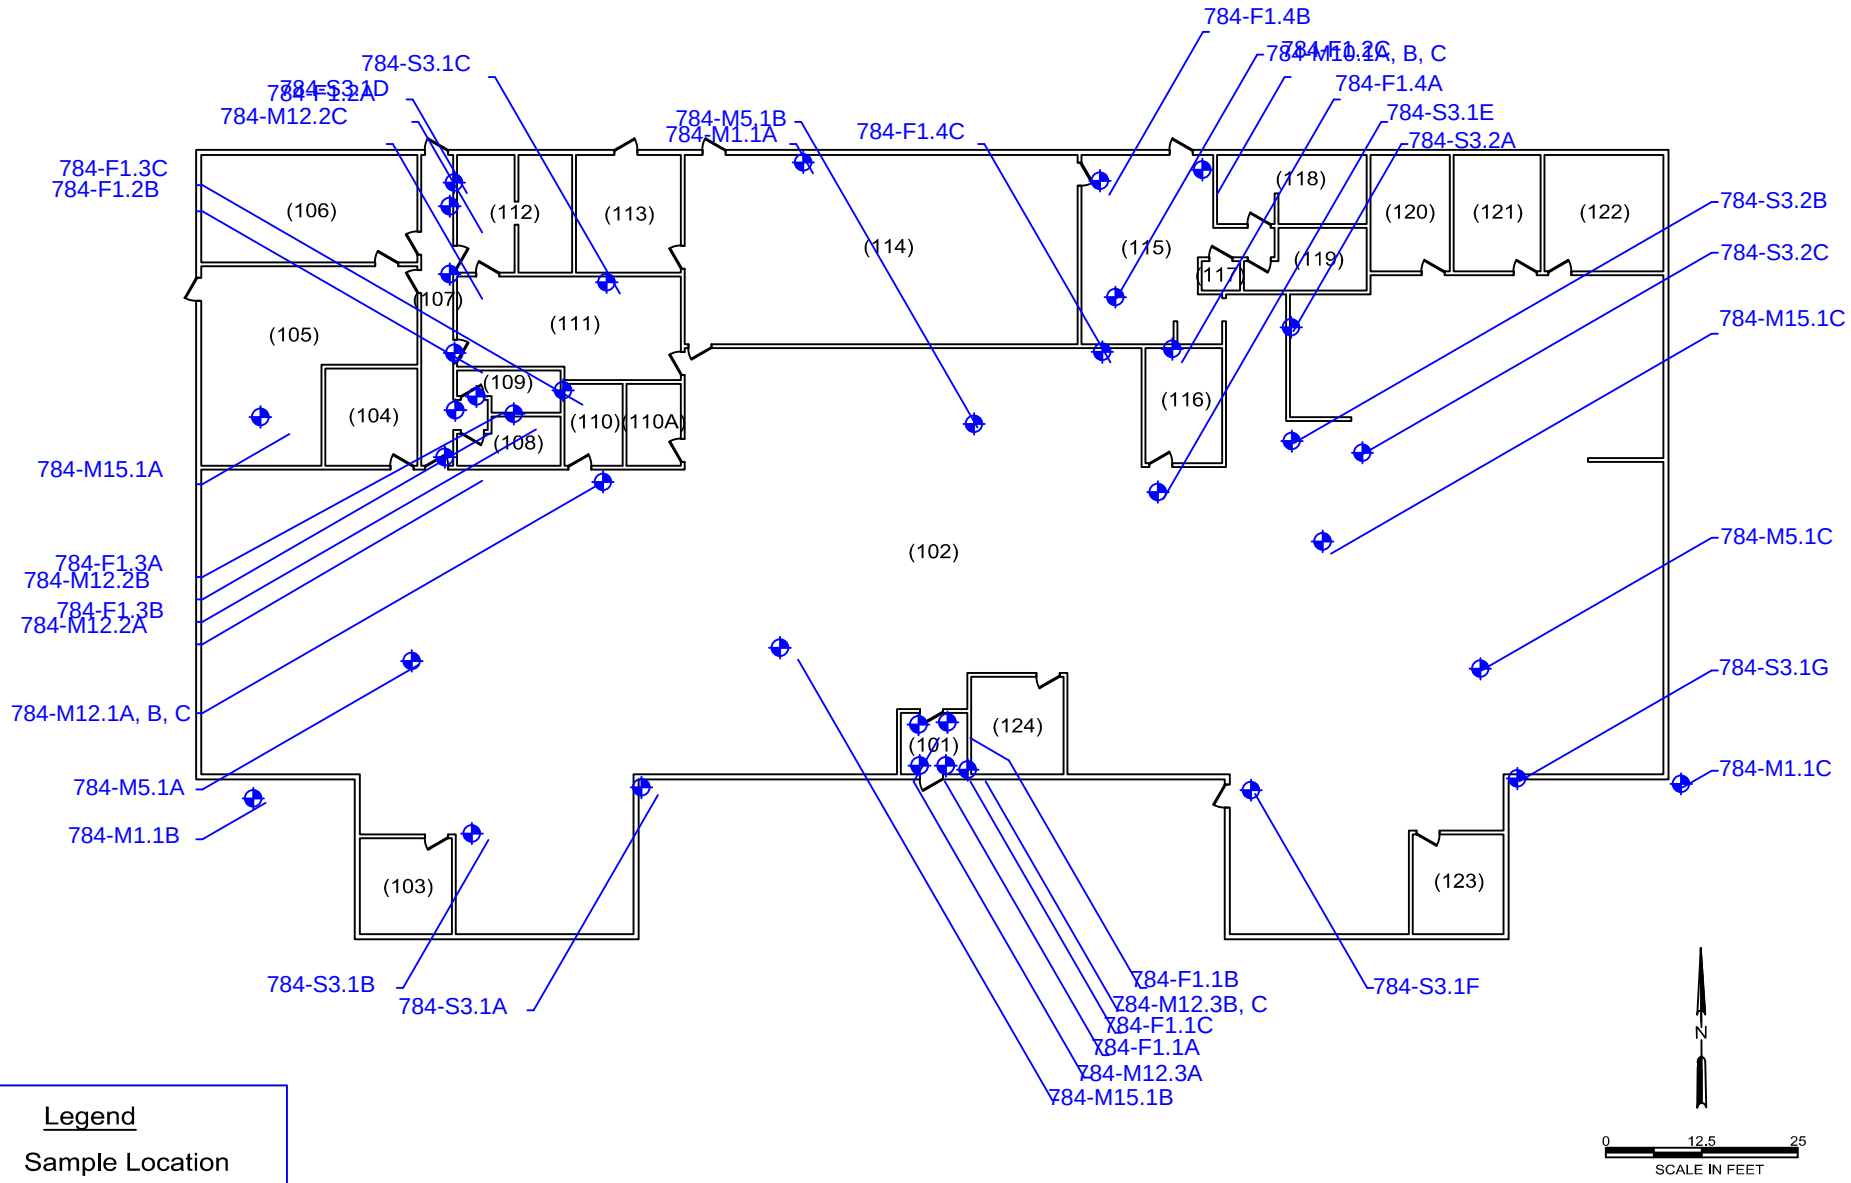
DATE: 06/21/2015	DRAWN BY: DLL
REVIEWED: RH	APPROX. SCALE: 1" = 25'
PROJ. NO. 114-551646	FIGURE NO. 1

Asbestos Survey
Sample Collection Locations
Vale District Office - Bldg L1440784
Vale District Office
Vale, Oregon

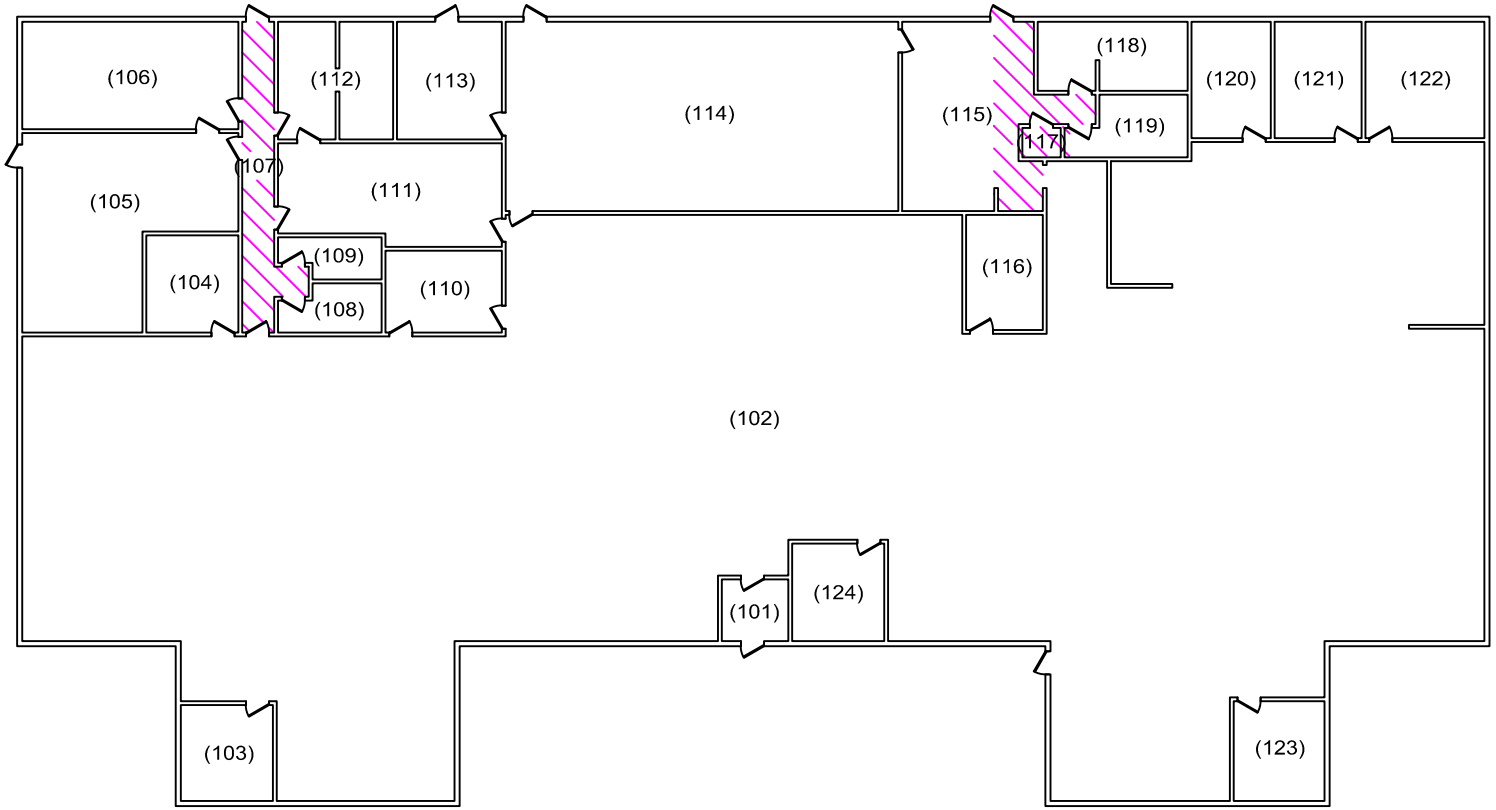
784-F1.2 - Brown Pebble Pattern Vinyl Sheet Flooring
