RE: SUBMITTAL OF ASBESTOS & LEAD SURVEY REPORTS
Ft. Bliss Bldg. #2417
ENCON Project #103-08-094

ASBESTOS SURVEY REPORT
BUILDING 2417
FORT BLISS, TEXAS 79916

ASBESTOS SURVEY REPORT
Ft. Bliss, Bldg. 2417

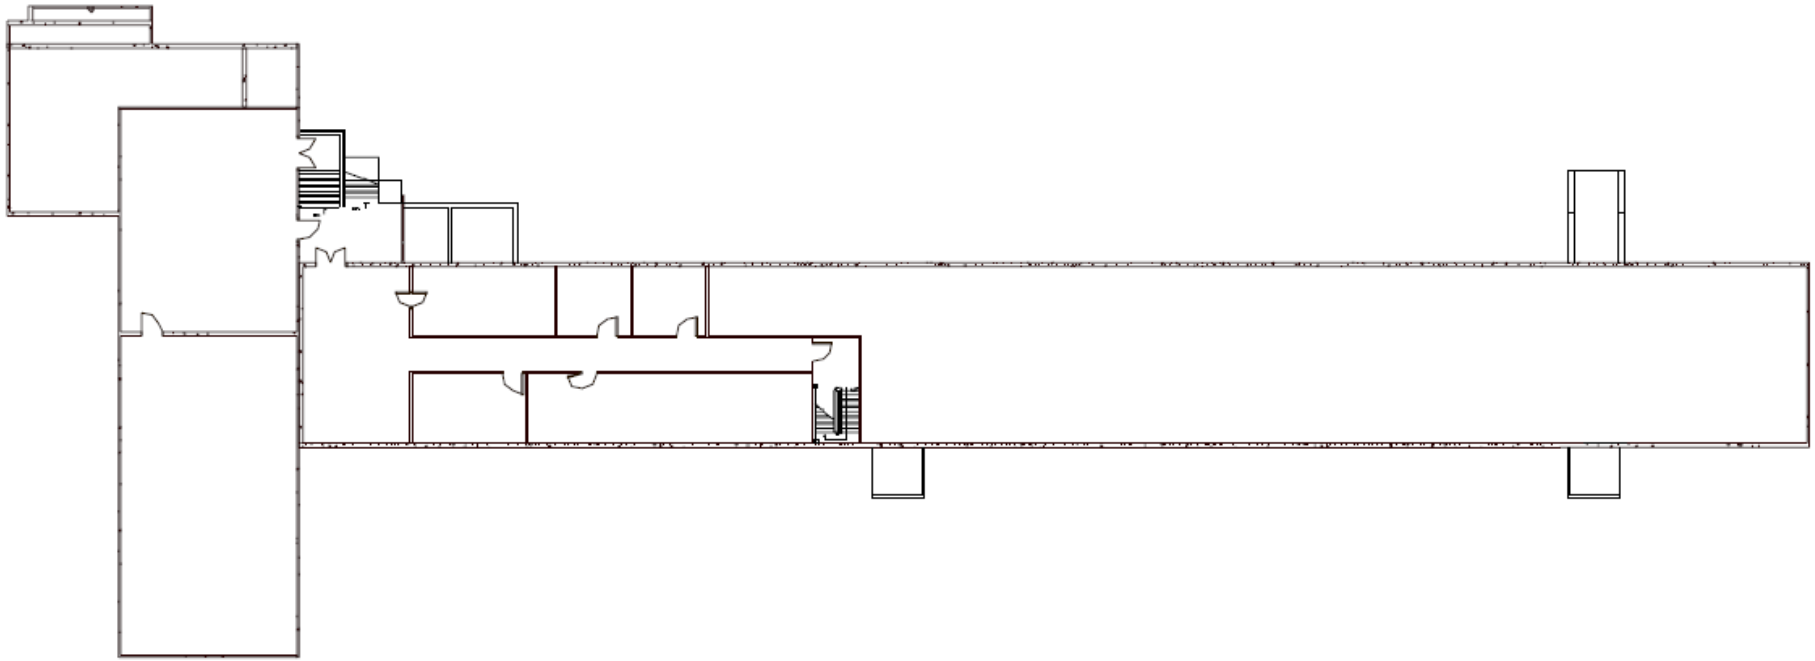
Asbestos Sample Locations **ENCON #: 103-08-094** **Date: 6/27/2008**	**# = Asbestos Sample Location** **# = Positive Asbestos Sample Location**	**Bldg. 2417 – basement** **Asbestos Sample Location Drawing**	**N.T.S**

No Access to Basement
