# Utility Crossing Inspection Program

Reference ID (DS\_ID): 17369

## Detailed Field Report

Sutter Maintenance Yard - (ST0003)

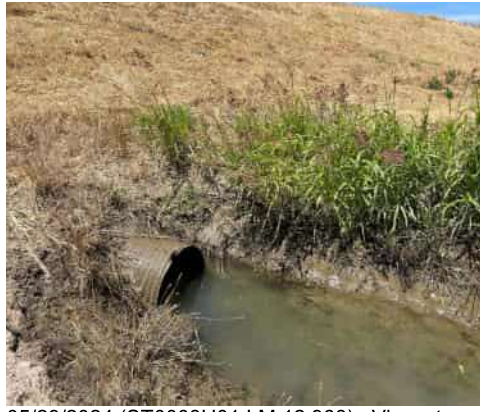
05/29/2024 (ST0003U01 LM:12.963) : View at landside pipe opening

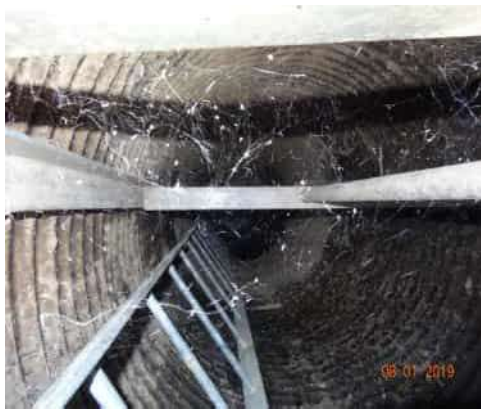
11/12/2019 (ST0003U01 LM:12.963) : WS view: inside view of CMP riser.

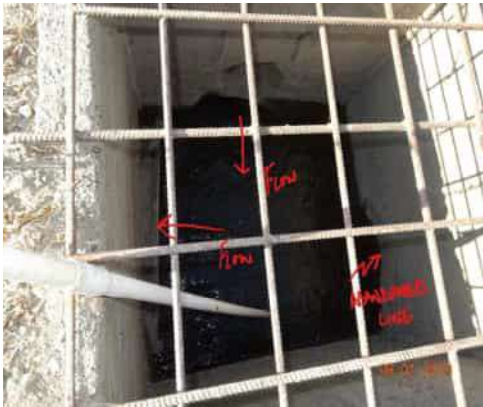
08/01/2019 (ST0003U01 LM:12.963) : WS view: pipe running during inspection (flow schematics).

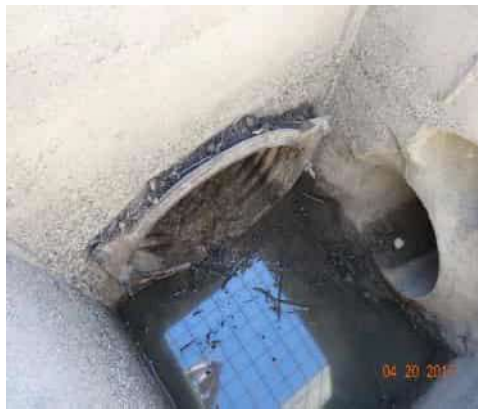
04/20/2017 (ST0003U01 LM:12.963) : View inside of WS surge box 4/20/2017

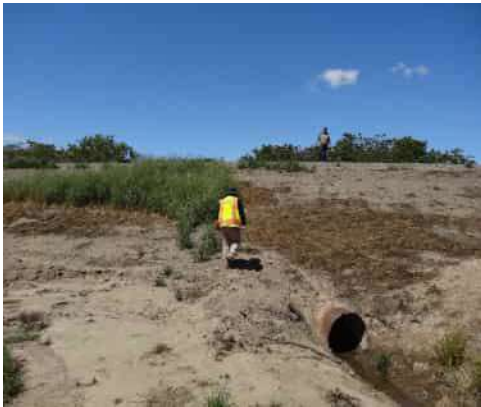
04/14/2016 (ST0003U01 LM:12.963) : View of LS slope above ditch.

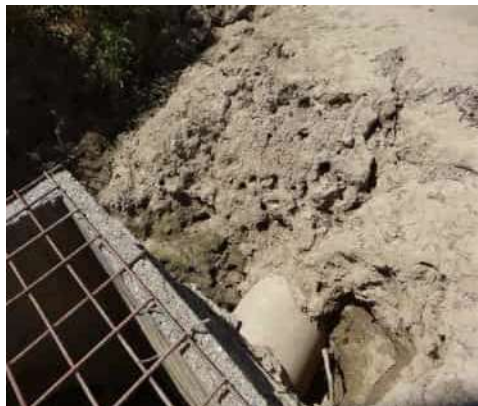
04/14/2016 (ST0003U01 LM:12.963) : WS slope: another view of scour hole

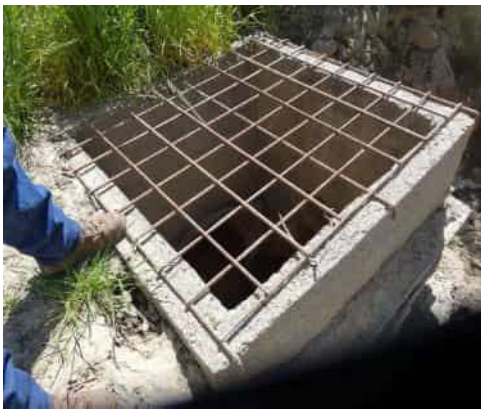
04/14/2016 (ST0003U01 LM:12.963) : WS slope: pipe visible inside concrete surge box (photo taken facing WS slope)

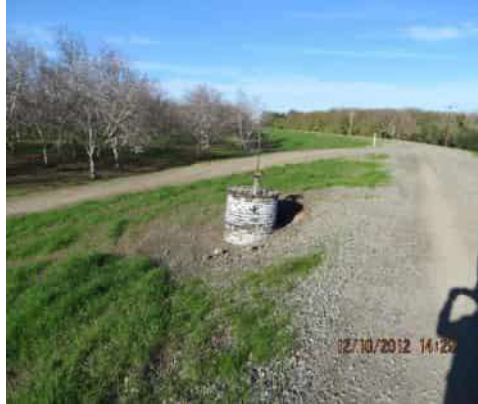
12/10/2012 (ST0003U01 LM:12.963) : WS view: CMP riser on levee slope.

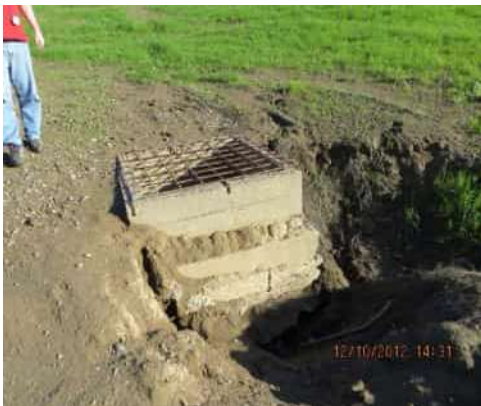
12/10/2012 (ST0003U01 LM:12.963) : WS view: huge erosion around concrete surge box

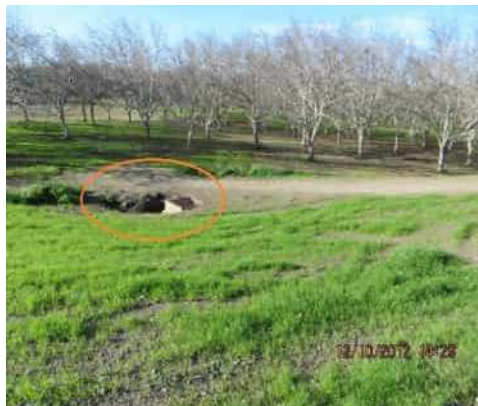
12/10/2012 (ST0003U01 LM:12.963) : WS view: overview of concrete surge box

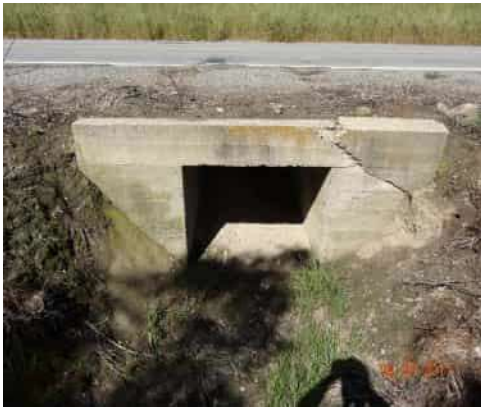
04/20/2017 (ST0003U01 LM:13.376) : LS headwall across River road.

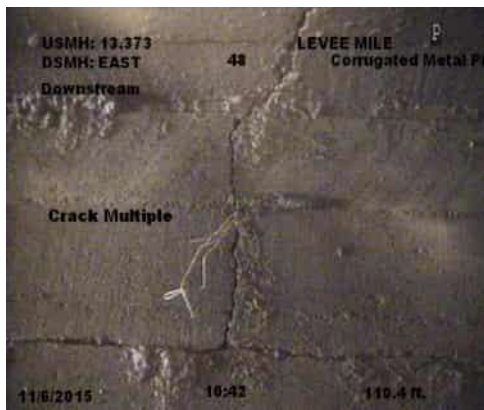
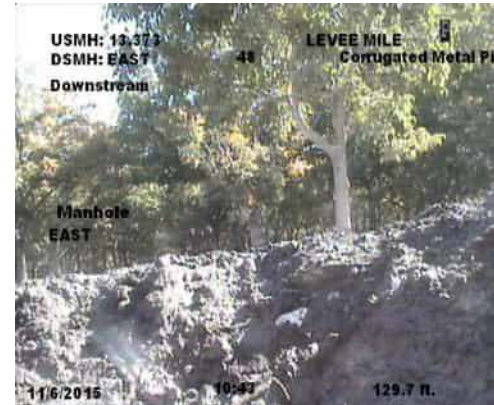
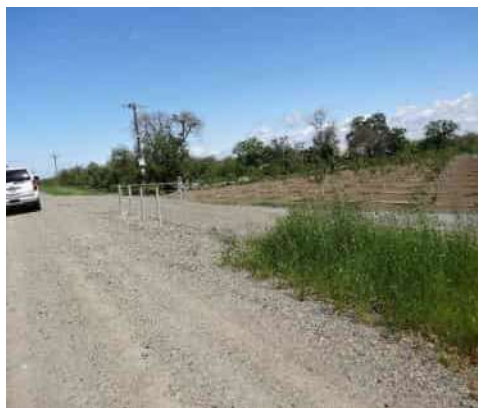
06/14/2016 Pipe was internally cleaned and camera inspected on 11-6-2015 by Nor-Cal Pipeline Services. The 48" cmp pipe section that runs through the levee was deemed to be in good condition. After the LS levee toe the pipe changes to a 48" concrete box culvert for under the roadway and that showed signs of some cracking. After the inspection the WS end was capped to keep sediment out until further abandonment can be achieved. (A. Freitag - DWR Sutter Yard)

06/16/2016 (ST0003U01 LM:13.376) : Snapshot from internal inspection performed by Nor-Cal Pipeline Services on 11/6/2015.

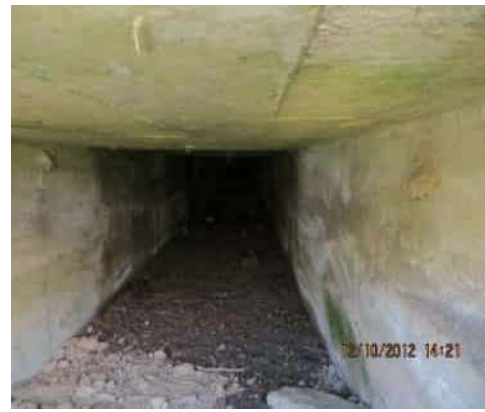
12/10/2012 (ST0003U01 LM:13.376) : LS view:  
damaged concrete culvert across the road

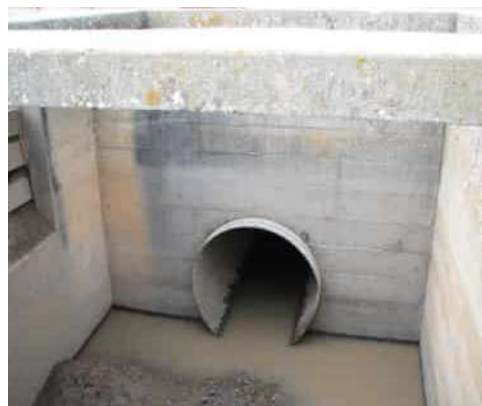
11/27/2012 (ST0003U01 LM:18.612) : LS view: inlet structure

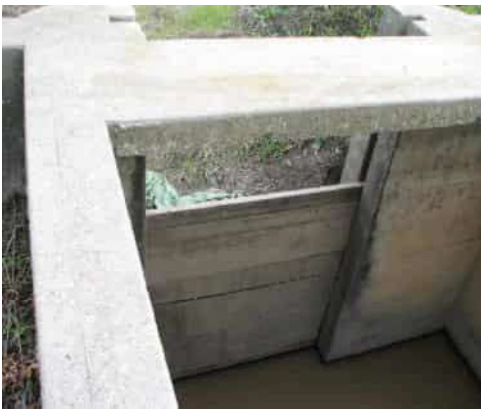
11/27/2012 (ST0003U01 LM:18.612) : LS view: wooden gate at inlet box.

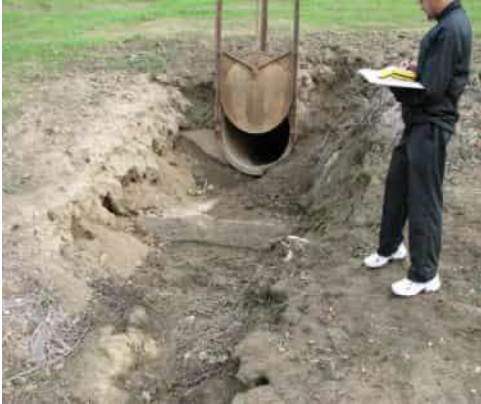
06/16/2016 Pipe was internally cleaned and camera inspected on 11-19-2015 by Nor-Cal Pipeline Services. Pipe is 155ft in total length and the inspection showed some minor rusting but no holes or other deformations were found. Pipe is still used by the landowner for irrigation and the sloughing near the WS end was repaired and rockered to prevent future sloughing or erosion. (A. Freitag - DWR Sutter Yard)  
04/14/2016 Sloughing repaired by Sutter Yard with rock revetment. (K. Fazel - DWR UCIP)  
04/02/2015 Same as last inspection. Pipe has been selected for internal camera inspection. (A. Freitag - DWR Sutter Yard)  
07/02/2014 Sloughing at outlet and levee slope is damaged due to sloughing. (A. Freitag - DWR Sutter Yard)  
12/19/2013 Same as last inspection. (A. Freitag - DWR Sutter Yard)  
07/24/2013 Same as last inspection. (A. Freitag - DWR Sutter Yard)  
11/27/2012 It is not an abandoned crossing. Sloughing at outlet and levee slope is damaged due to sloughing. (P. Amatya - DWR UCIP)

11/27/2012 (ST0003U01 LM:18.612) : WS view: damaged levee slope

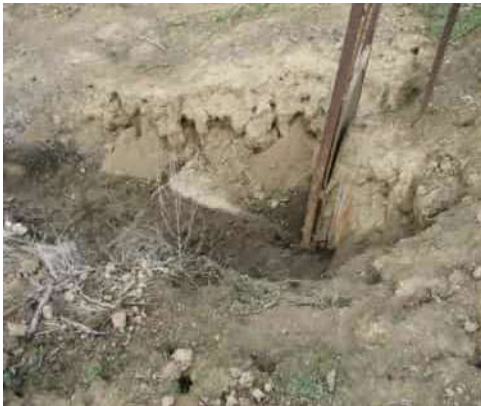
11/27/2012 (ST0003U01 LM:18.612) : WS view: sloughing at outlet pipe
