# Utility Crossing Inspection Program

Reference ID (DS\_ID): 17369

## Detailed Field Report

Sutter Maintenance Yard - (ST0003)

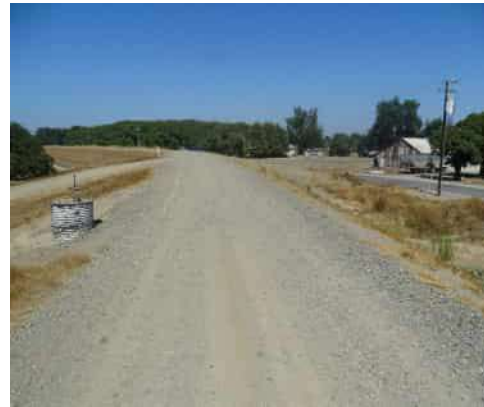
08/30/2018 (ST0003U01 LM:12.963) : Crown view: no signs of levee threat.

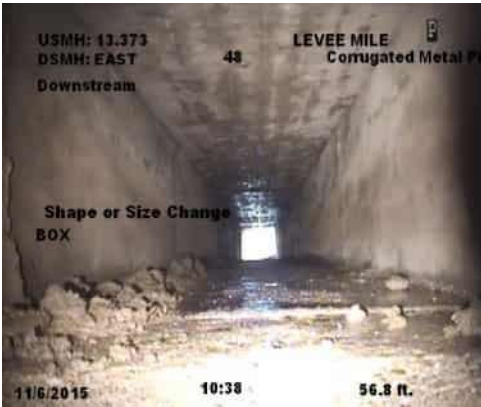
06/16/2016 (ST0003U01 LM:13.376) : Snapshot from internal inspection performed by Nor-Cal Pipeline Services on 11/6/2015.

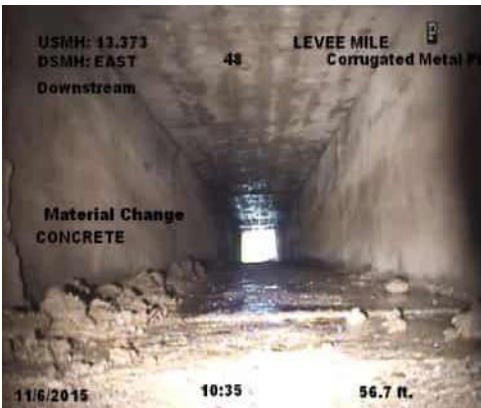
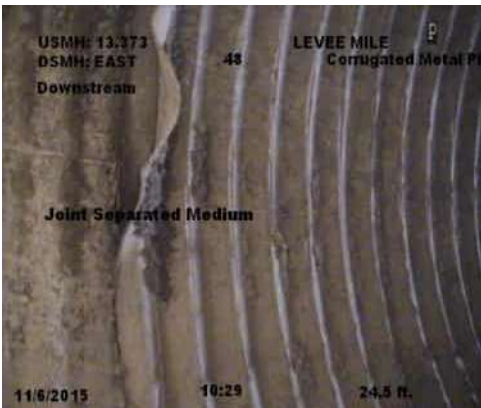
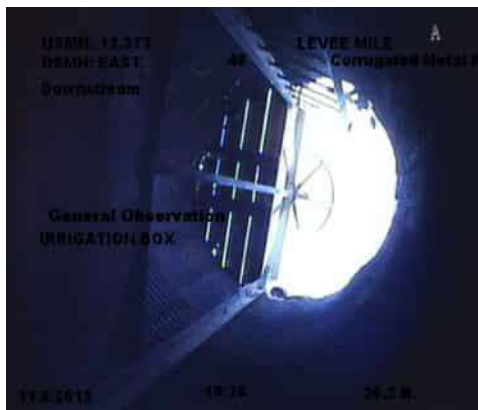
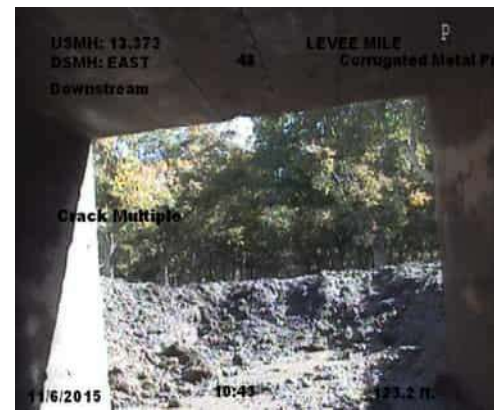
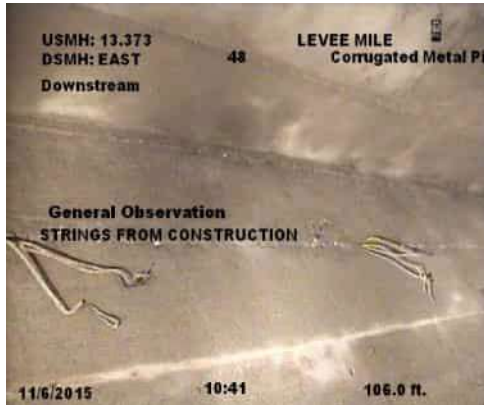
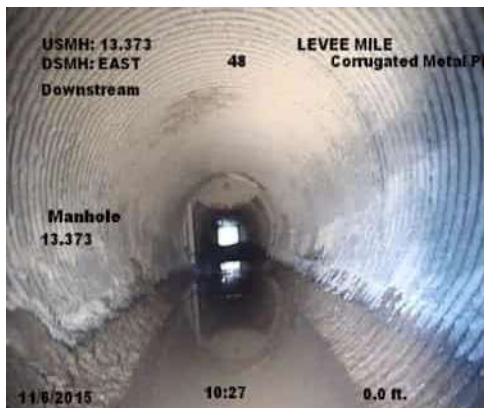
06/14/2016 Pipe was internally cleaned and camera inspected on 11-6-2015 by Nor-Cal Pipeline Services. The 48" cmp pipe section that runs through the levee was deemed to be in good condition. After the LS levee toe the pipe changes to a 48" concrete box culvert for under the roadway and that showed signs of some cracking. After the inspection the WS end was capped to keep sediment out until further abandonment can be achieved. (A. Freitag - DWR Sutter Yard)

06/16/2016 (ST0003U01 LM:13.376) : Snapshot from internal inspection performed by Nor-Cal Pipeline Services on 11/6/2015.

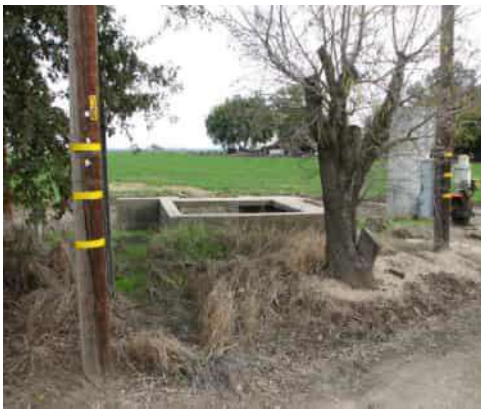
11/27/2012 (ST0003U01 LM:18.612) : LS view: overview
